VEHICLE HAS NEVER BEEN IN AN ACCIDENT; AN INCREDIBLE ACHIEVEMENT CONSIDERING IT HAS ROAMED THE WORLD.

ROADRANGER 2

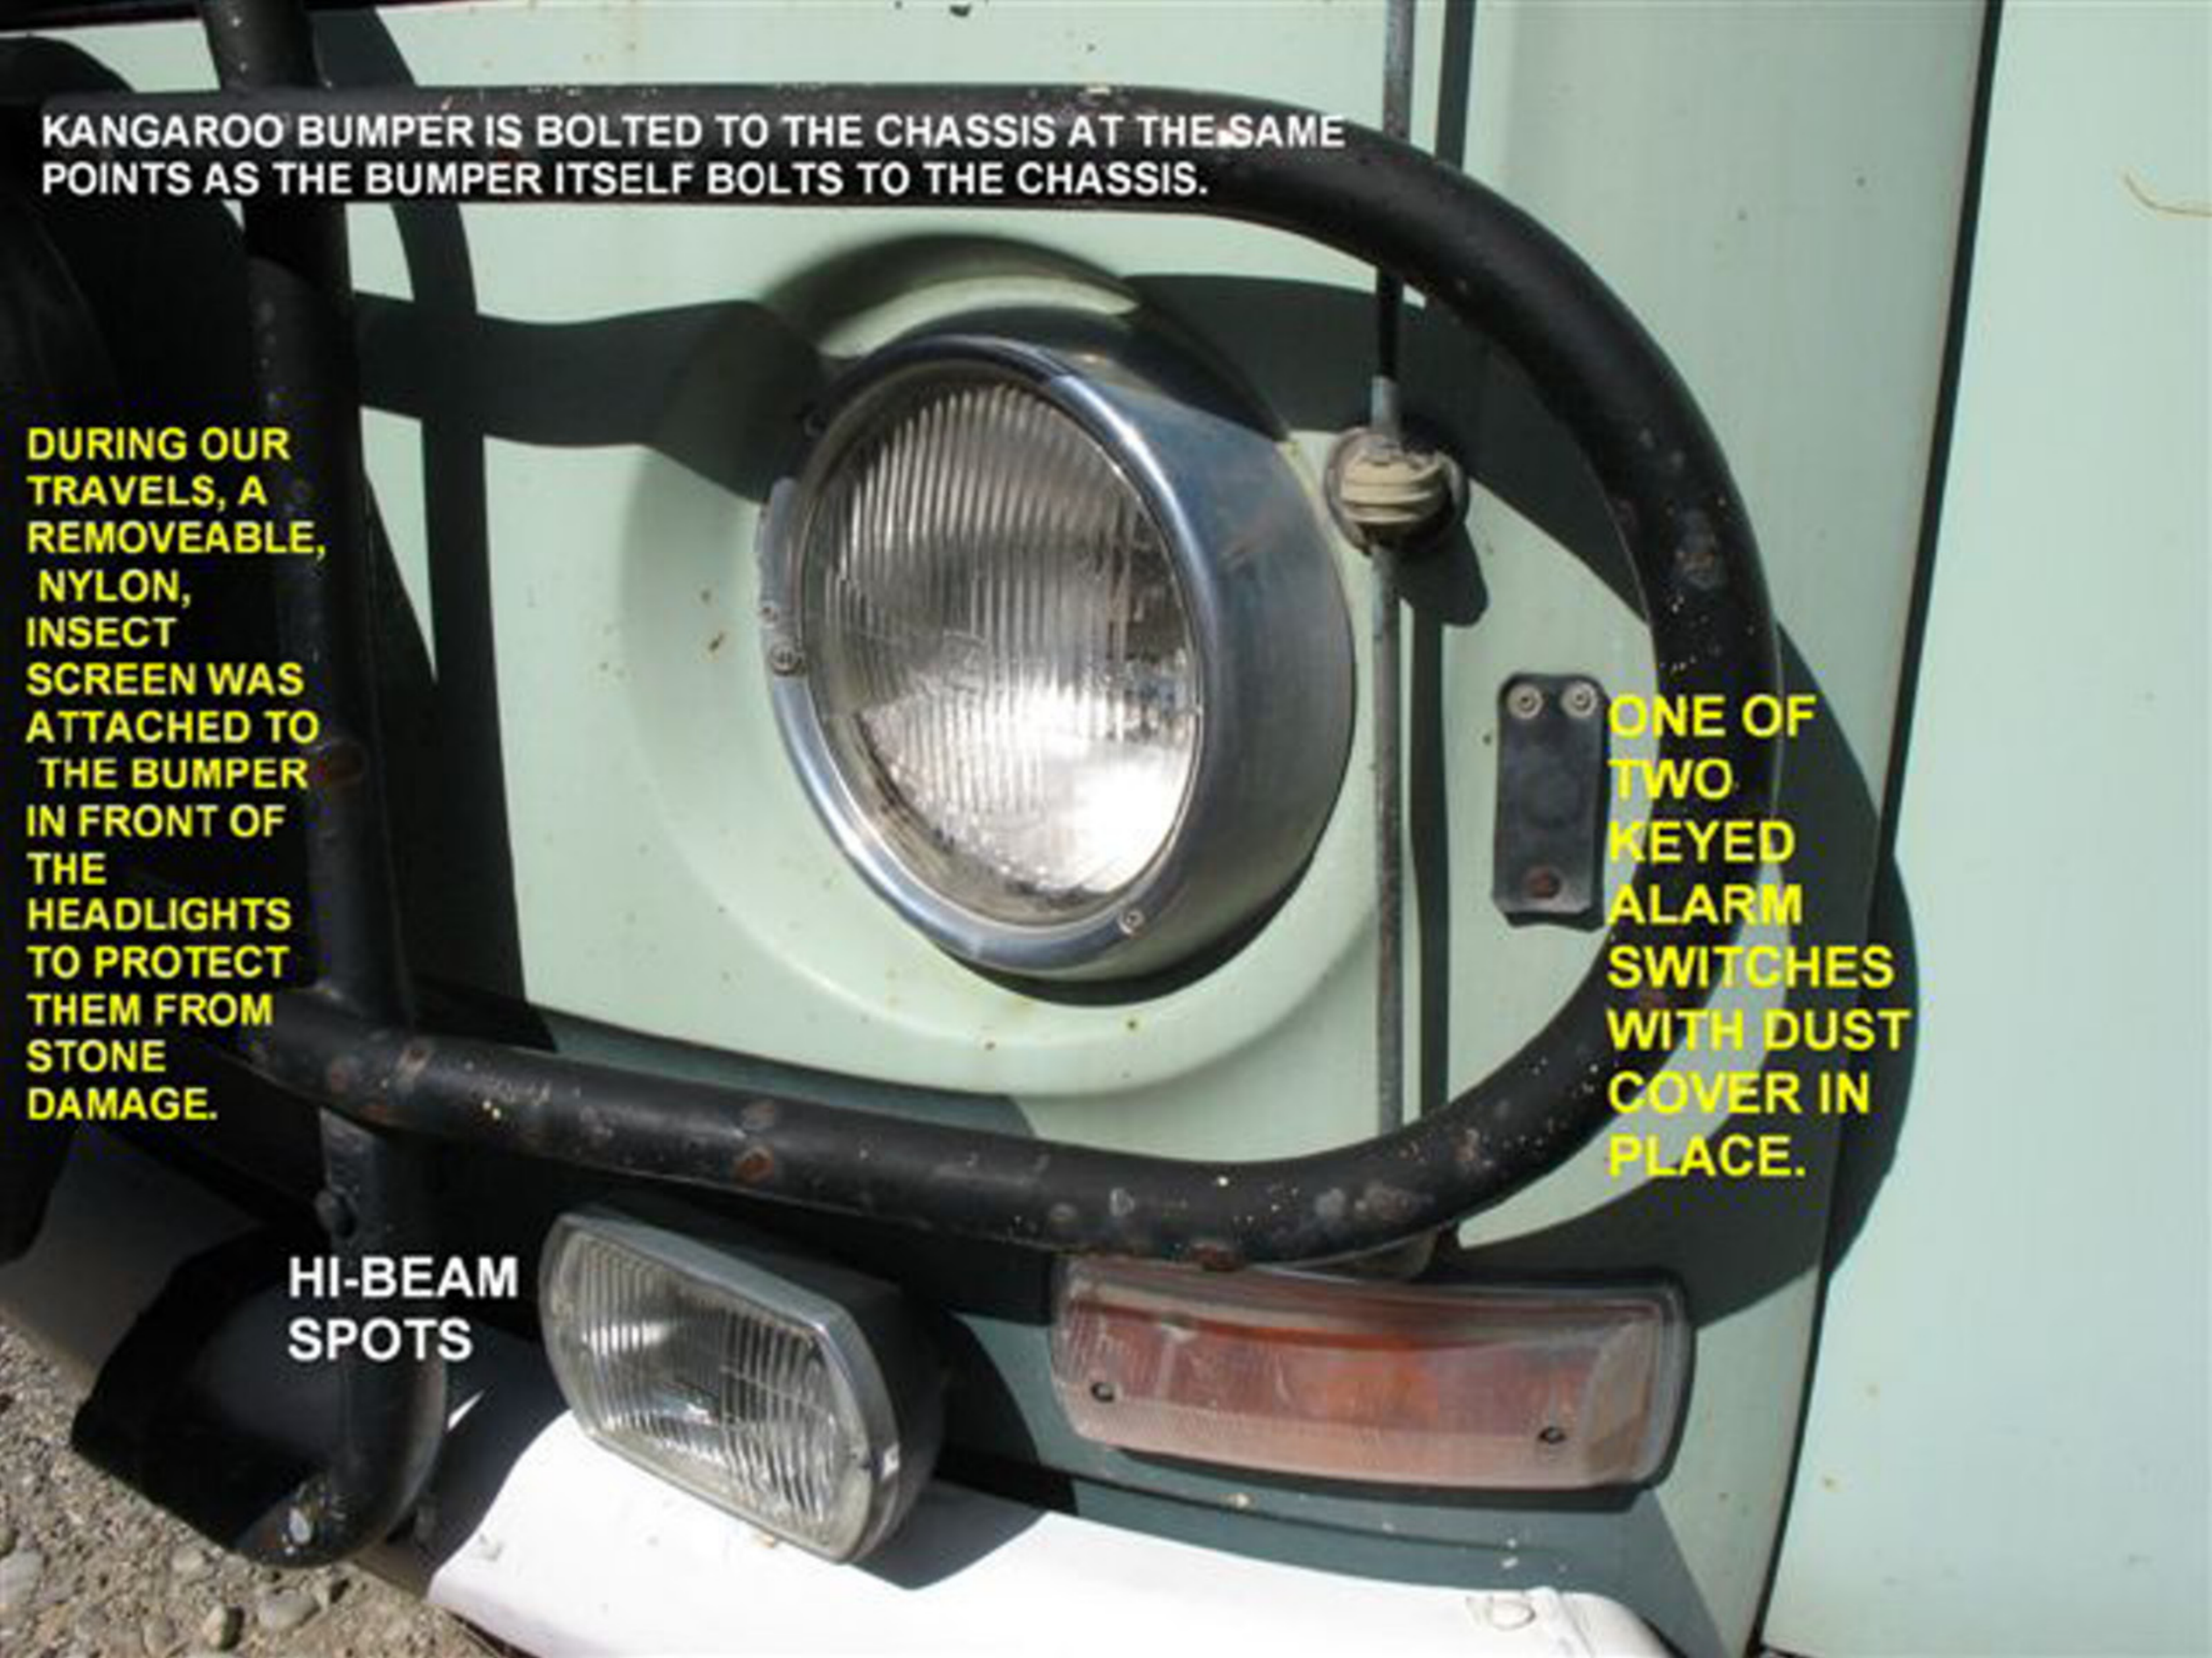
ALUMINIUM MESH SUNVISOR

WIND DEFLECTOR

AUSSIE STYLE BULL BUMPER; VERY SOLID.

THE REMOVEABLE POLYCARBONATE WINDSHIELD HAS SAVED THE ORIGINAL FROM REPLACEMENT MANY TIMES OVER. RUBBER SPACES KEEP THE TWO APART SO THEY DON'T ABRAISE EACH OTHER AND ALLOWS THE WIPERS TO OPERATE ON THE SAME CURVE AS THE ORIGINAL SCREEN. AT ONE POINT IN TIME, I HAD ENGINE HEAT PIPED BETWEEN THE TWO....GREAT DEMISTER!! WEATHERING HAS DETERIORATED THE POLYCARBONATE NOW.

KANGAROO BUMPER IS BOLTED TO THE CHASSIS AT THE SAME POINTS AS THE BUMPER ITSELF BOLTS TO THE CHASSIS.

DURING OUR TRAVELS, A REMOVEABLE, NYLON, INSECT SCREEN WAS ATTACHED TO THE BUMPER IN FRONT OF THE HEADLIGHTS TO PROTECT THEM FROM STONE DAMAGE.

ONE OF TWO KEYED ALARM SWITCHES WITH DUST COVER IN PLACE.

HI-BEAM SPOTS

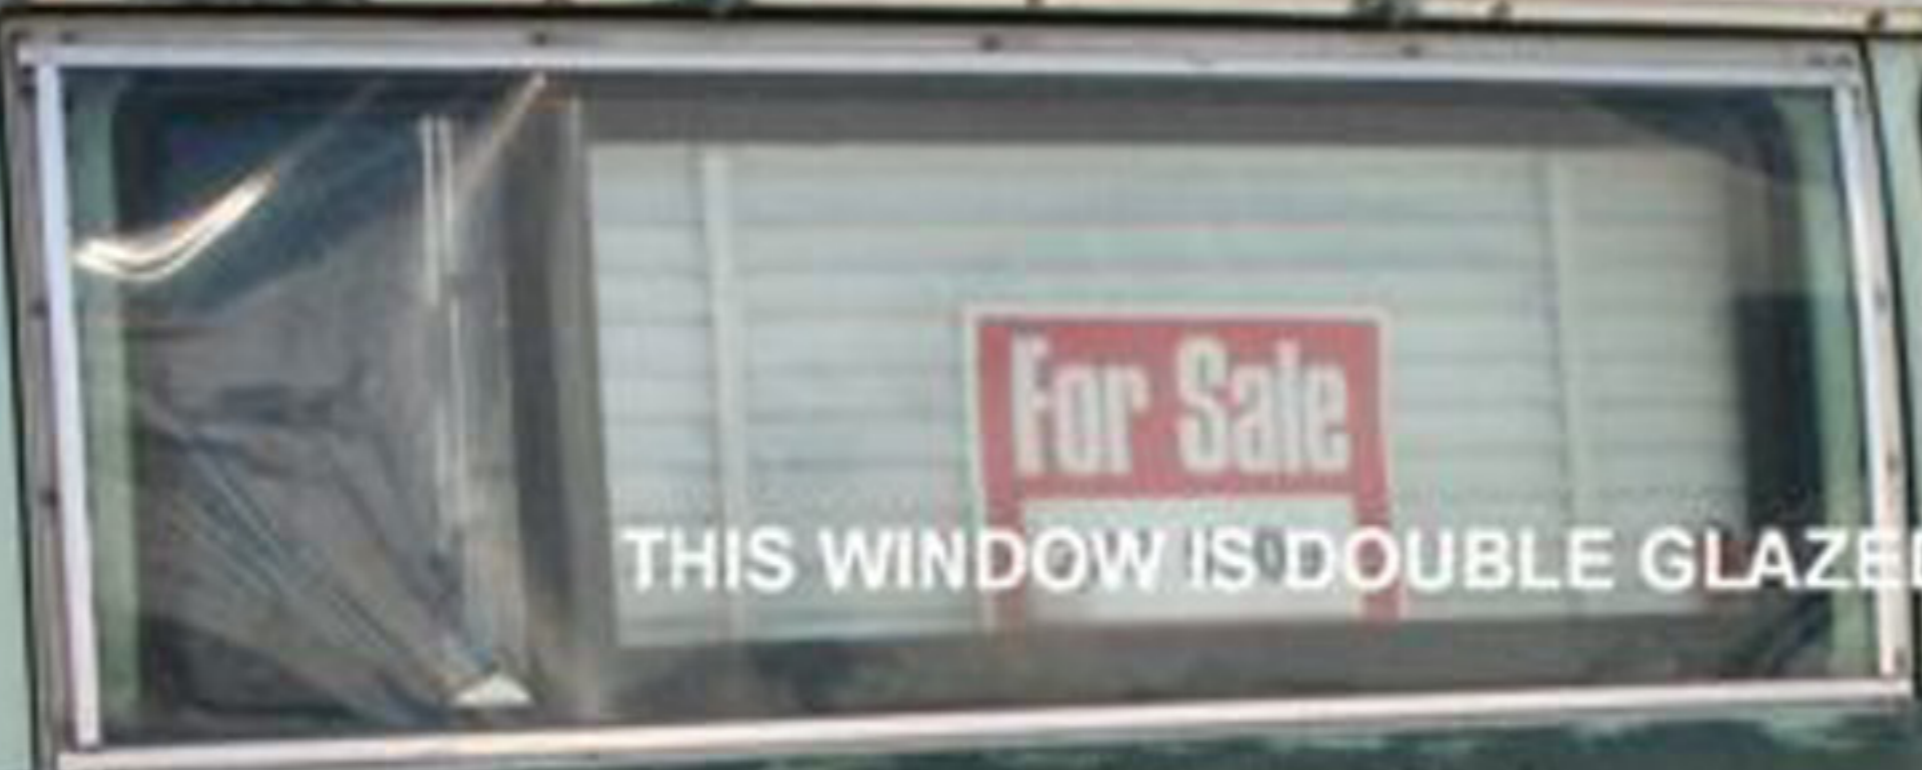
BODY COLOR IS THE ORIGINAL. DARK GREEN TRIMS WERE LATER HANDPAINTED TO GIVE THE VEHICLE-ITS DISTINCTIVE APPEARANCE

FIBREGLOSS ROOF STEPS DOWN AT THE BACK TO ACCOMMODATE REAR ROOFRACK.

THE BODY IS IN GOOD SHAPE FOR ITS AGE WITH VERY LITTLE FROM THE INSIDE OUT RUST BUT WITH SOME SUPERFICIAL EXTERIOR BECAUSE OF WEATHER EXPOSURE. NOT A DIFFICULT RESTORE.

ALUMINIUM PANELS OVER WINDOWS WERE INTRODUCED LATER TO PREVENT FORCED ENTRY AND ALSO KEEP THE VEHICLE WARMER IN WINTER.

GUTTER HOOKS WERE USED TO ATTACH A VINYL TARPAULIN THAT STRETCHED OVER THE VEHICLE FROM SIDE TO SIDE.

DARK GREEN IS WEATHERING OFF TO SHOW PRIMER UNDERNEATH.

ONE HALF OF THIS SIDE WINDOW IS PERMANENTLY DOUBLE GLAZED WITH POLY-CARBONATE; THE OTHER HALF IS ANOTHER CARBONATE PANEL THAT SLIDES IN FRONT OF THE OPEN WINDOW WITH AN OVERLAP SO THAT AIR STILL ENTERS BUT RAIN WILL NOT; MAINTAINS AIR SUPPLY IN HEAVY WEATHER.

HINGED
COVER FOR
REFRIG,
GAS
BURNER
OUTLET.

TEMPORARY COVERPLATE OVER THE
REFRIGERATOR COOLING VENT PREVENTS
SNOW ENTRY IN WINTER.

OPENING SIDE WINDOW IS ALSO GLAZED PRESENTLY COVERED IN PLASTIC TO PROTECT IT FROM SNOW/ICE MELT.

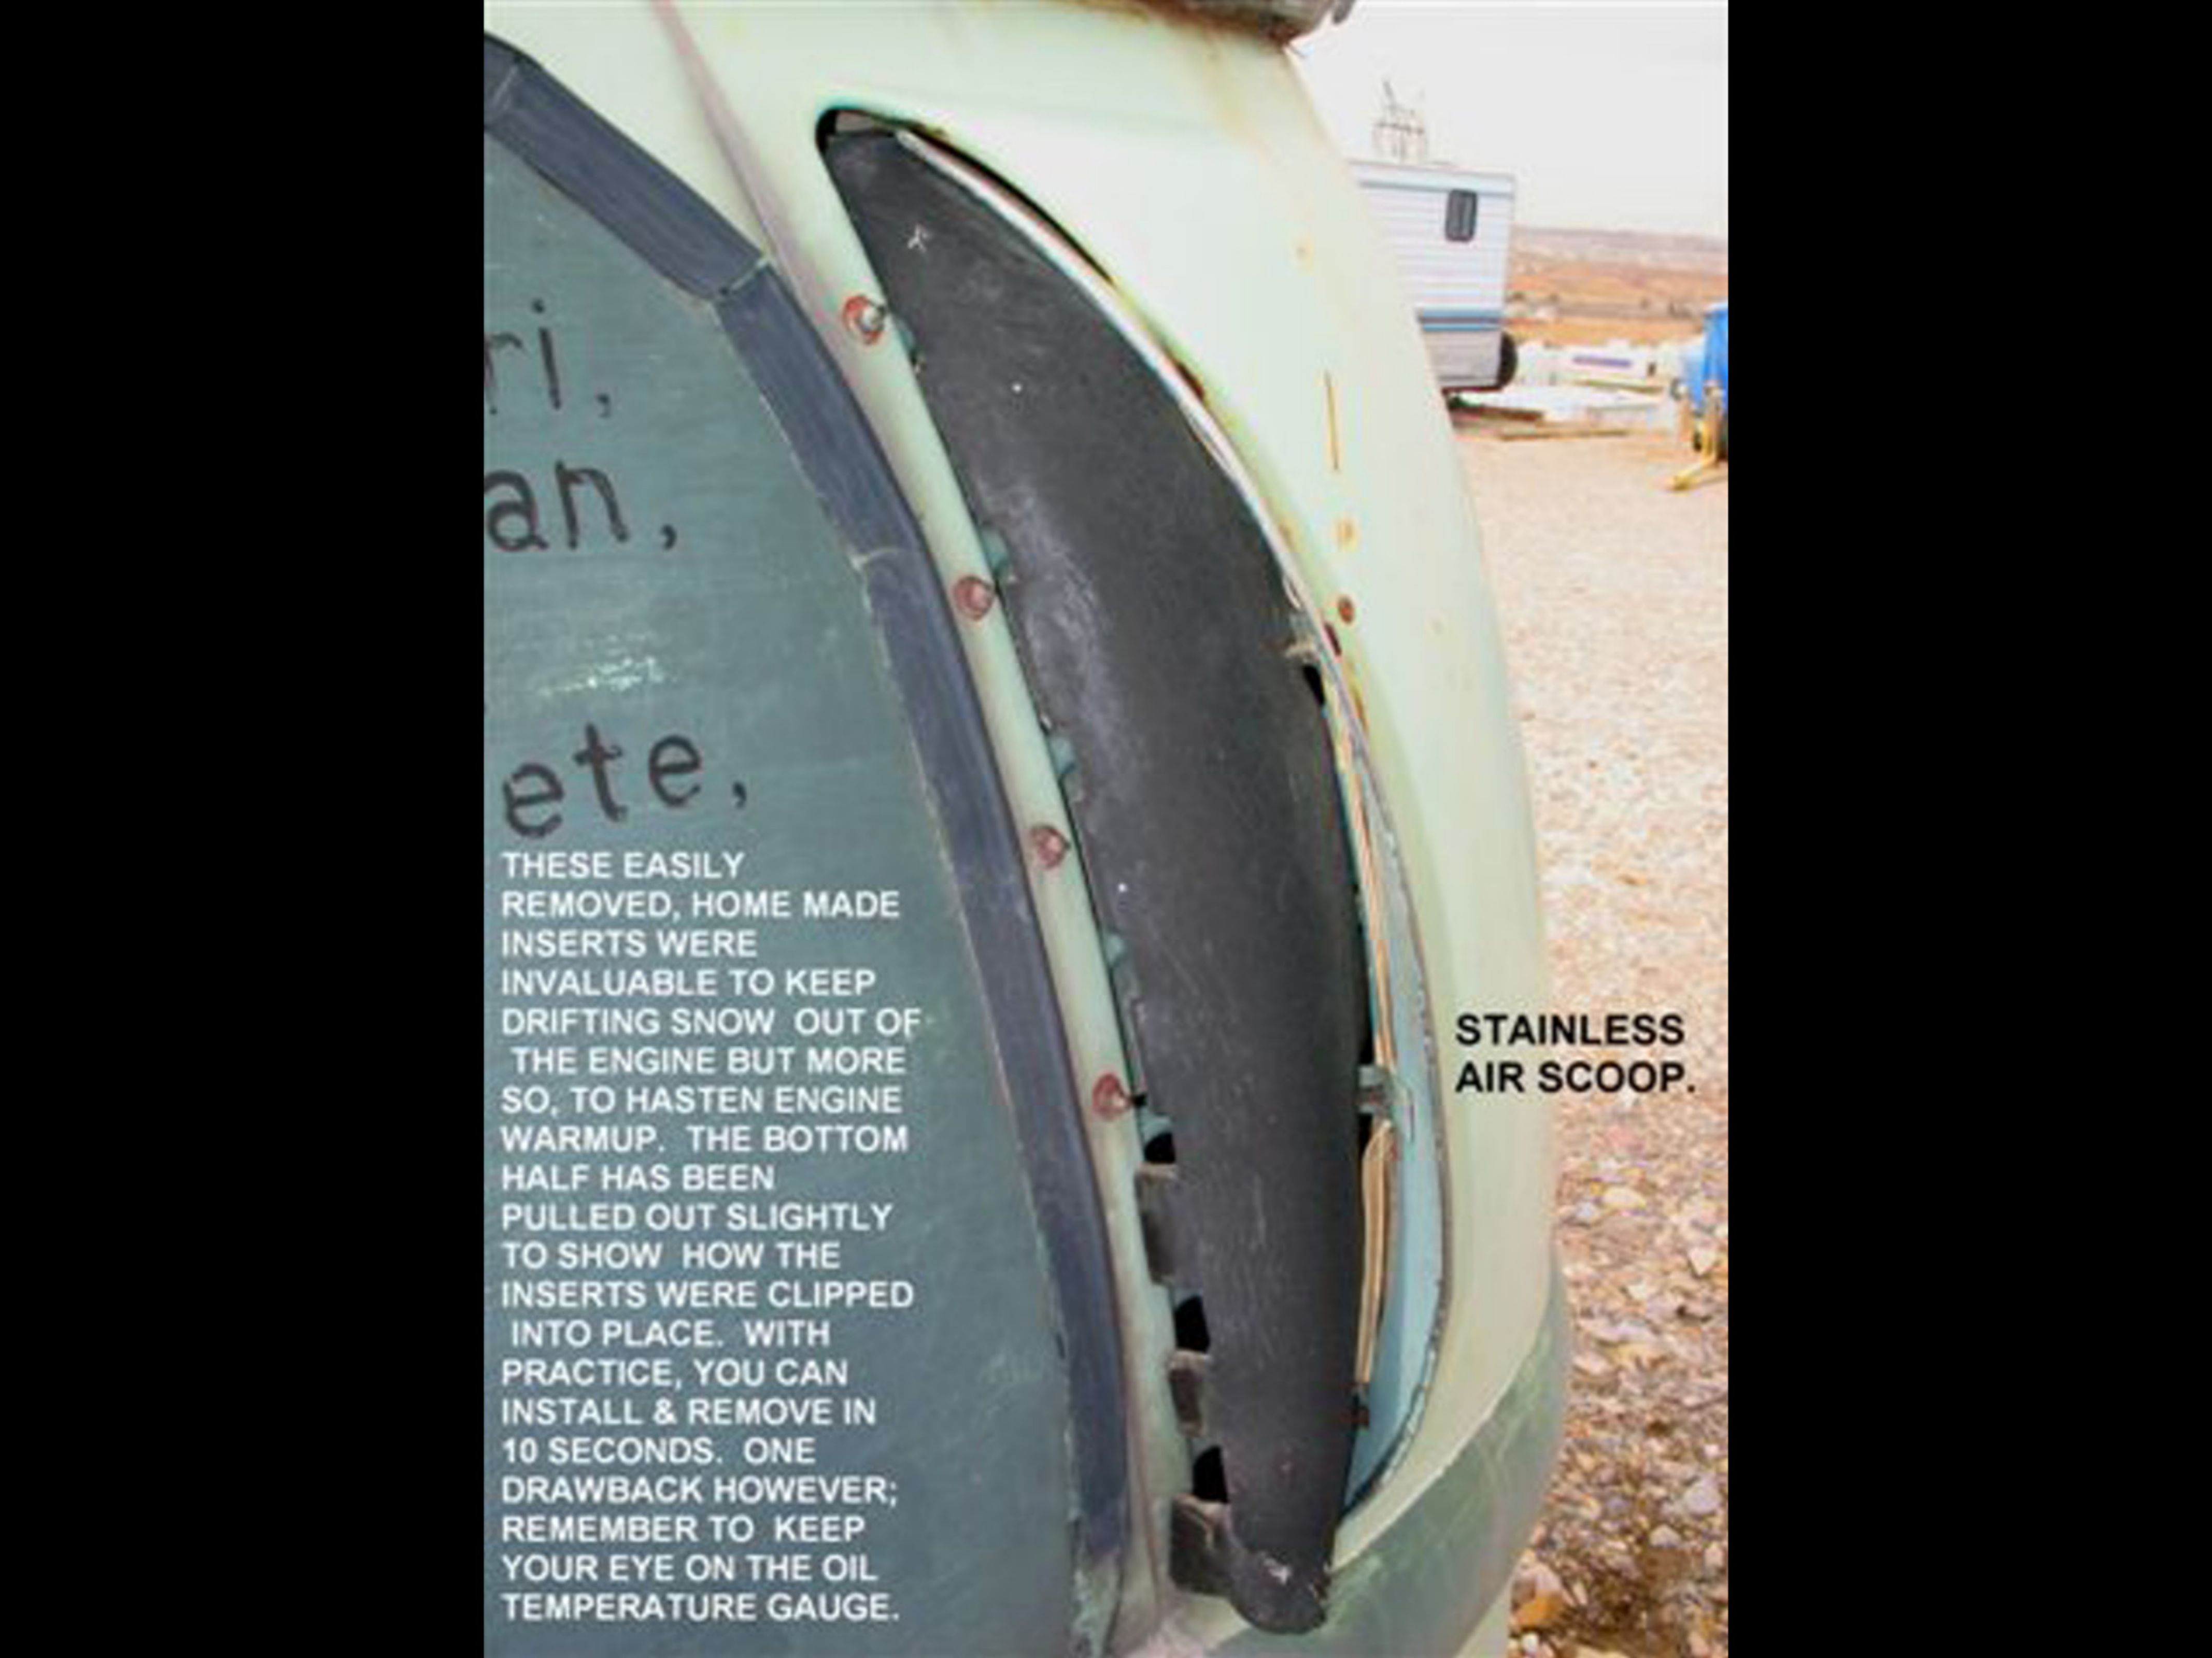
BECAUSE THE VEHICLE IS RIGHT HAND DRIVE, DOUBLE MIRROR SYSTEM WAS NECESSARY, ESPECIALLY WHEN OVERTAKING WHICH WAS RARE FOR THIS VEHICLE BECAUSE OF LACK OF POWER. VEHICLE IS HEAVY, STILL CRUISES AT 50-60 ON FLAT BUT WIND AND HILLS WILL SOON SLOW IT DOWN; DIDN'T WORRY US AS WE WERE NEVER IN A HURRY ANYWAY.

OIL PAINT HAS NOT STOOD UP WELL TO THE WEATHERING IN STORAGE; ORIGINAL BODY COLOR HAS DONE MUCH BETTER.

9FT
SIDE-
COWL
CAR
RADIO
AERIAL

THESE EASILY
REMOVED, HOME MADE
INSERTS WERE
INVALUABLE TO KEEP
DRIFTING SNOW OUT OF
THE ENGINE BUT MORE
SO, TO HASTEN ENGINE
WARMUP. THE BOTTOM
HALF HAS BEEN
PULLED OUT SLIGHTLY
TO SHOW HOW THE
INSERTS WERE CLIPPED
INTO PLACE. WITH
PRACTICE, YOU CAN
INSTALL & REMOVE IN
10 SECONDS. ONE
DRAWBACK HOWEVER;
REMEMBER TO KEEP
YOUR EYE ON THE OIL
TEMPERATURE GAUGE.

STAINLESS
AIR SCOOP.

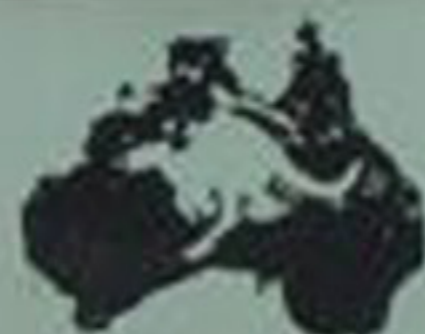
WATER TANK (BEHIND HERE) WAS MOUNTED INSIDE OVER THE BED FOR TWO MAIN REASONS. (1) PREVENT FREEZING; (2) DO AWAY WITH ANY KIND OF MECHANICAL PUMP; GRAVITY FEED IS SIMPLICITY ITSELF.

BLACK SKIRT (ABOVE) KEEPS SNOW MELT FROM GETTING BEHIND THE TAILGATE.

NZ (NEW ZEALAND) PLATES ARE MOUNTED BEHIND THE CURRENT PLATES.

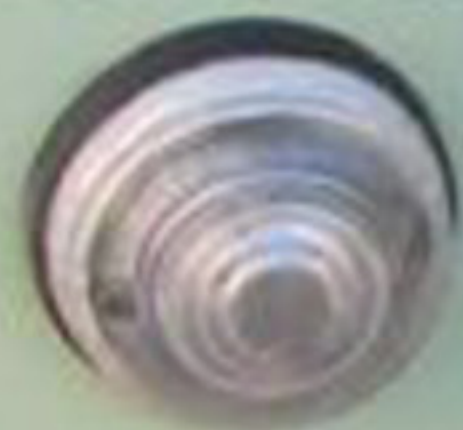
BOX MOUNTS X 2

SWING-OUT OR LIFT OFF BOX SERVED MANY PURPOSES. EXTRA FUEL CARRYING WHEN NEEDED OR WATER; STEPUP ACCESS TO UPPER ROOF RACK WHEN NEEDED; PREVENTED UNWANTED ACCESS TO ENGINE; MADE IT IMPOSSIBLE TO OPEN TAILGATE UNLESS IT WAS REMOVED.

BACKUP LIGHT
ON BOTH SIDES.

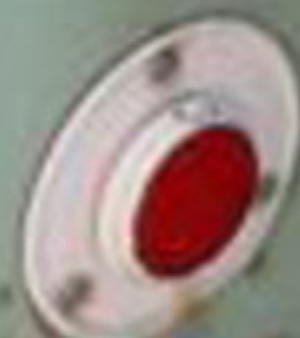
ONE OF TWO KEYED
ALARM SWITCHES
USED AFTER
LEAVING VEHICLE.

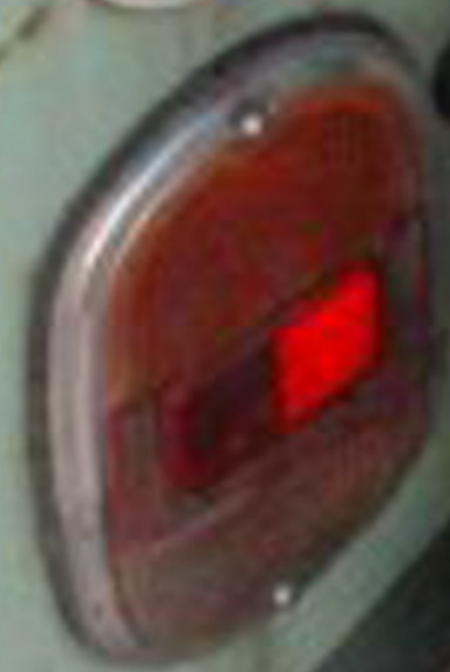
ADDITIONAL,
BRIGHTER, BRAKE
LIGHT X 2.

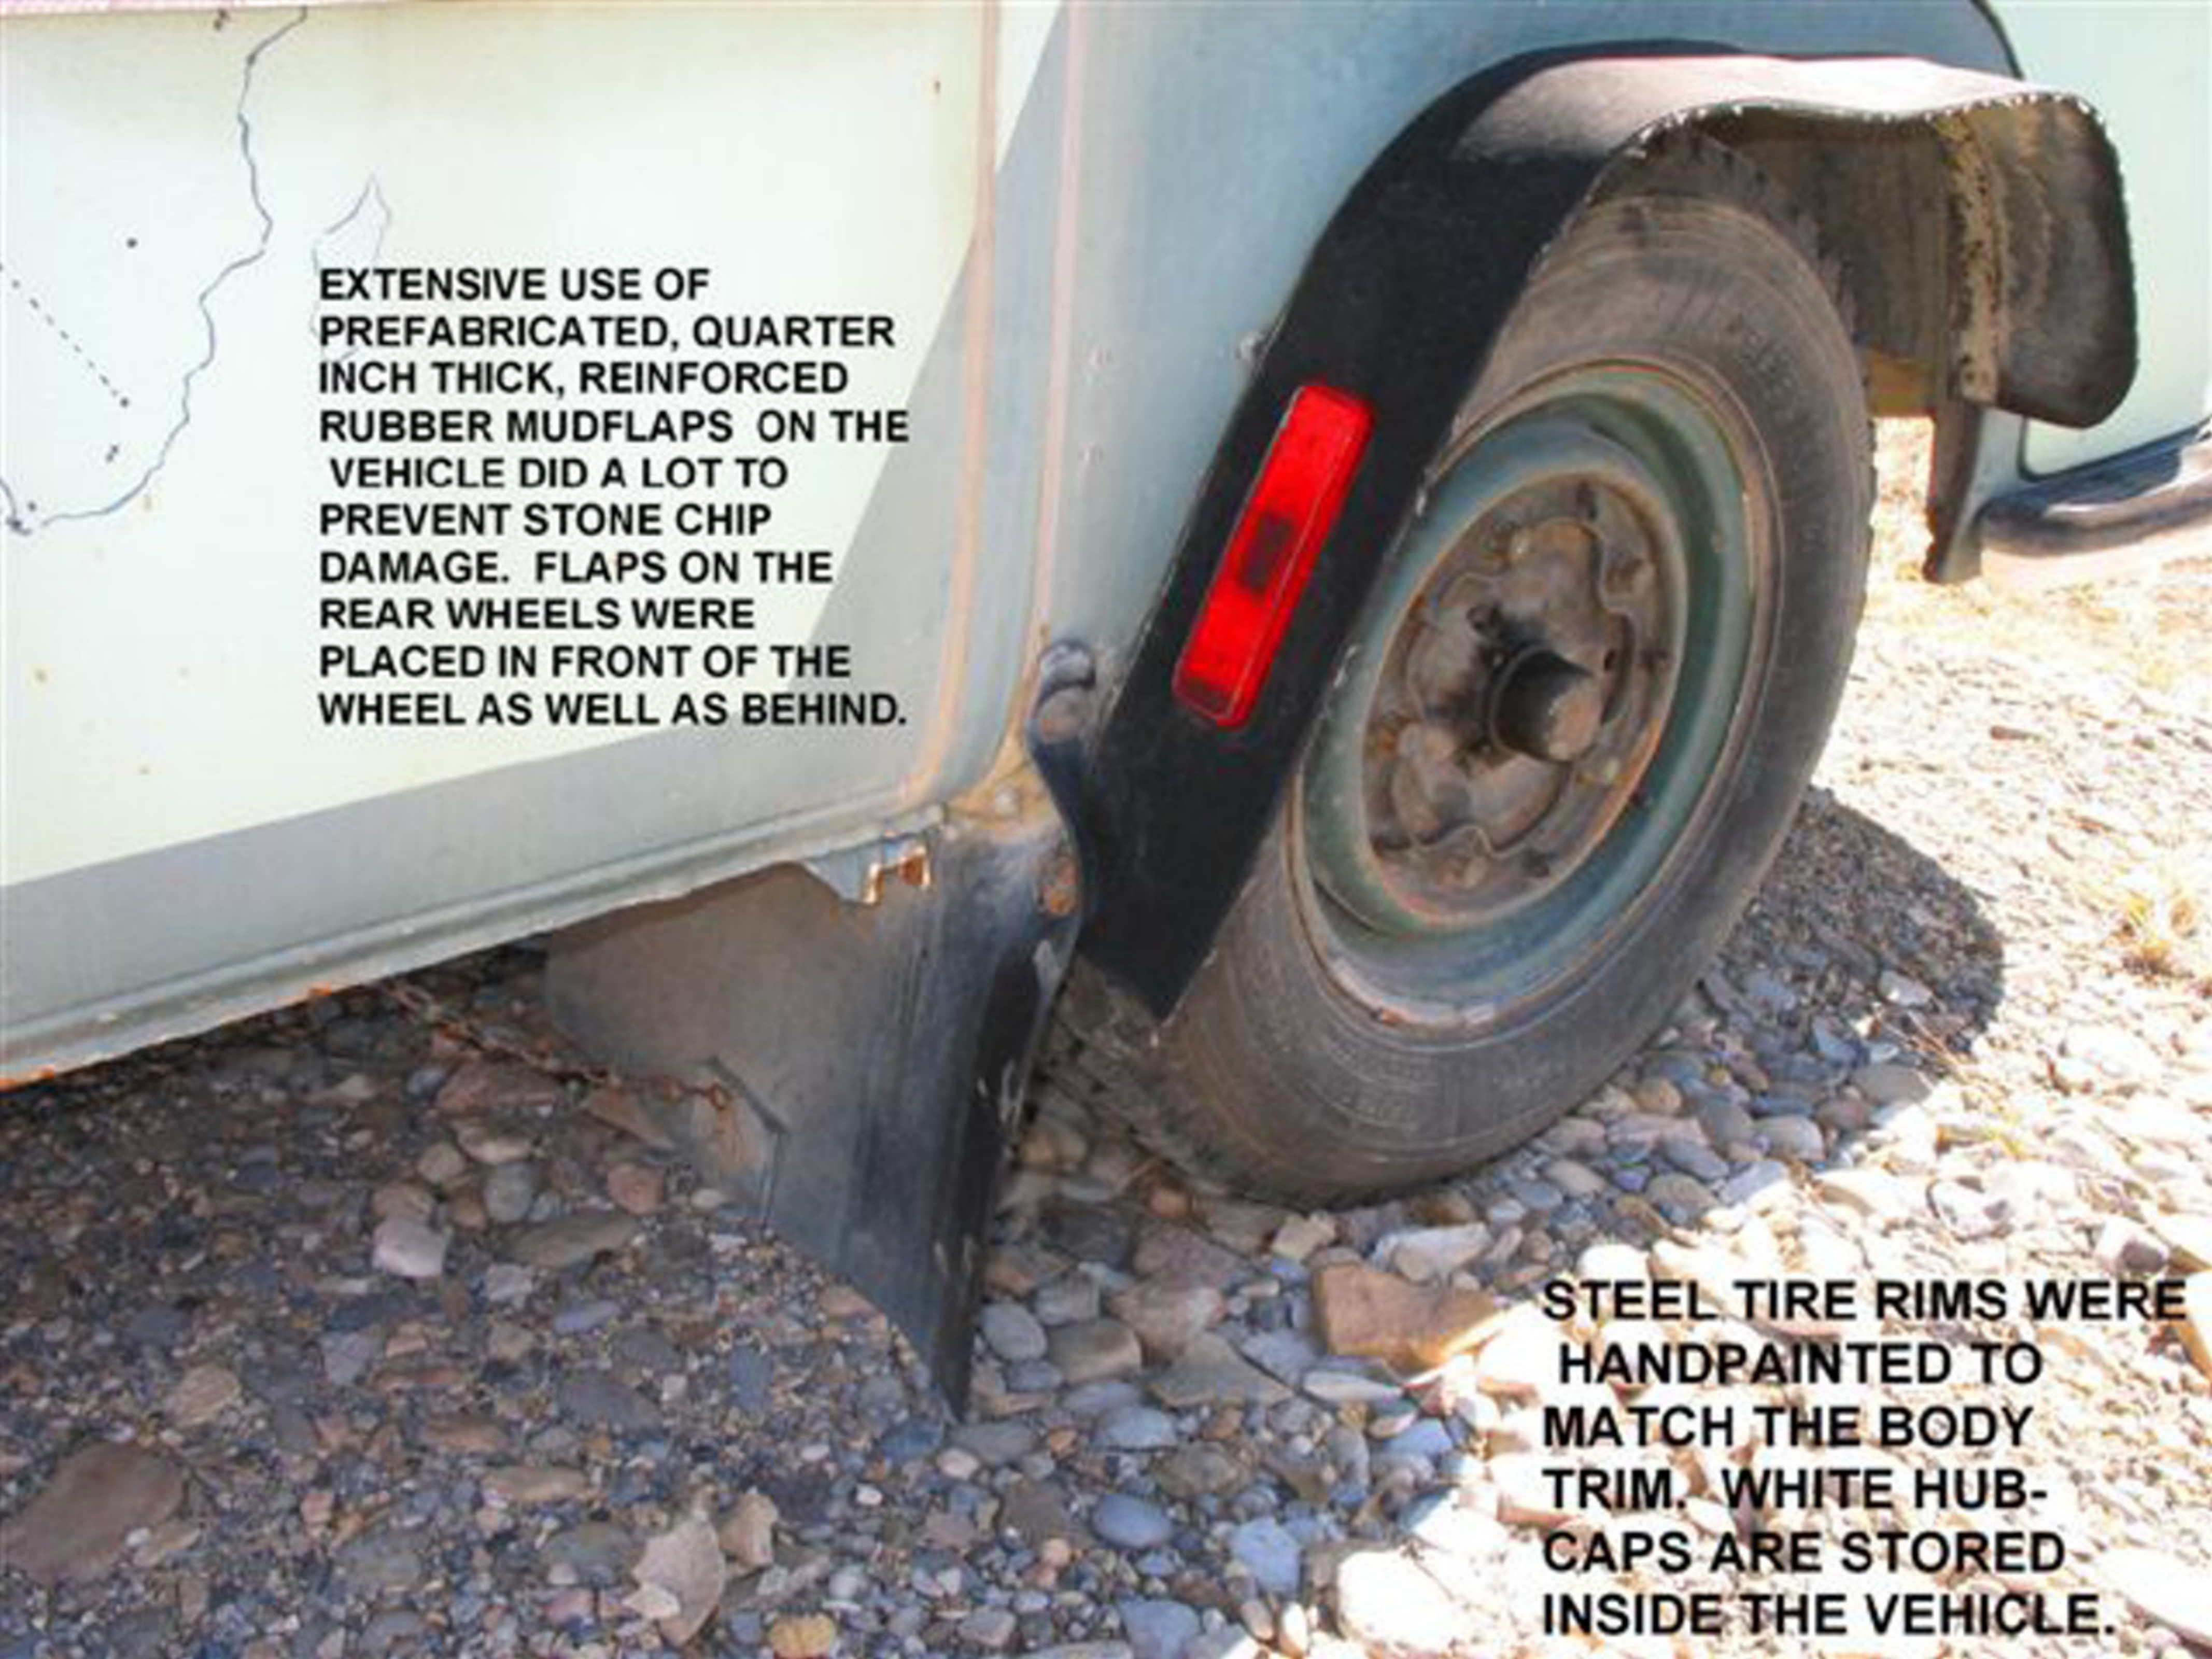
A close-up photograph of the rear wheel and mudflap area of a light blue vehicle. The wheel is a steel rim with a white hubcap, mounted on a black tire. A black mudflap is attached to the wheel well, featuring a red reflective strip. The vehicle's body is light blue, and the ground is covered in gravel. The text is overlaid on the left side of the image.

**EXTENSIVE USE OF
PREFABRICATED, QUARTER
INCH THICK, REINFORCED
RUBBER MUDFLAPS ON THE
VEHICLE DID A LOT TO
PREVENT STONE CHIP
DAMAGE. FLAPS ON THE
REAR WHEELS WERE
PLACED IN FRONT OF THE
WHEEL AS WELL AS BEHIND.**

**STEEL TIRE RIMS WERE
HANDPAINTED TO
MATCH THE BODY
TRIM. WHITE HUB-
CAPS ARE STORED
INSIDE THE VEHICLE.**

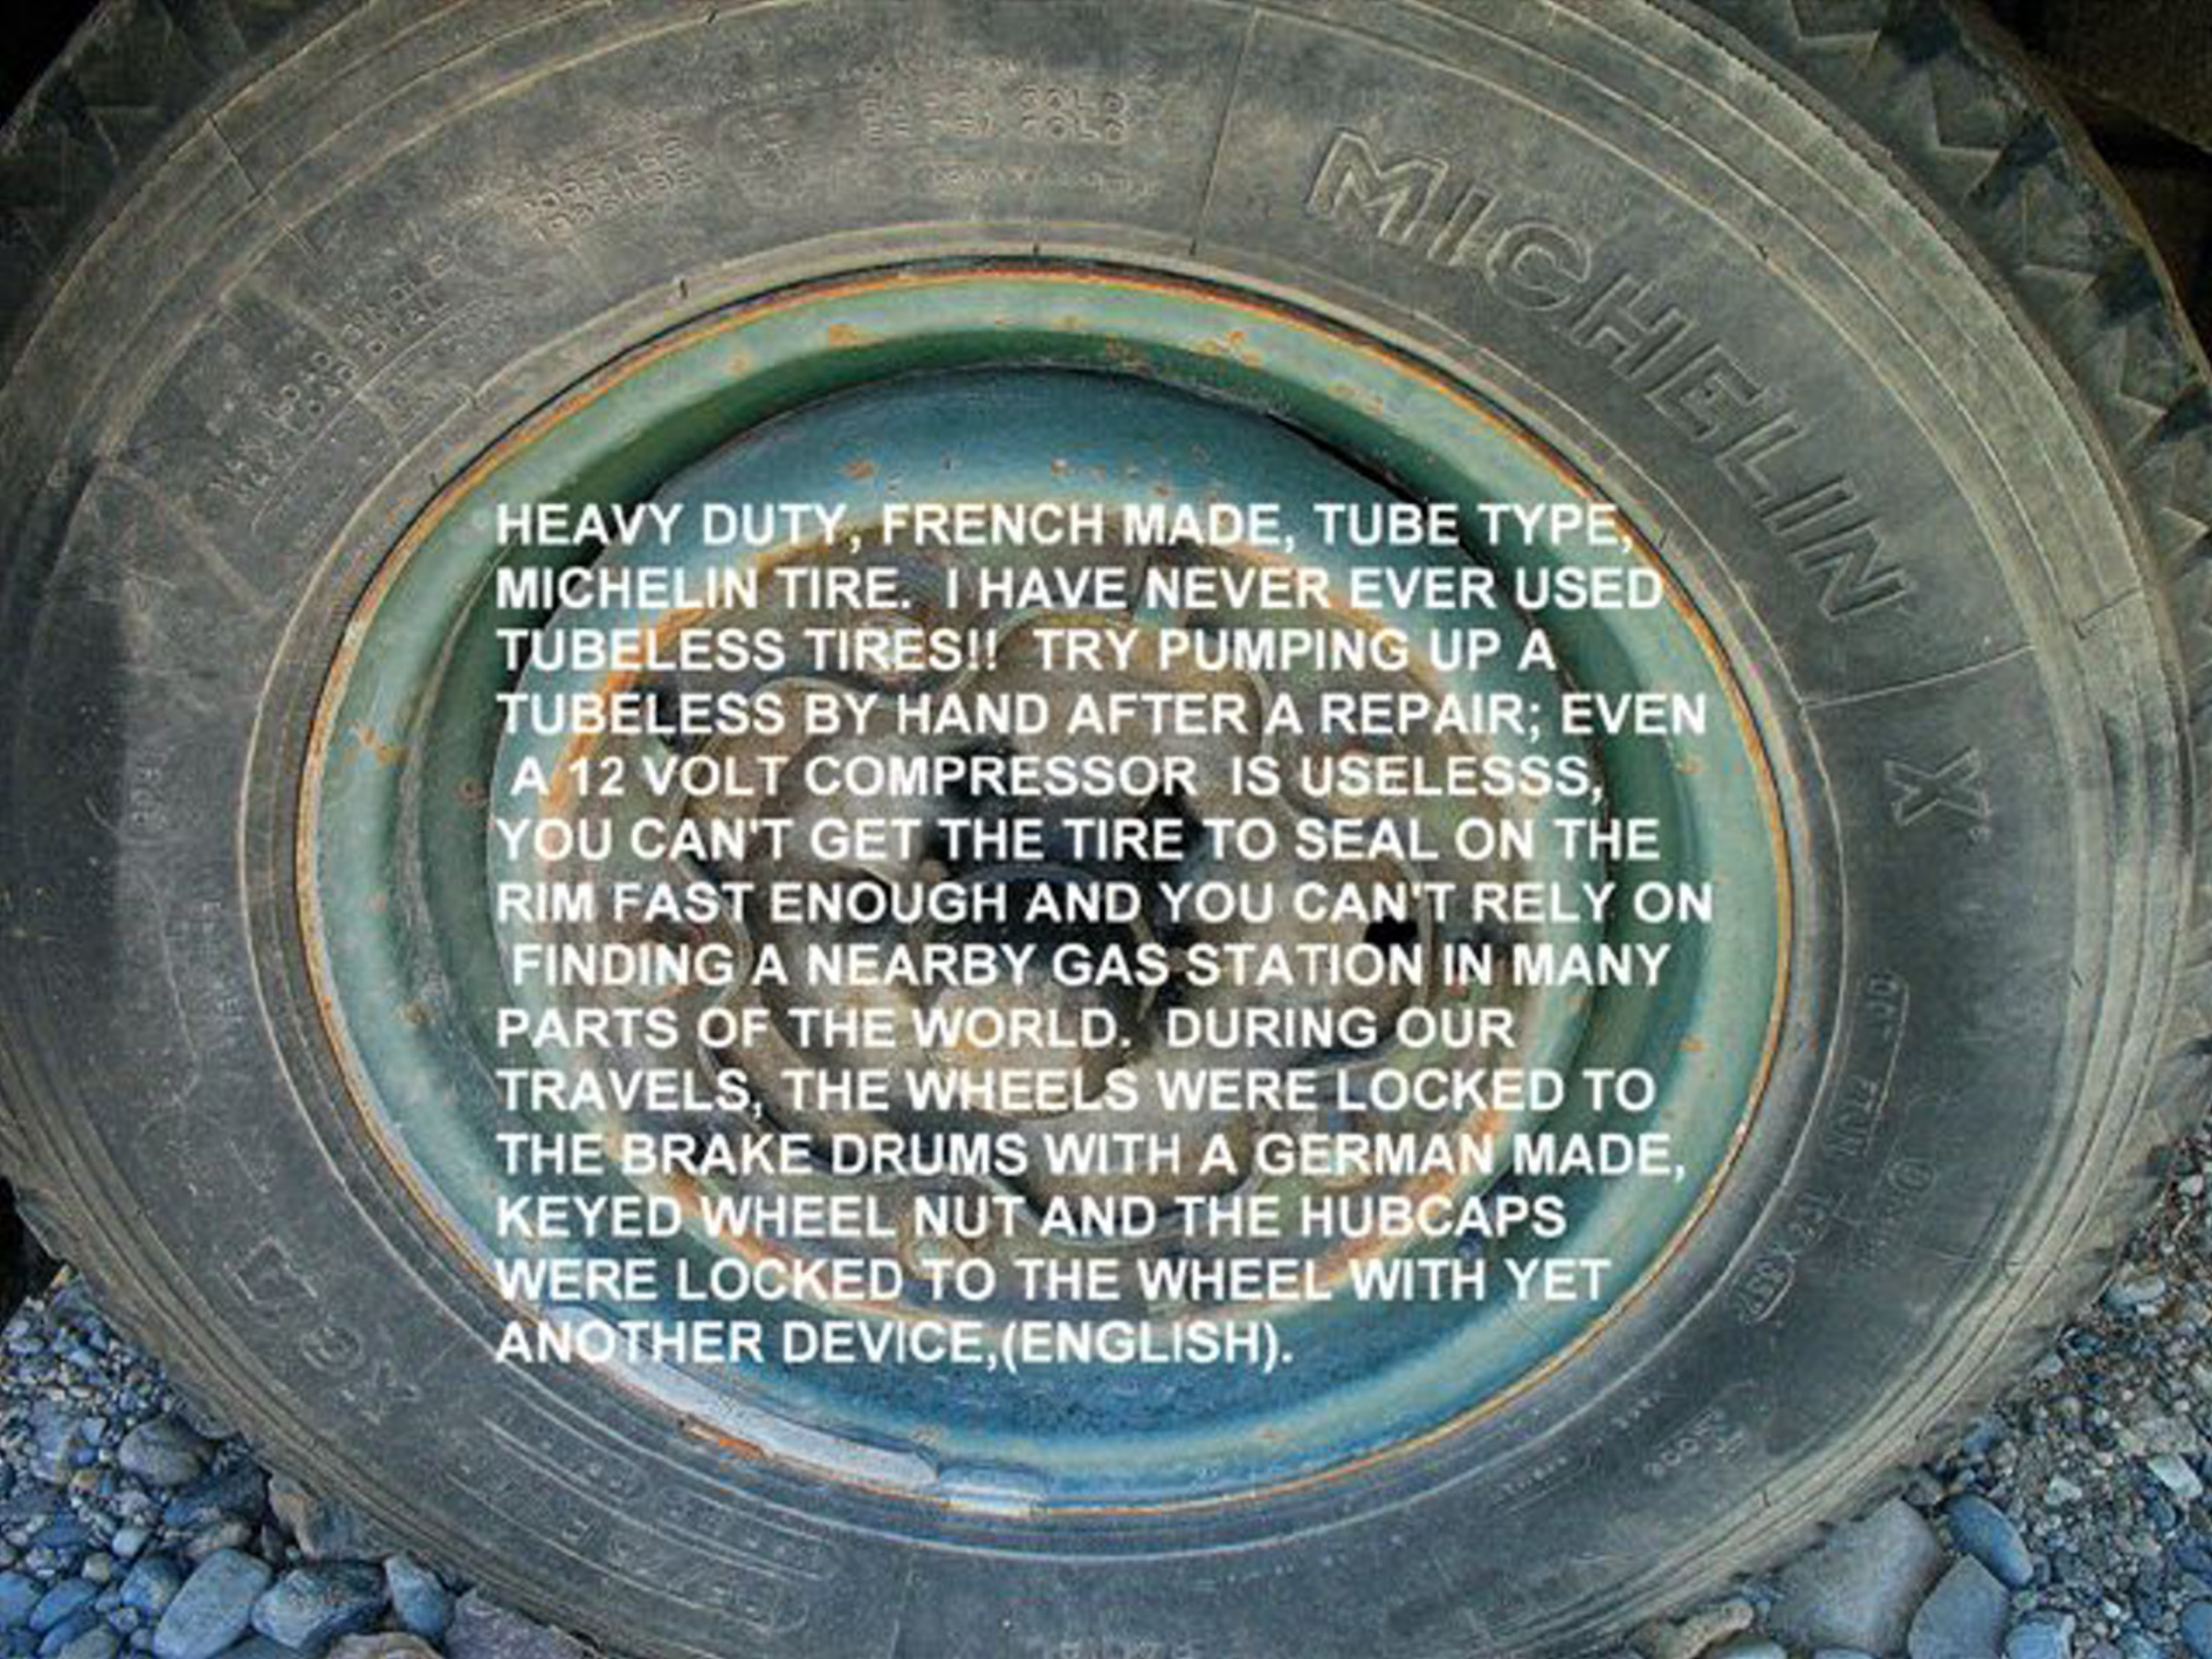
HEAVY DUTY, FRENCH MADE, TUBE TYPE, MICHELIN TIRE. I HAVE NEVER EVER USED TUBELESS TIRES!! TRY PUMPING UP A TUBELESS BY HAND AFTER A REPAIR; EVEN A 12 VOLT COMPRESSOR IS USELESS, YOU CAN'T GET THE TIRE TO SEAL ON THE RIM FAST ENOUGH AND YOU CAN'T RELY ON FINDING A NEARBY GAS STATION IN MANY PARTS OF THE WORLD. DURING OUR TRAVELS, THE WHEELS WERE LOCKED TO THE BRAKE DRUMS WITH A GERMAN MADE, KEYED WHEEL NUT AND THE HUBCAPS WERE LOCKED TO THE WHEEL WITH YET ANOTHER DEVICE,(ENGLISH).
