As experience dictated, the living quarters of RR2 was refined many times to cater for changing conditions but not forgetting the fact that it had to remain a vehicle suited for less than ideal conditions. It was no luxury motorhome but in contrast to such a vehicle, it would park, camp and go almost anywhere economically and reliably. In many countries, campgrounds were few and far between and trying to reach them, placed an undesirable burden on one's day. However, if there was one thing while travelling that we really tried to avoid, it was a campground; for the most part, they represented everything we were trying to escape from. But enough said, let's have a look inside what was our home for 17 years.

LIVING AREA VIEW
FROM SIDE DOOR

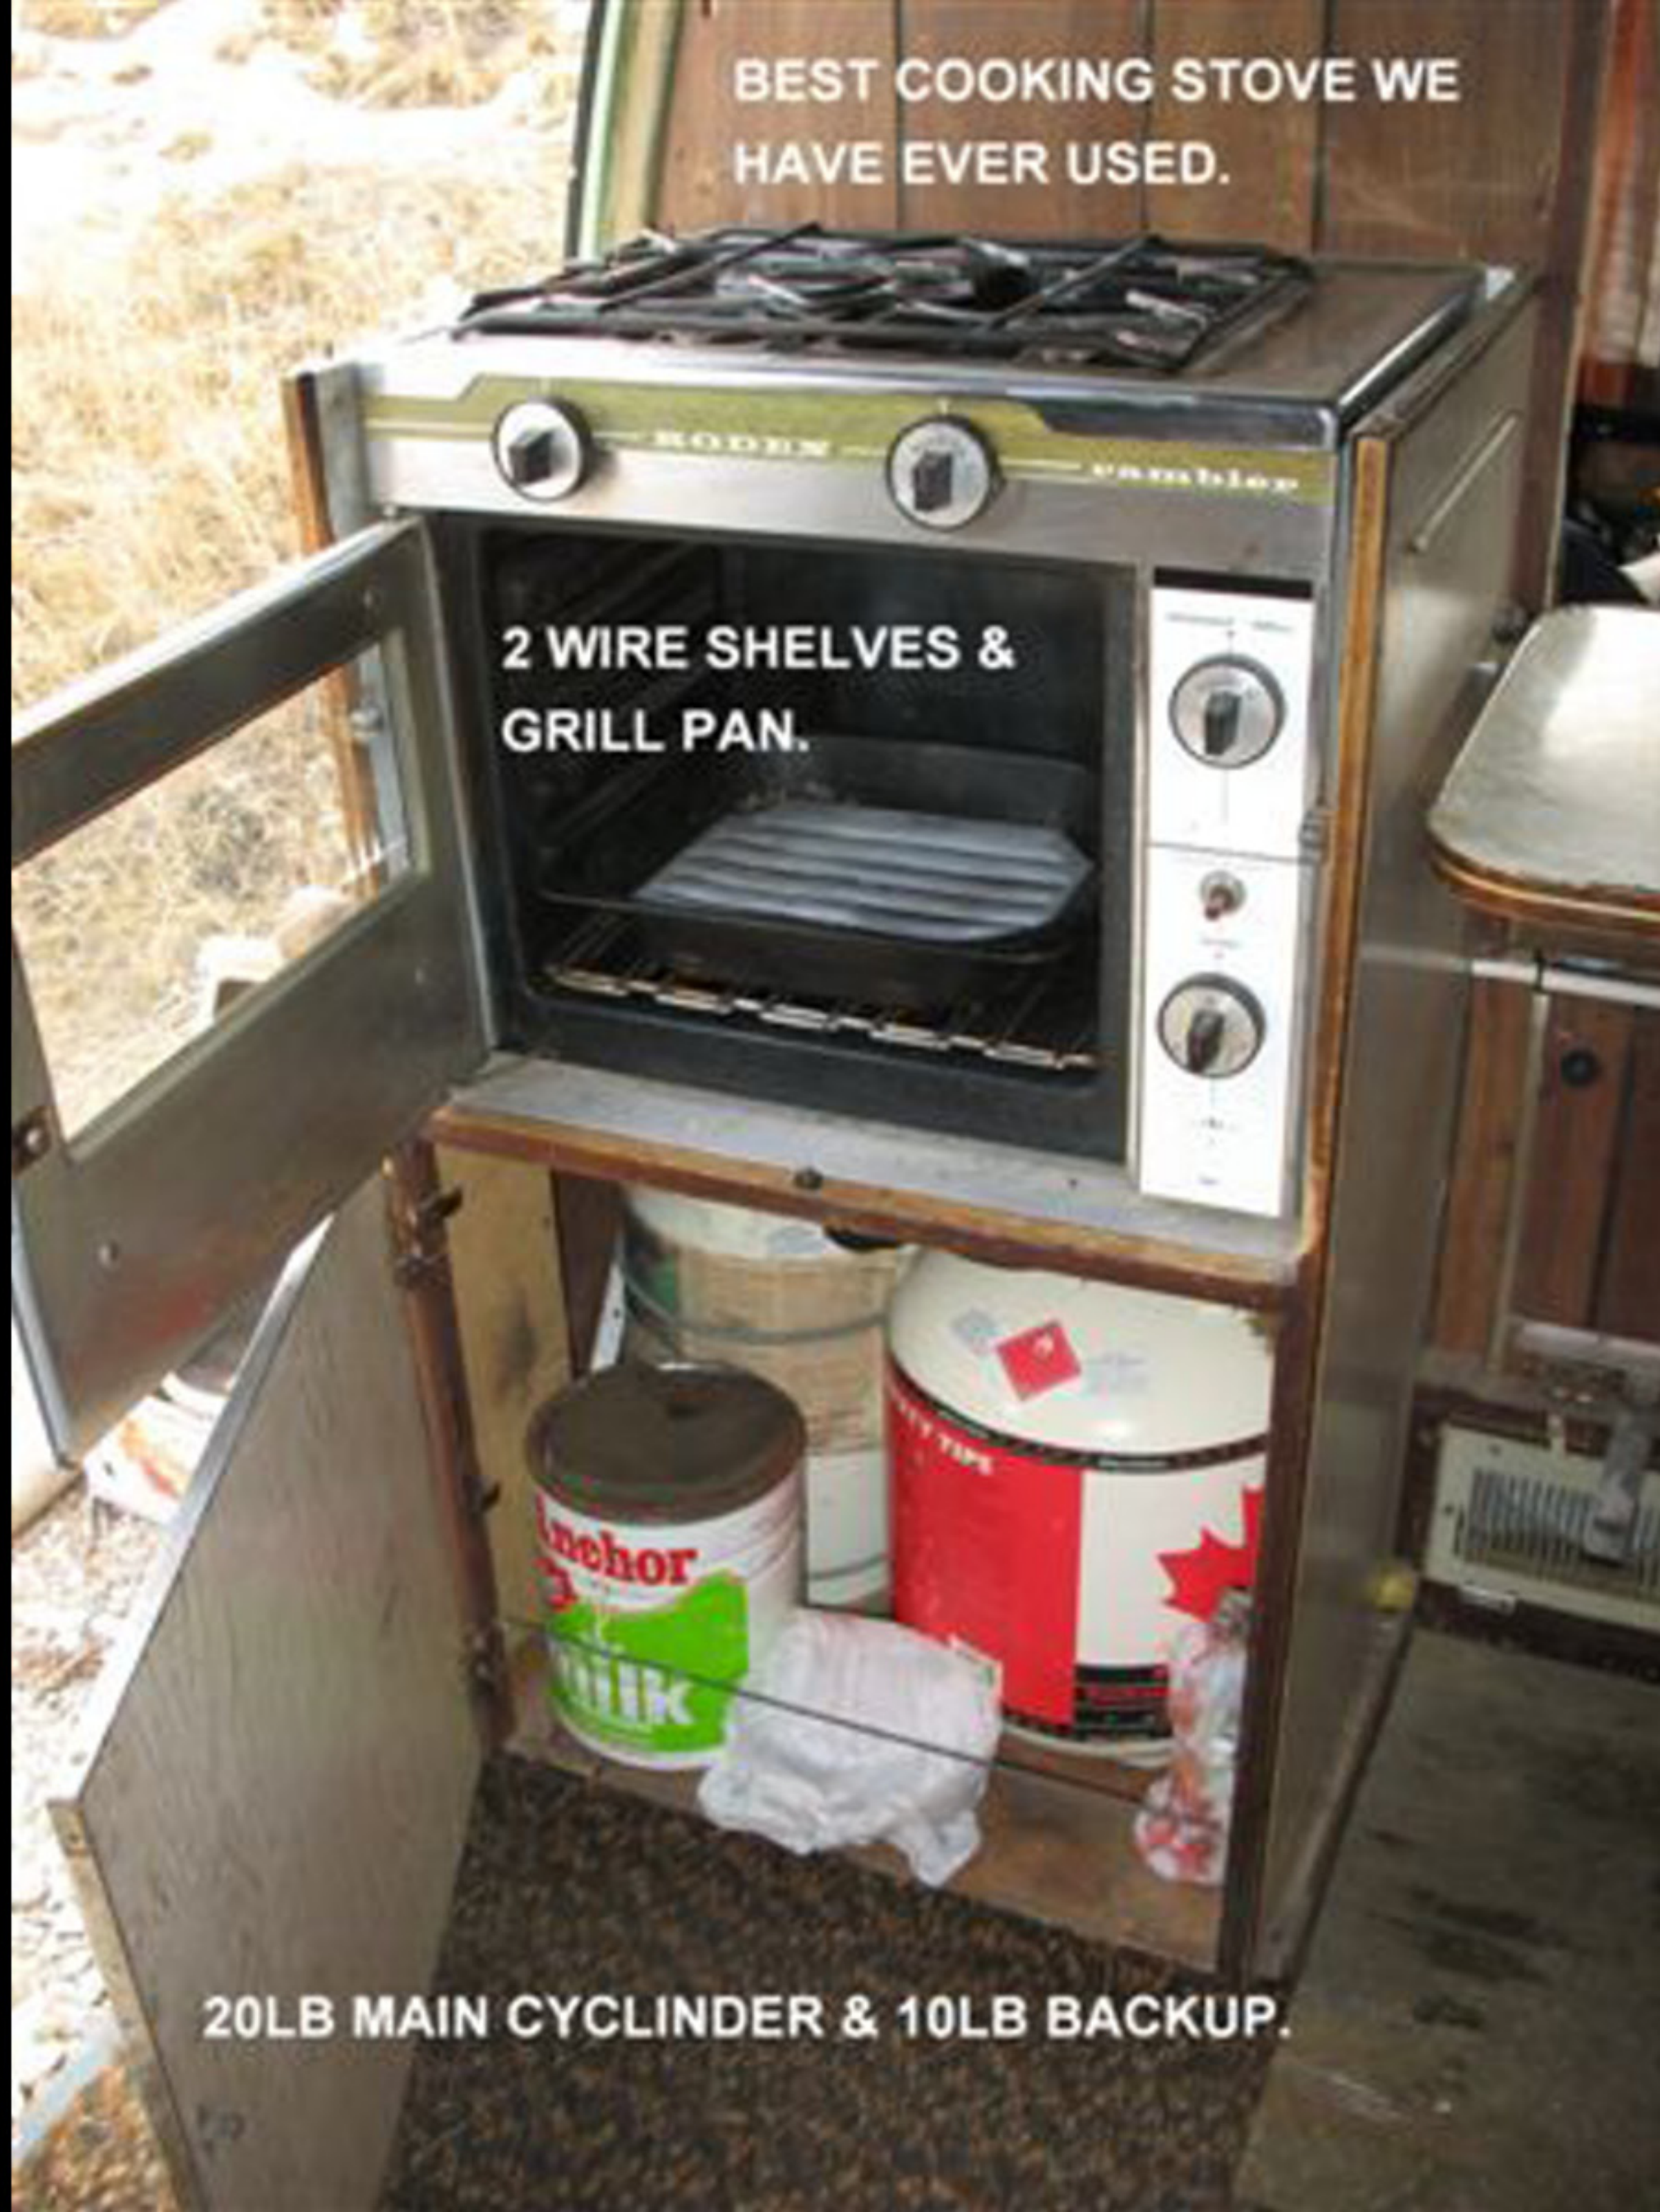
TWO BURNER GAS STOVE IS OF AUSTRALIAN ORIGIN. FEATURES AN AUTOMATIC OVEN AND A VERY EFFECTIVE INFRA-RED GRILLER.

STOVE ACTS AS STORAGE WHEN IN TRAVEL, BREAD ETC.

ATTACHES TO FRONT OF STOVE DURING TRAVEL.

**BEST COOKING STOVE WE
HAVE EVER USED.**

**2 WIRE SHELVES &
GRILL PAN.**

20LB MAIN CYCLINDER & 10LB BACKUP.

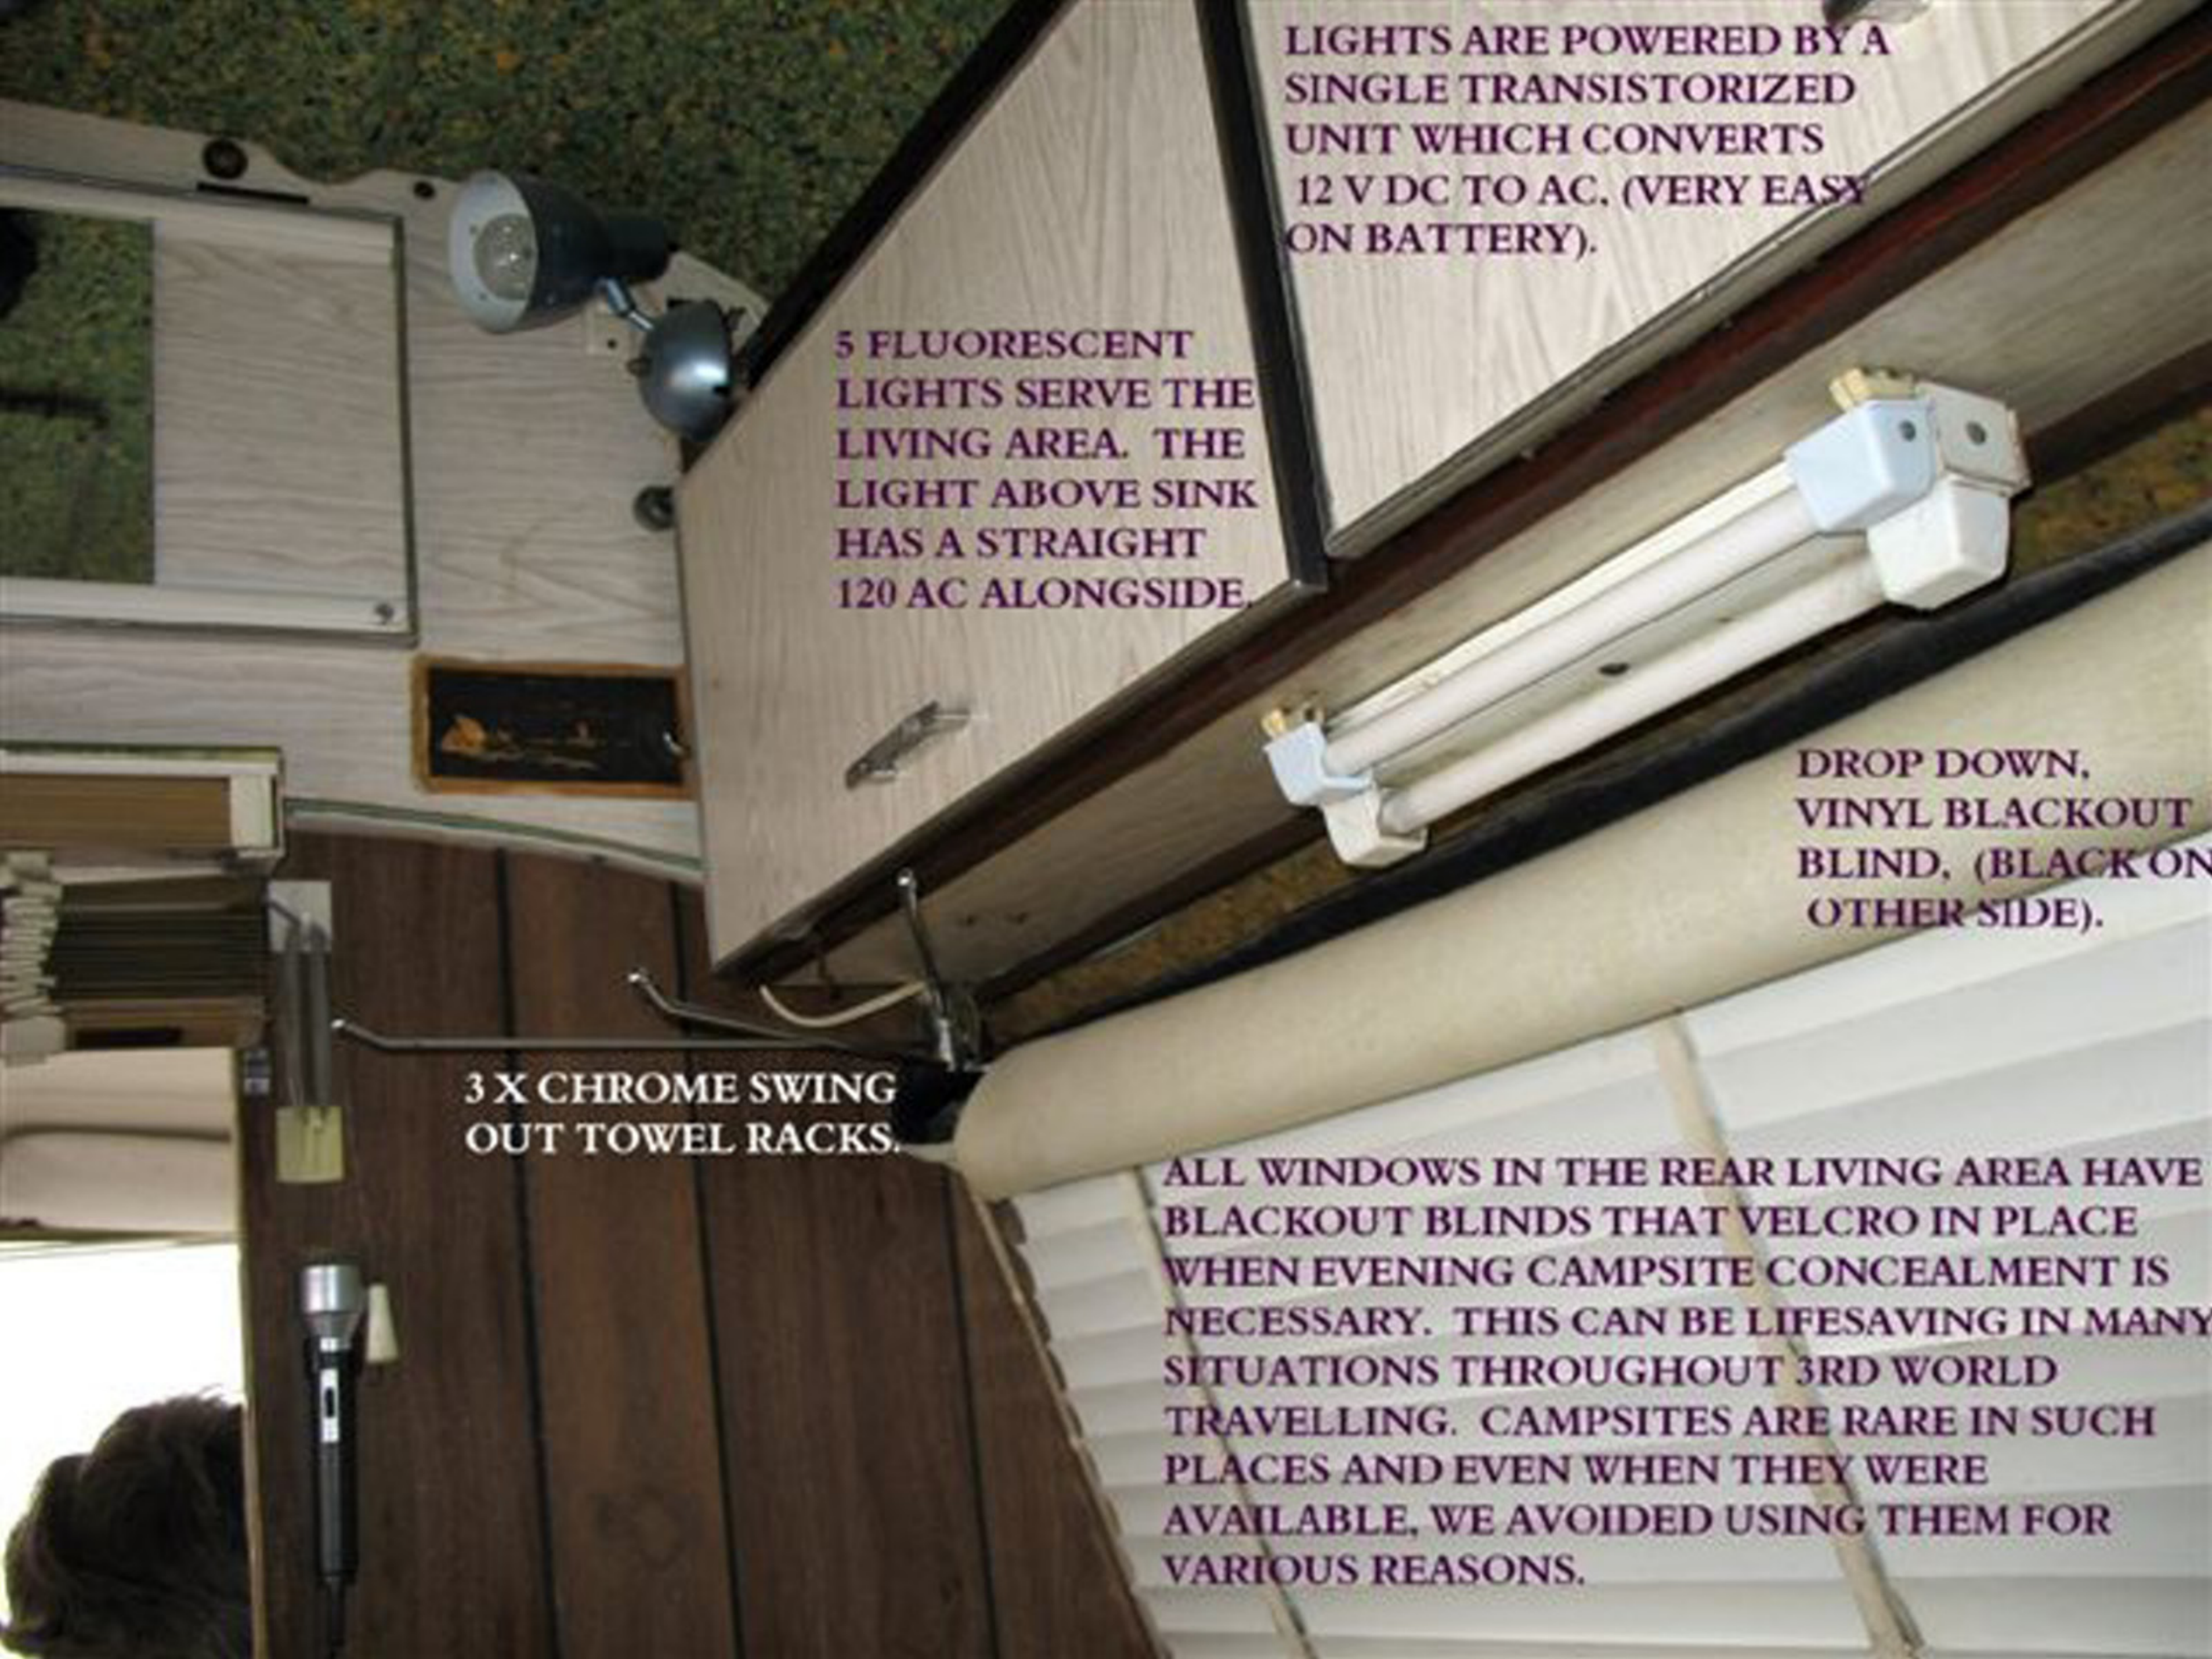
**BLACKOUT CURTAIN DROPS DOWN
OVER VENETIAN BLIND.**

**MICROPHONE
FOR EXTERNAL
P.A. SYSTEM.**

**METAL TRACK ALLOWS FOR TABLE
TO SLIDE FORWARD FOR DINING
FROM SOFA BED POSITION;
A LEG SCREWS UNDERNEATH.**

**MULTI
USE
REFRIG-
ERATOR**

SHIPPING AUTHIORITYES
INSIST ON HAVING VEHICLE
IGNITION KEY WHICH OPENS
UP ACCESS TO THE LIV ING
AREA, (VERY UNDESIREABLE
BECAUSE OF PILFERING).
PROBLEM WAS SOLVED BY
ADAPTING DINING TABLE
TO SLIPBOLT FOUR WAYS
INTO STEP-THROUGH AREA.

BECAUSE OF
PLACEMENT, OVER
SINK VENETIAN
REMAINS CLIPPED IN
PLACE AT ALL TIMES.

PRIVACY
DROP DOWN
VENETIAN
WHEN
CURTAINS
NOT IN USE
WHICH IS
MOST OF THE
TIME.

The image shows the interior of a vehicle, likely a motorhome or camper, with several storage compartments. The compartments are made of wood and metal. A white drop-down grill is visible, which is used to store a portable propane and electric blower heater. A rubbish bin holder is also present. A roof exhaust fan switch is located on the right side. The stove top is visible in the bottom right corner.

**ROOF
EXHAUST
FAN
SWITCH.**

RUBBISH BIN HOLDER.

**PORTABLE PROPANE AND
ELECTRIC BLOWER HEATER
STORED BEHIND DROP
DOWN GRILL.**

TOILET IS UNDER CHILD SEAT.

HINGED PANELS OPEN
TO ACCESS 3 STORAGE
AREAS BETWEEN THE
TWO FRONT CAB
SEATS. WE USED AS
VEGETABLE STORAGE.

REFRIGERATOR

240 AC BATTERY
CHARGER UNDER
WORKTOP.

HEAVY DUTY
TRANSFORMER
STORED IN THE
WARDROBE
STEPSUP 120 AC
TO 240 AC (AUST)
IF REQUIRED.

MIRROR
SLIDES TO
VIEW TV
BEHIND

WHILE TV IS IN USE, A
CLEAR WINDOW
BEHIND THE MIRROR
IS USED. THIS ALLOWS
THE CUPBOARD
DOOR TO REMAIN
CLOSED AGAINST
CONDENSATION
BUILDUP.

**THIS IS PILLOW END OF BED
WHEN SET UP AT NIGHT.
MIRROR ON THE CUPBOARD
DOOR ABOVE, PIVOTS DOWN
AT AN ANGLE TO ALLOW
VIEWING OF TV BEHIND YOU IN
FRONT CUPBOARD.**

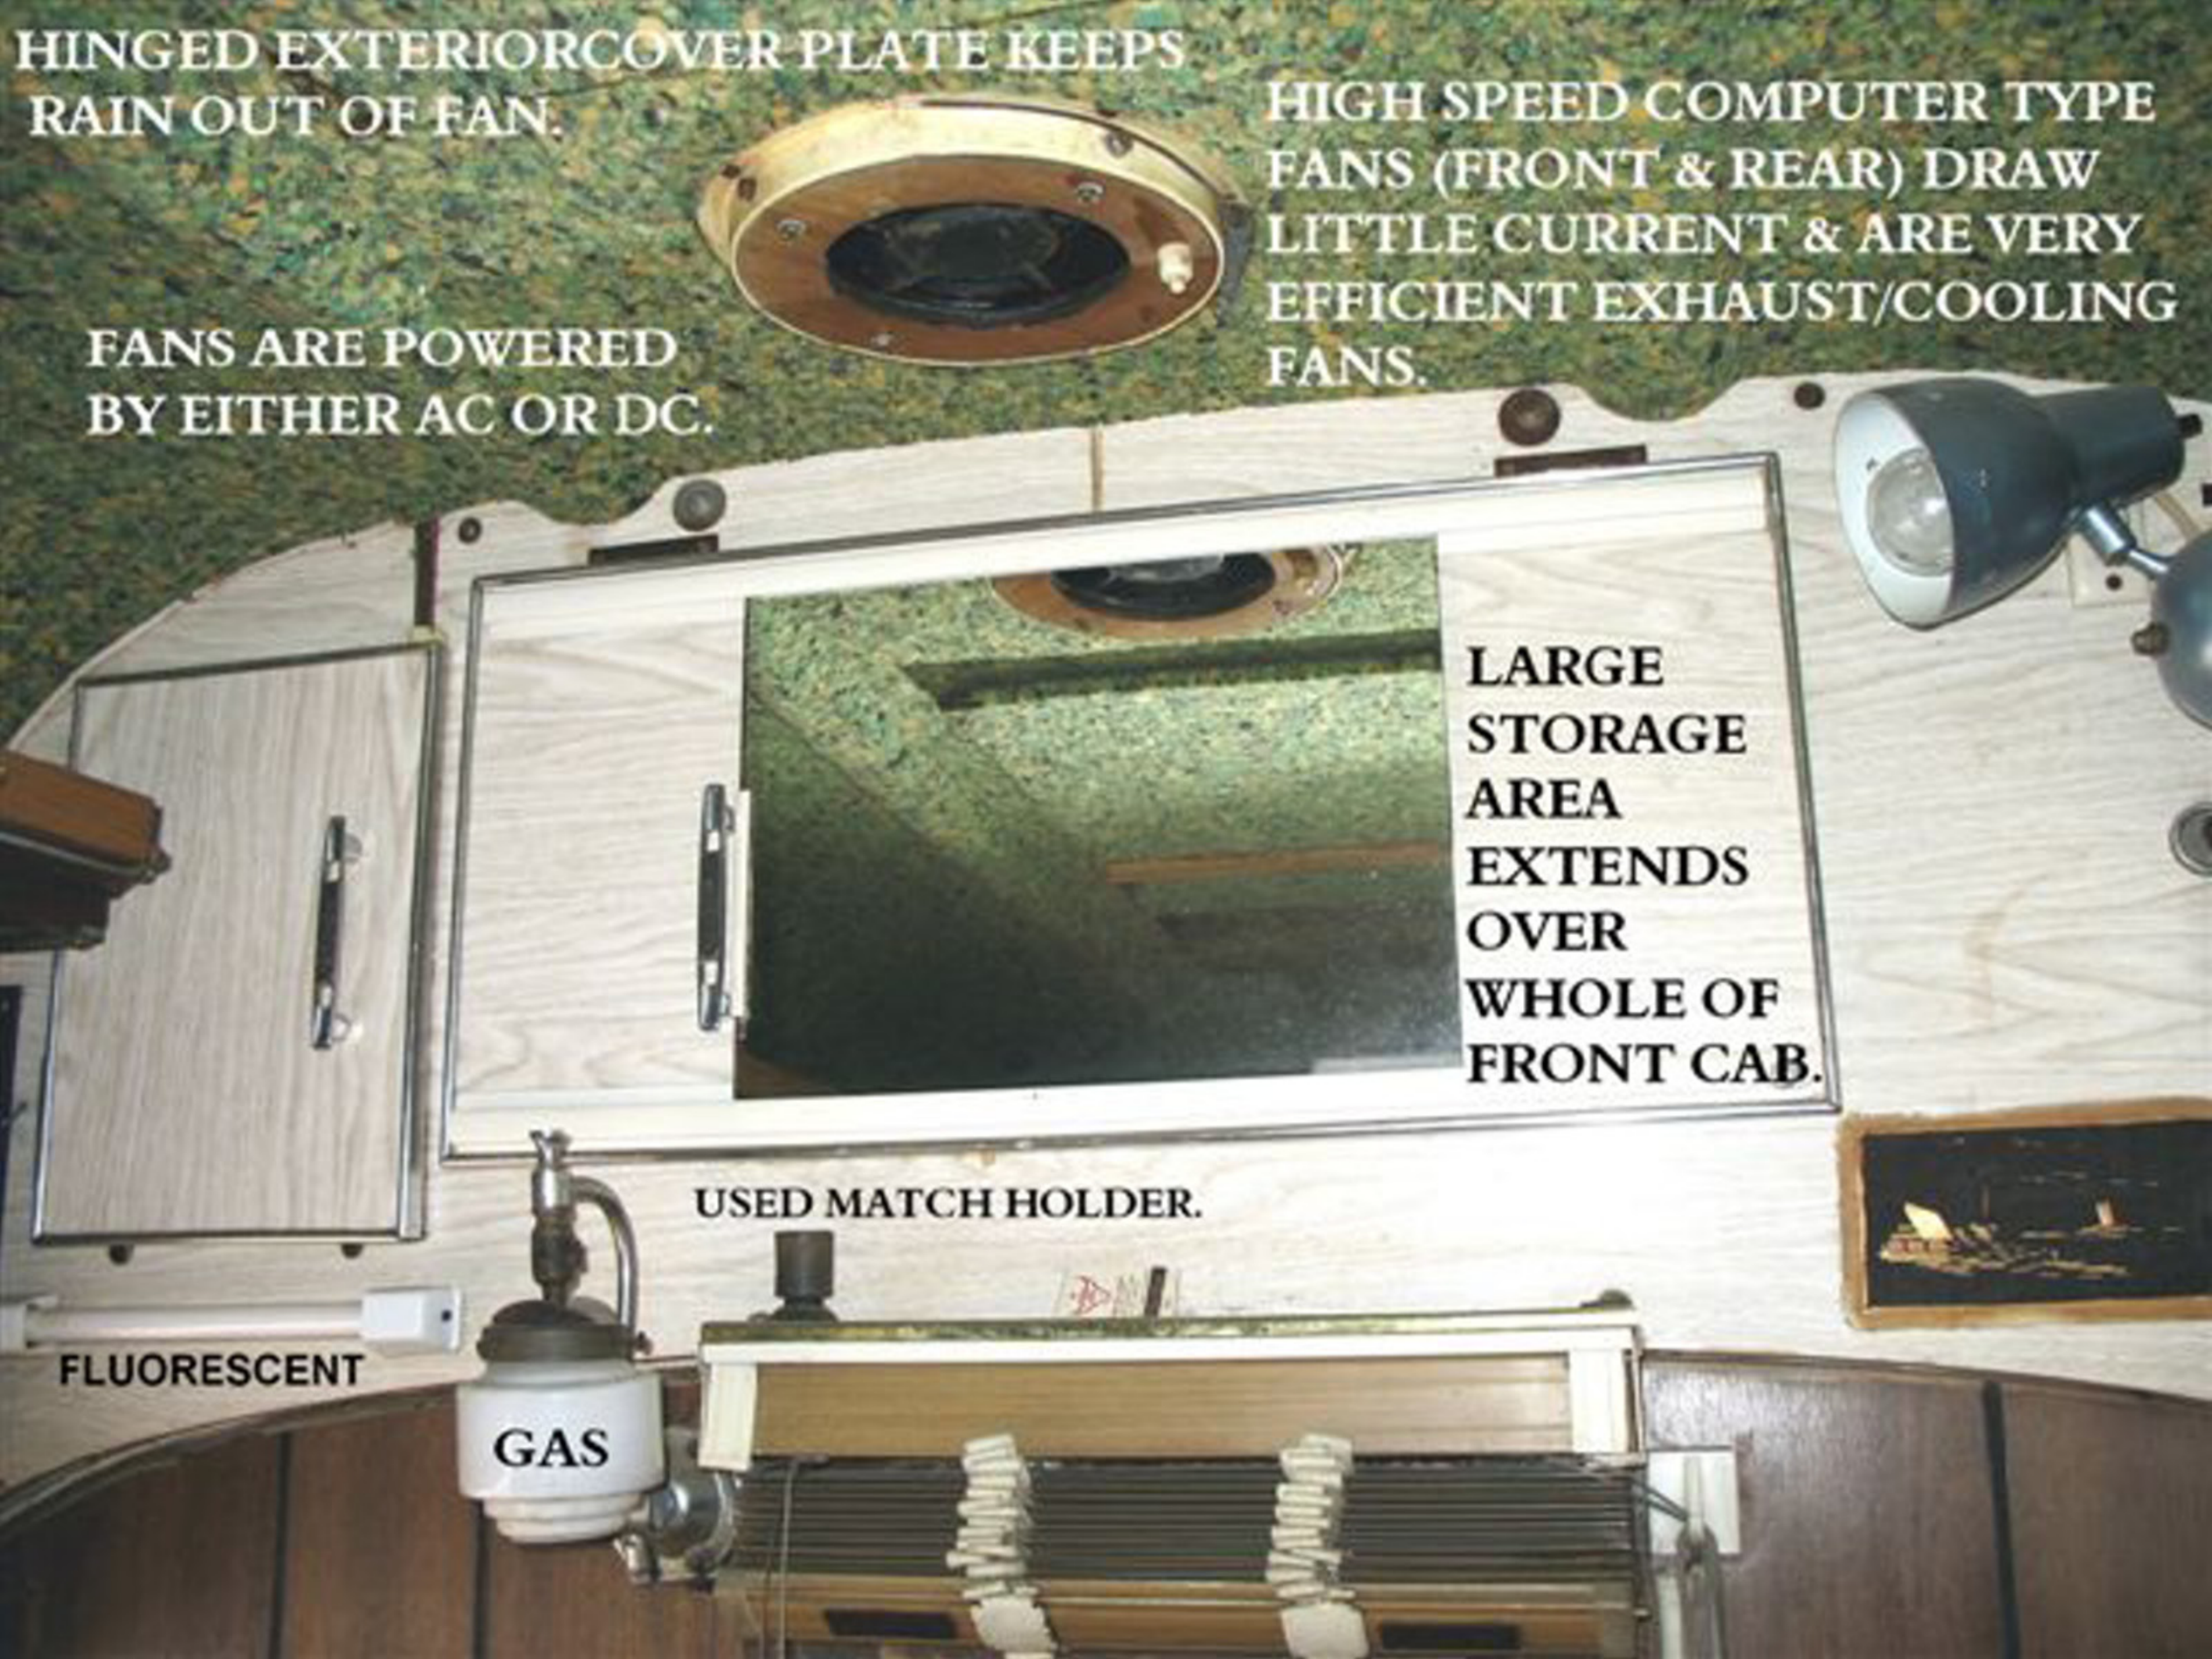
LIGHTS ARE POWERED BY A SINGLE TRANSISTORIZED UNIT WHICH CONVERTS 12 V DC TO AC. (VERY EASY ON BATTERY).

5 FLUORESCENT LIGHTS SERVE THE LIVING AREA. THE LIGHT ABOVE SINK HAS A STRAIGHT 120 AC ALONGSIDE.

DROP DOWN, VINYL BLACKOUT BLIND, (BLACK ON OTHER SIDE).

ALL WINDOWS IN THE REAR LIVING AREA HAVE BLACKOUT BLINDS THAT VELCRO IN PLACE WHEN EVENING CAMPSITE CONCEALMENT IS NECESSARY. THIS CAN BE LIFESAVING IN MANY SITUATIONS THROUGHOUT 3RD WORLD TRAVELLING. CAMPSITES ARE RARE IN SUCH PLACES AND EVEN WHEN THEY WERE AVAILABLE, WE AVOIDED USING THEM FOR VARIOUS REASONS.

**MOST VAN CUPBOARD DOORS
ARE FOAM STRIP SEALED ON
INSIDE TO KEEP OUT DUST.**

**ALL VAN CUPBOARDS ARE LINED
TO REDUCE CONDENSATION.**

FLUORE-SCENT READING LIGHT SHIELDED TO CAST LIGHT DOWN ONLY.

DROP DOWN BLACKOUT BLIND COVERS WIDE, OPENING, WINDOW OVER SIDE DOOR.

**HINGED EXTERIOR COVER PLATE KEEPS
RAIN OUT OF FAN.**

**FANS ARE POWERED
BY EITHER AC OR DC.**

**HIGH SPEED COMPUTER TYPE
FANS (FRONT & REAR) DRAW
LITTLE CURRENT & ARE VERY
EFFICIENT EXHAUST/COOLING
FANS.**

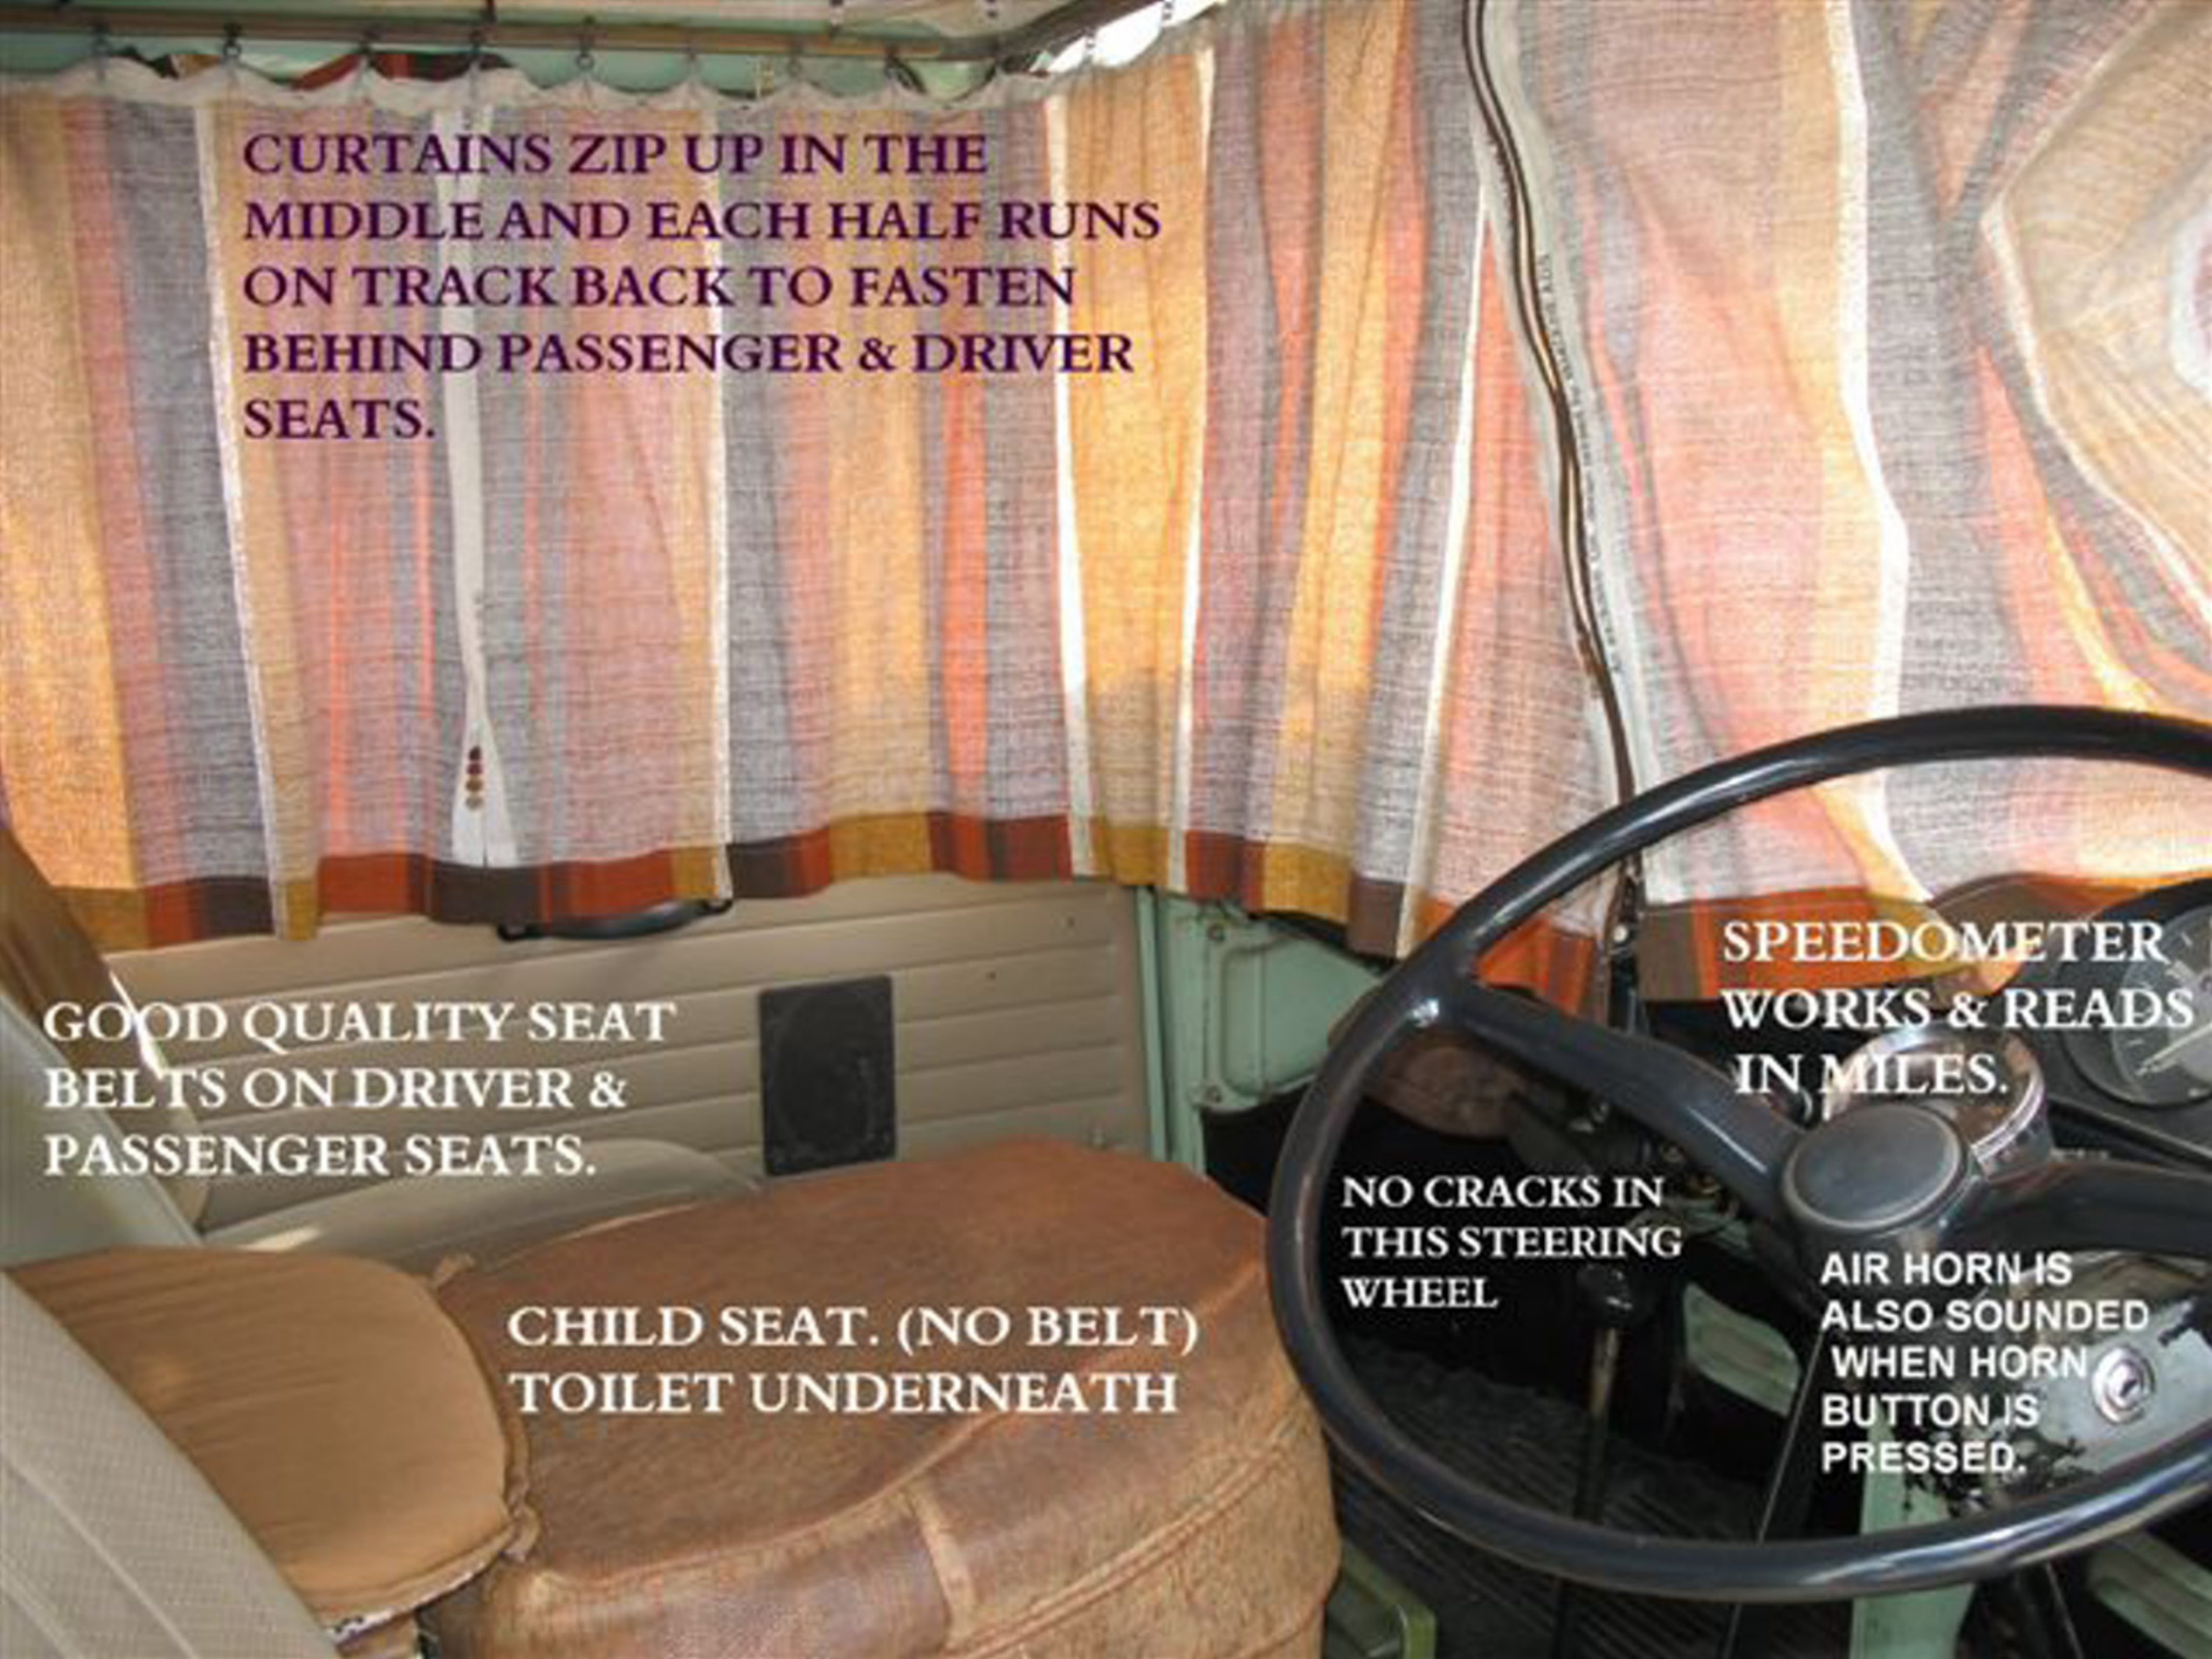
**1" FOAM INSULATION
THROUGHOUT, ALWAYS
WITH CONDENSATION IN
MIND.**

**IN PLASTIC BAG ARE AMERICAN, ENGLISH, &
GERMAN (IN ENGLISH) VERSIONS OF SERVICE
MANUALS FOR THE 1970 TRANSPORTER.**

WATER REACHES SINK VIA GRAVITY FEED FROM VINYL TANK ABOVE THE BED.

2 X 20LB GAS CYLINDERS KEPT BEHIND THIS DOOR (LEFT) WHICH MOST LIKELY WILL NEVER BE ALLOWED IN THE USA. VERY NECESSARY IN WORLD TRAVELLING HOWEVER. PILFERING WOULD SOON REMOVE THEM IF THEY WERE KEPT OUTSIDE. HOLES DRILLED IN FLOOR OF THE CUPBOARD DISPENSES GAS LEAKAGE SHOULD IT OCCUR.

TWO WAY VALVE DIRECTS
WATER EITHER OUTSIDE
BELOW VEHICLE OR, INTO A 2
GALLON, FLEXIBLE, CATCH
CONTAINER IF SITUATION
DICTATES.

REFRIG. HAS SWITCHED
INTERIOR LIGHT AND FREEZER
COMPARTMENT. SWEDISH
MADE UNIT. MULTIVOLTAGE
& GAS.

**ALUMINUM TRACK ALLOWS
EATING TABLE TO SLIDE
RIGHT UP TO BED SITTING
POSITION.**

TRUCKER C.B. UNDER HAT,
(KEEPS SUN OFF)

SWEDEN
MADE
MULTI
WAVE
RADIO

TACHO-
METER
WITH
LIGHT.

OIL PRESSURE &
TEMPERATURE
WITH LIGHTS

STANDARD SIZE
TOILET SEAT.

CASSETTE
PLAY AND
RECORD
WITH
EXTERNAL
MIKE.

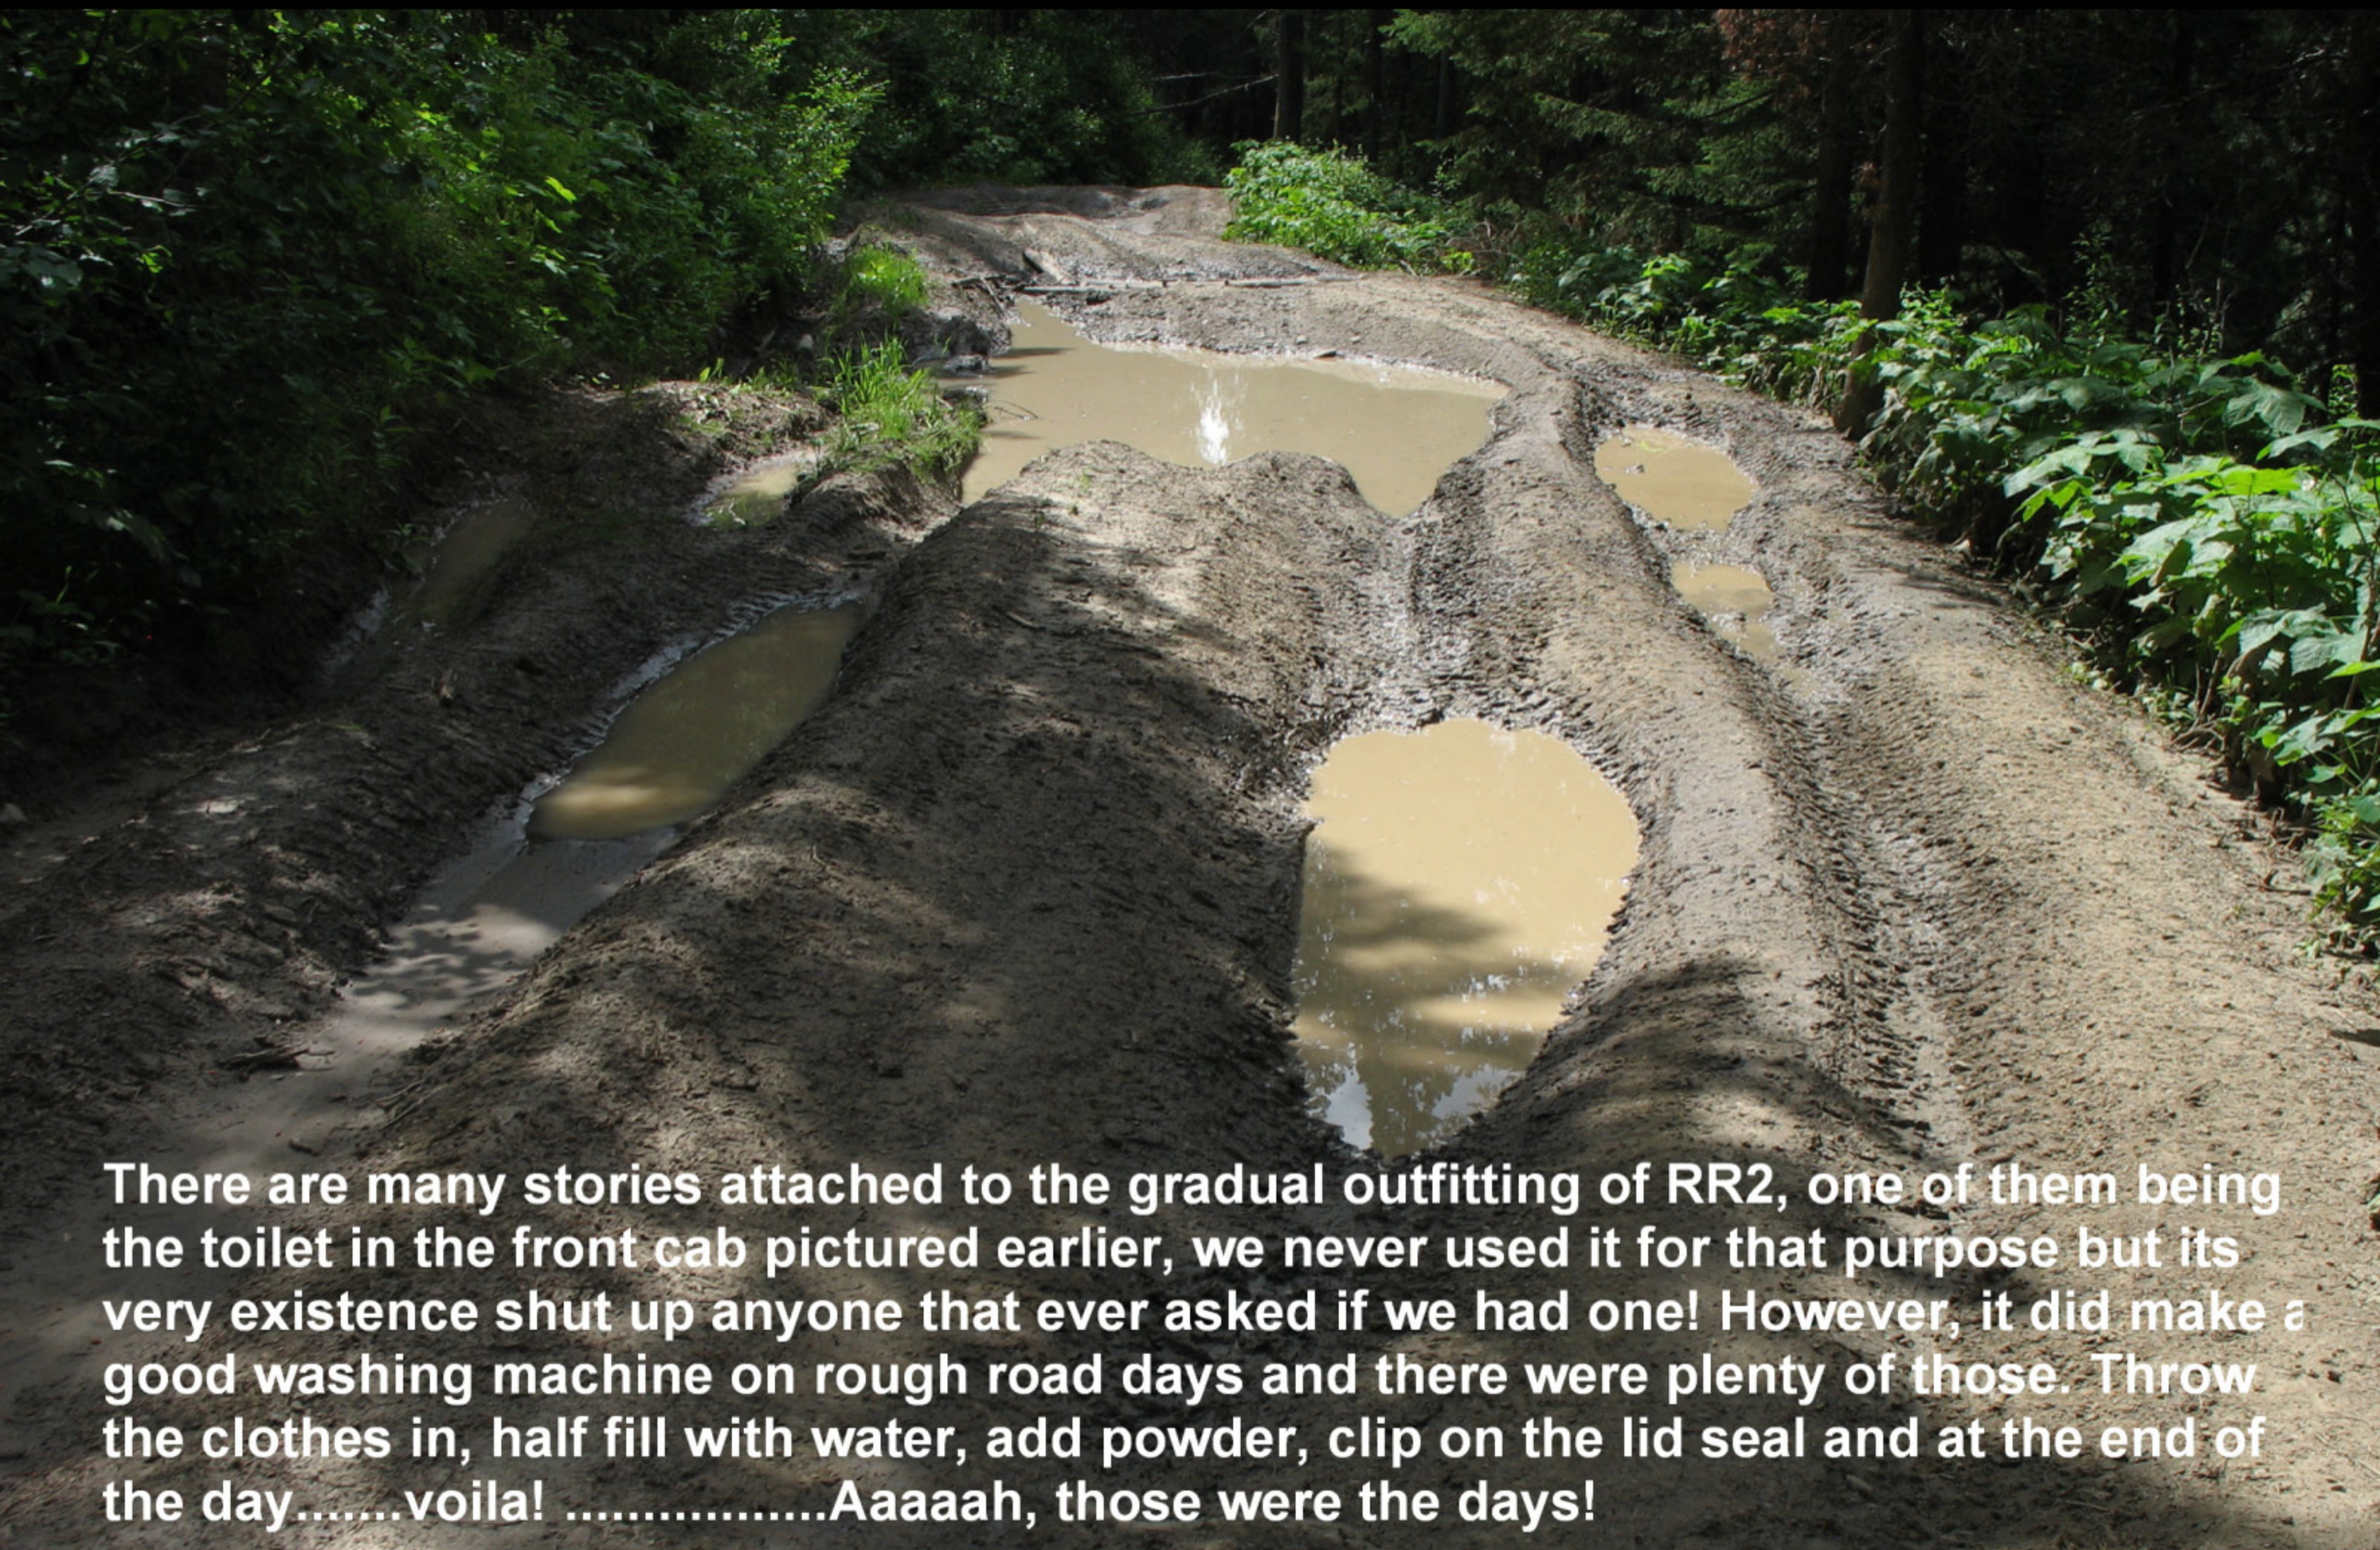
CURTAINS ZIP UP IN THE MIDDLE AND EACH HALF RUNS ON TRACK BACK TO FASTEN BEHIND PASSENGER & DRIVER SEATS.

GOOD QUALITY SEAT BELTS ON DRIVER & PASSENGER SEATS.

**CHILD SEAT. (NO BELT)
TOILET UNDERNEATH**

SPEEDOMETER WORKS & READS IN MILES.

NO CRACKS IN THIS STEERING WHEEL

AIR HORN IS ALSO SOUNDED WHEN HORN BUTTON IS PRESSED.

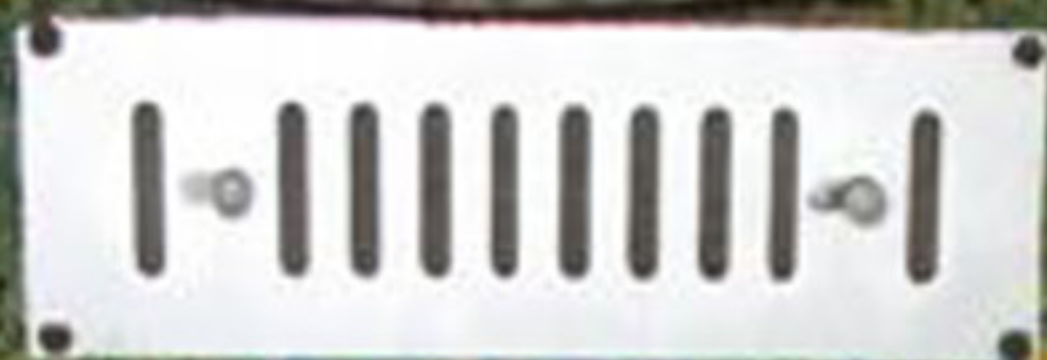
AIR VENT, CLOSEABLE.

EXTENSIVE USE OF HALF INCH FOAM ON ALL COLD AREAS TO CUT BACK ON CONDENSATION.

CHROME DRYING RAILS.

LARGE STORAGE AREA ABOVE BED. ALL CUPBOARDS ARE FOAM LINED.

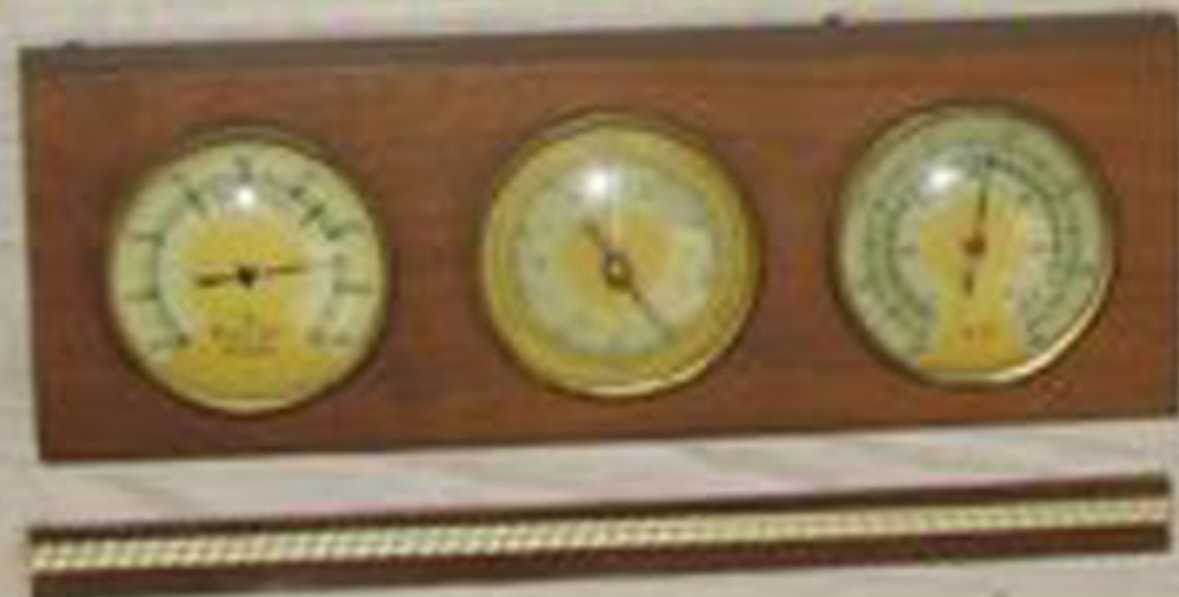
WEATHER STATION

GADGETRY, SEE LATER.
