As experience dictated, the living quarters of RR2 was refined many times to cater for changing conditions but not forgetting the fact that it had to remain a vehicle suited for less than ideal conditions. It was no luxury motorhome but in contrast to such a vehicle, it would park, camp and go almost anywhere economically and reliably. In many countries, campgrounds were few and far between and trying to reach them, placed an undesirable burden on one's day. However, if there was one thing while travelling that we really tried to avoid, it was a campground; for the most part, they represented everything we were trying to escape from. But enough said, let's have a look inside what was our home for 17 years.

LIVING AREA VIEW
FROM SIDE DOOR

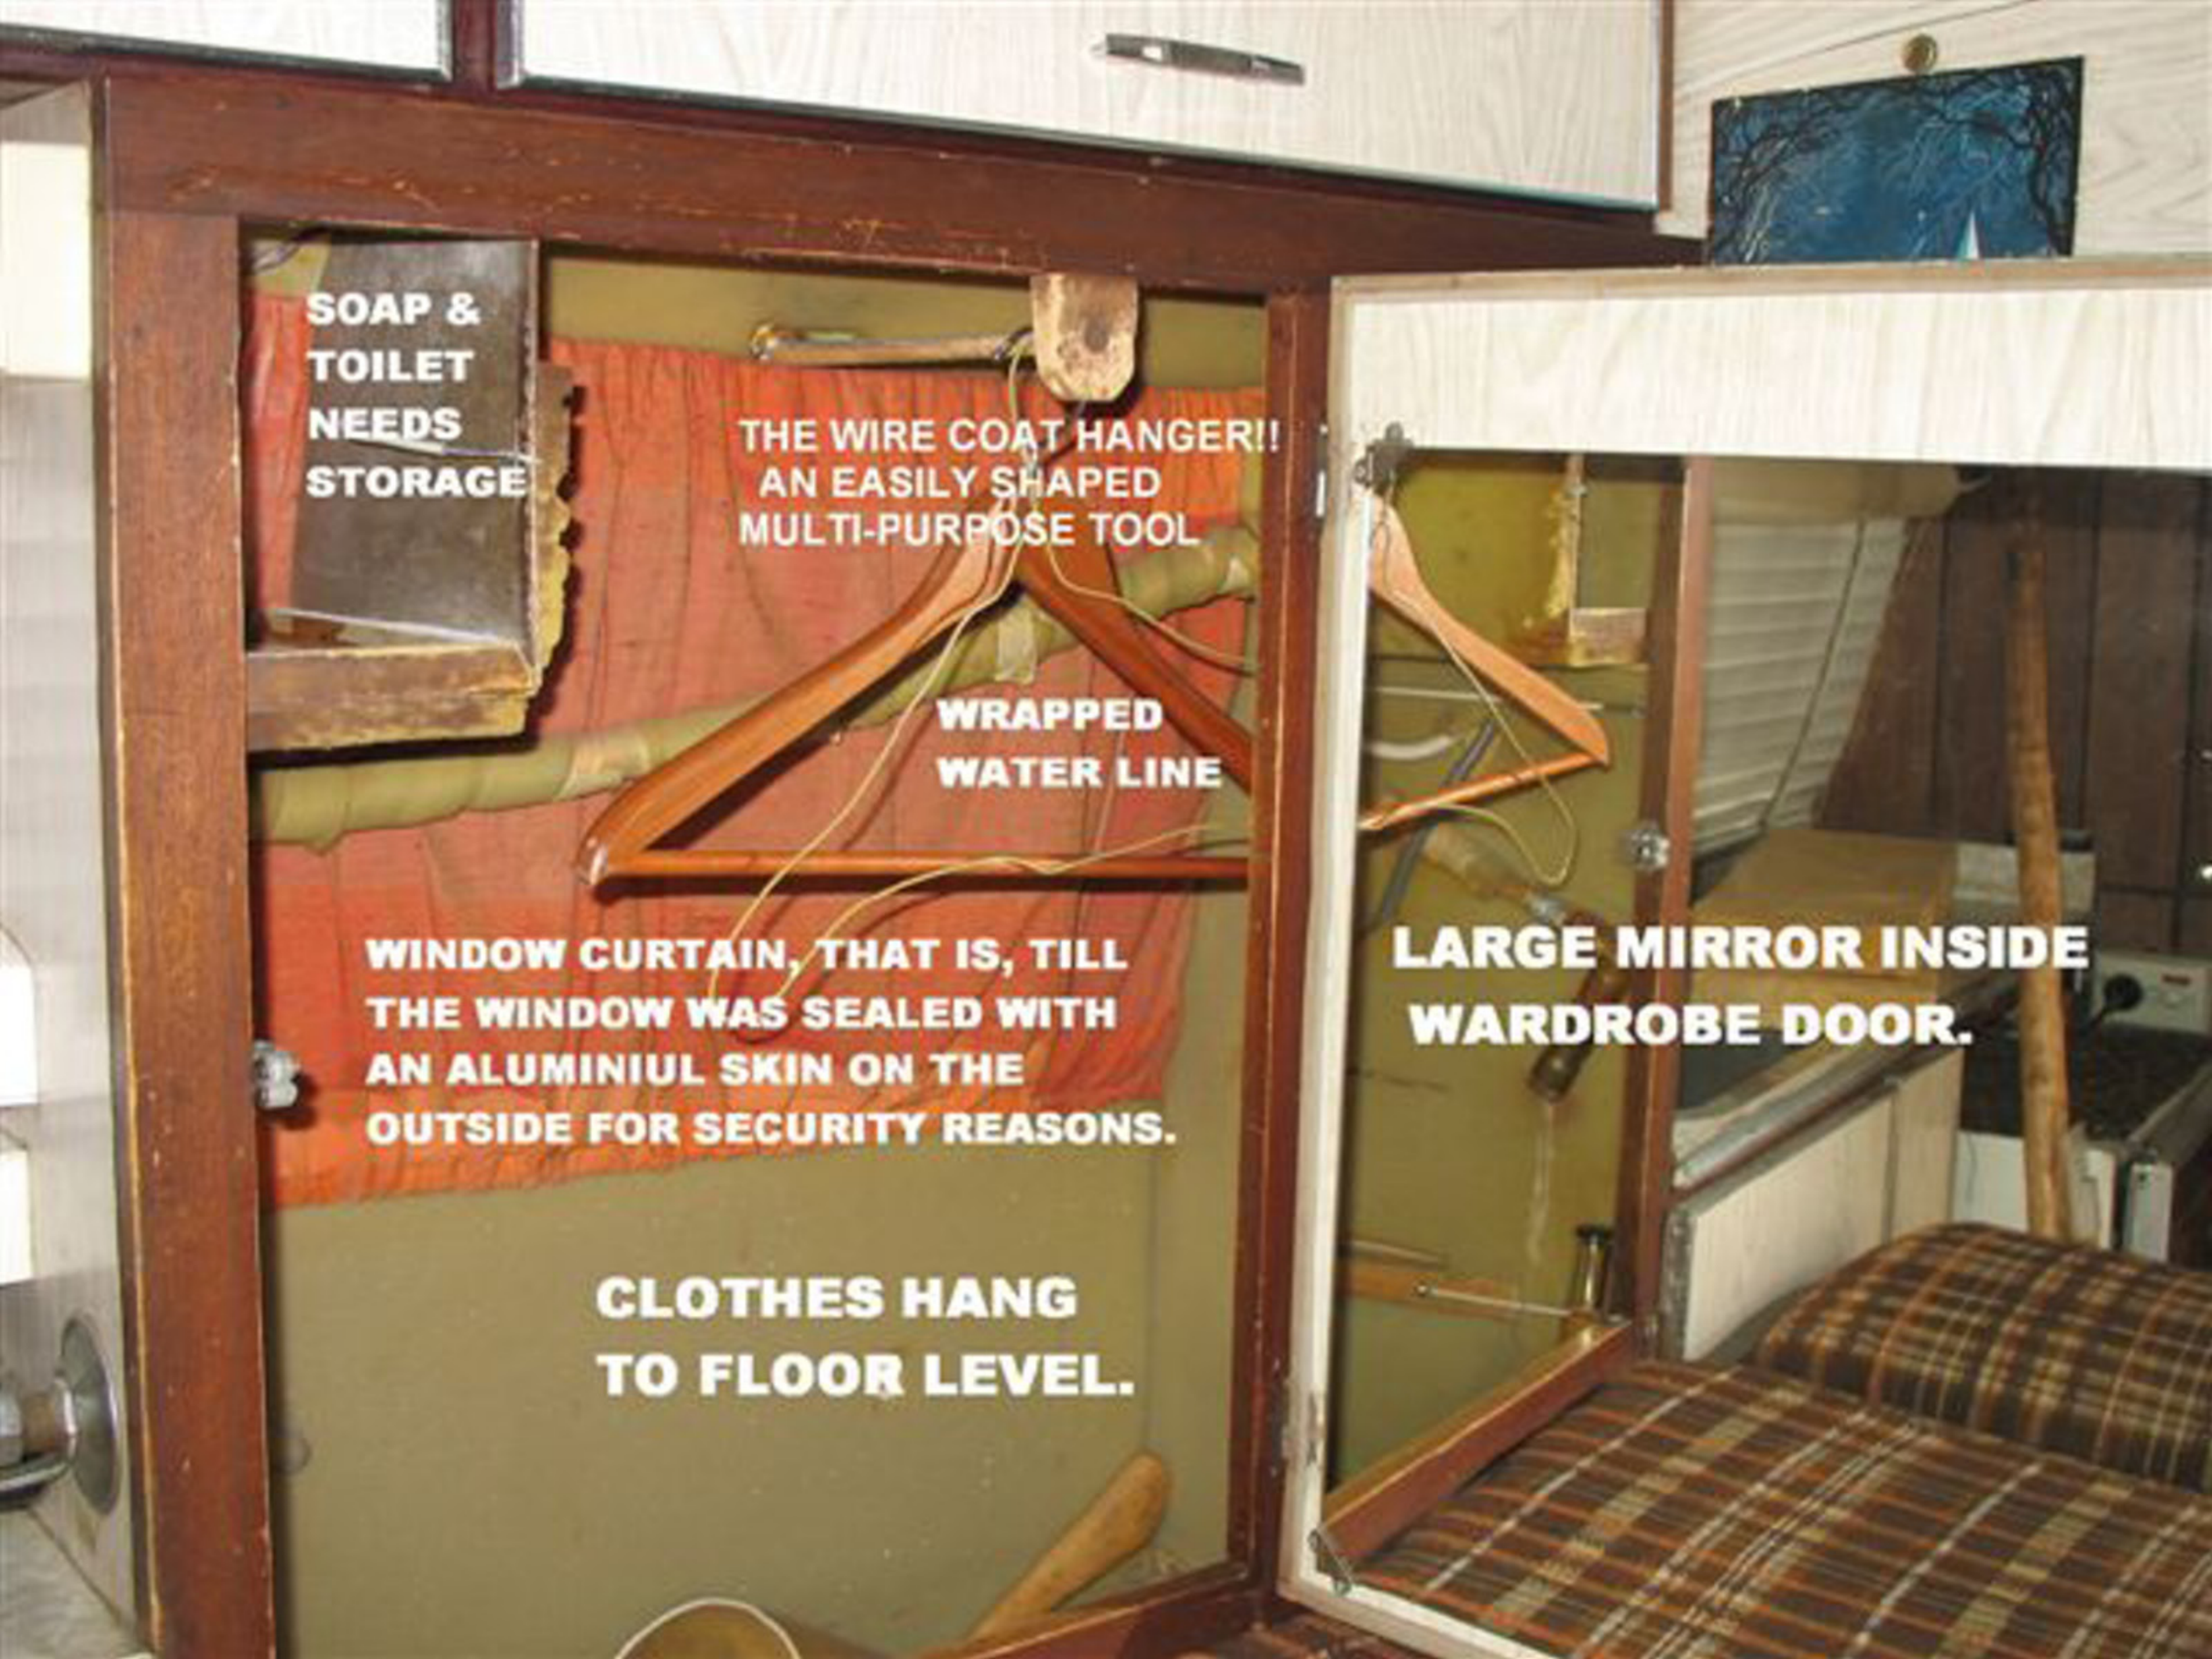
CHROME TOWEL
DRYING RAILS

CLOSEABLE AIR VENT.
AIR MOVEMENT VERY
IMPORTANT IN SMALL
AREA ESPECIALLY
WHEN COOKING
INSIDE IN COLD
WEATHER.

REAR FAN

PANELS SLIDE OUT TO
ACCESS & OPEN SKYLIGHT.

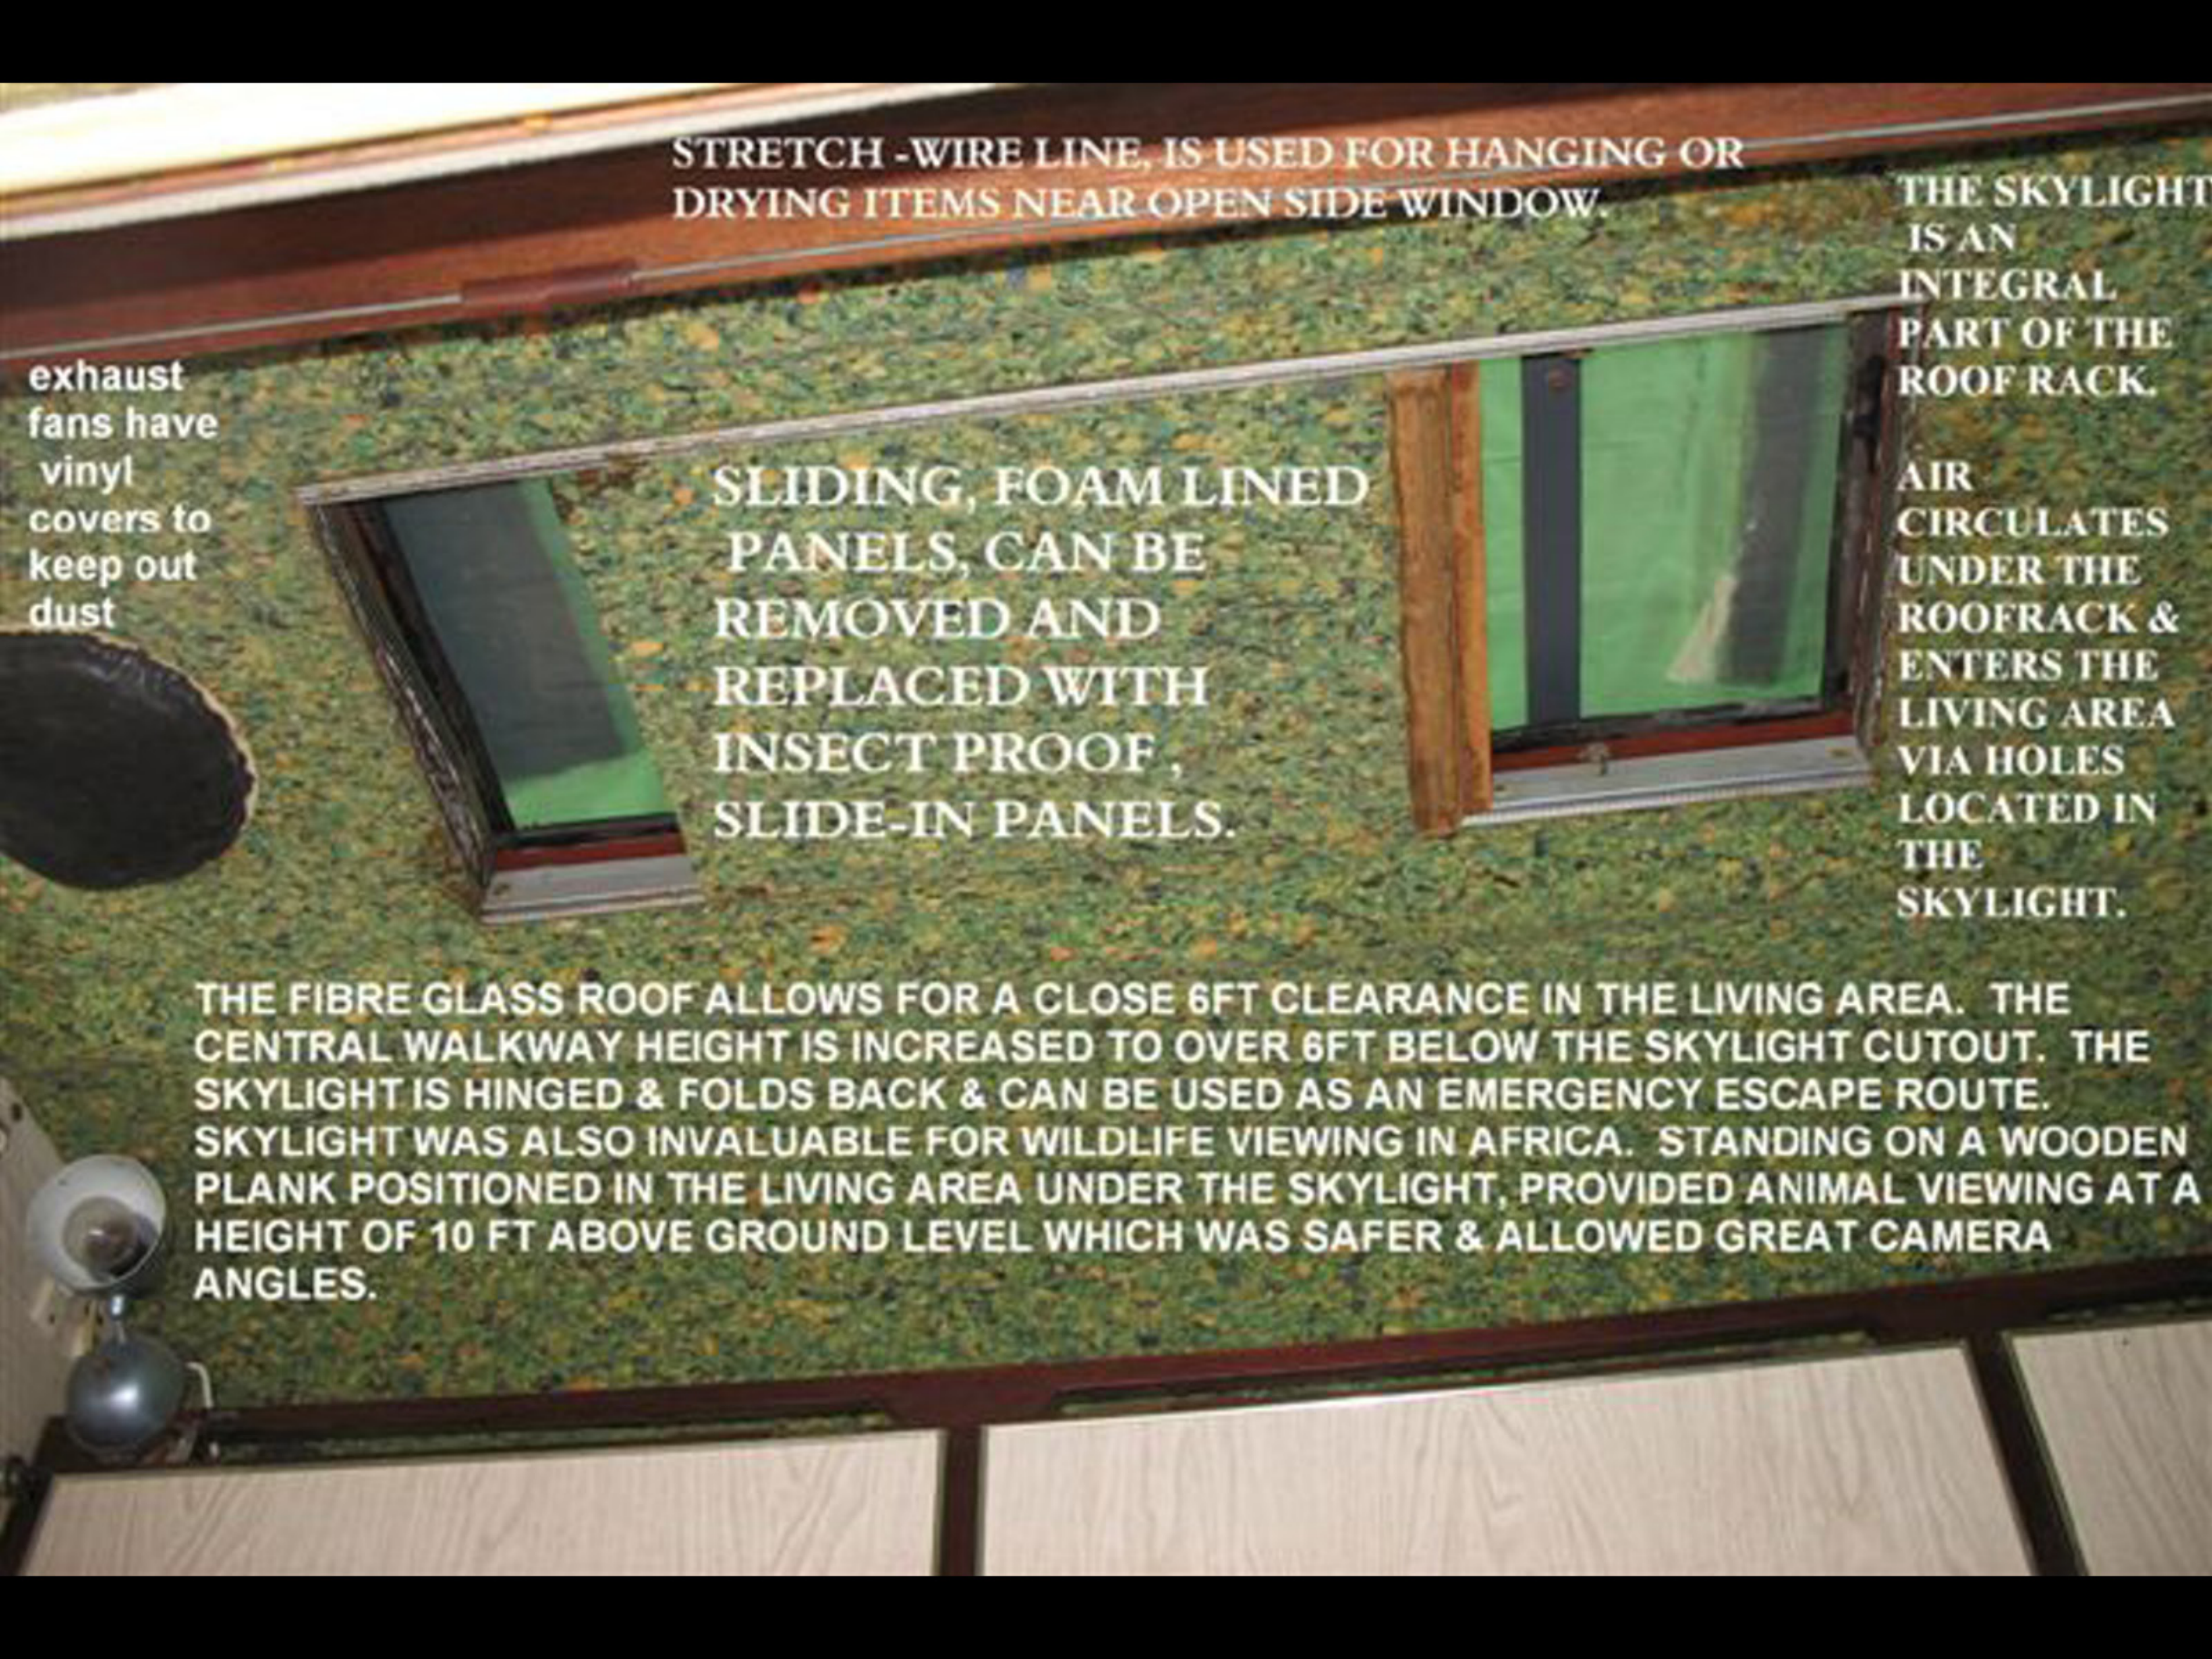
The image shows the interior of a living area with a green fibre glass roof. A skylight is visible, which is hinged and can fold back. A wooden plank is positioned under the skylight. The floor is made of light-colored wood. There are two exhaust fans on the left side, one of which has a vinyl cover. A stretch-wire line is visible near the top of the roof. The skylight is an integral part of the roof rack. Air circulates under the roof rack and enters the living area via holes located in the skylight. The fibre glass roof allows for a close 6ft clearance in the living area. The central walkway height is increased to over 6ft below the skylight cutout. The skylight is hinged & folds back & can be used as an emergency escape route. The skylight was also invaluable for wildlife viewing in Africa. Standing on a wooden plank positioned in the living area under the skylight, provided animal viewing at a height of 10 ft above ground level which was safer & allowed great camera angles.

STRETCH -WIRE LINE, IS USED FOR HANGING OR DRYING ITEMS NEAR OPEN SIDE WINDOW.

THE SKYLIGHT IS AN INTEGRAL PART OF THE ROOF RACK.

AIR CIRCULATES UNDER THE ROOF RACK & ENTERS THE LIVING AREA VIA HOLES LOCATED IN THE SKYLIGHT.

SLIDING, FOAM LINED PANELS, CAN BE REMOVED AND REPLACED WITH INSECT PROOF, SLIDE-IN PANELS.

THE FIBRE GLASS ROOF ALLOWS FOR A CLOSE 6FT CLEARANCE IN THE LIVING AREA. THE CENTRAL WALKWAY HEIGHT IS INCREASED TO OVER 6FT BELOW THE SKYLIGHT CUTOUT. THE SKYLIGHT IS HINGED & FOLDS BACK & CAN BE USED AS AN EMERGENCY ESCAPE ROUTE. SKYLIGHT WAS ALSO INVALUABLE FOR WILDLIFE VIEWING IN AFRICA. STANDING ON A WOODEN PLANK POSITIONED IN THE LIVING AREA UNDER THE SKYLIGHT, PROVIDED ANIMAL VIEWING AT A HEIGHT OF 10 FT ABOVE GROUND LEVEL WHICH WAS SAFER & ALLOWED GREAT CAMERA ANGLES.

exhaust fans have vinyl covers to keep out dust

ONE CANNOT STRESS ENOUGH THE IMPORTANCE OF PREVENTING WARM AIR INSIDE THE VAN FROM CONTACTING COLD AREAS LIKE METAL OR THE FIBREGLASS ROOF. IN WINTER, CONDENSATION CAN BE A BIG PROBLEM IF IGNORED.

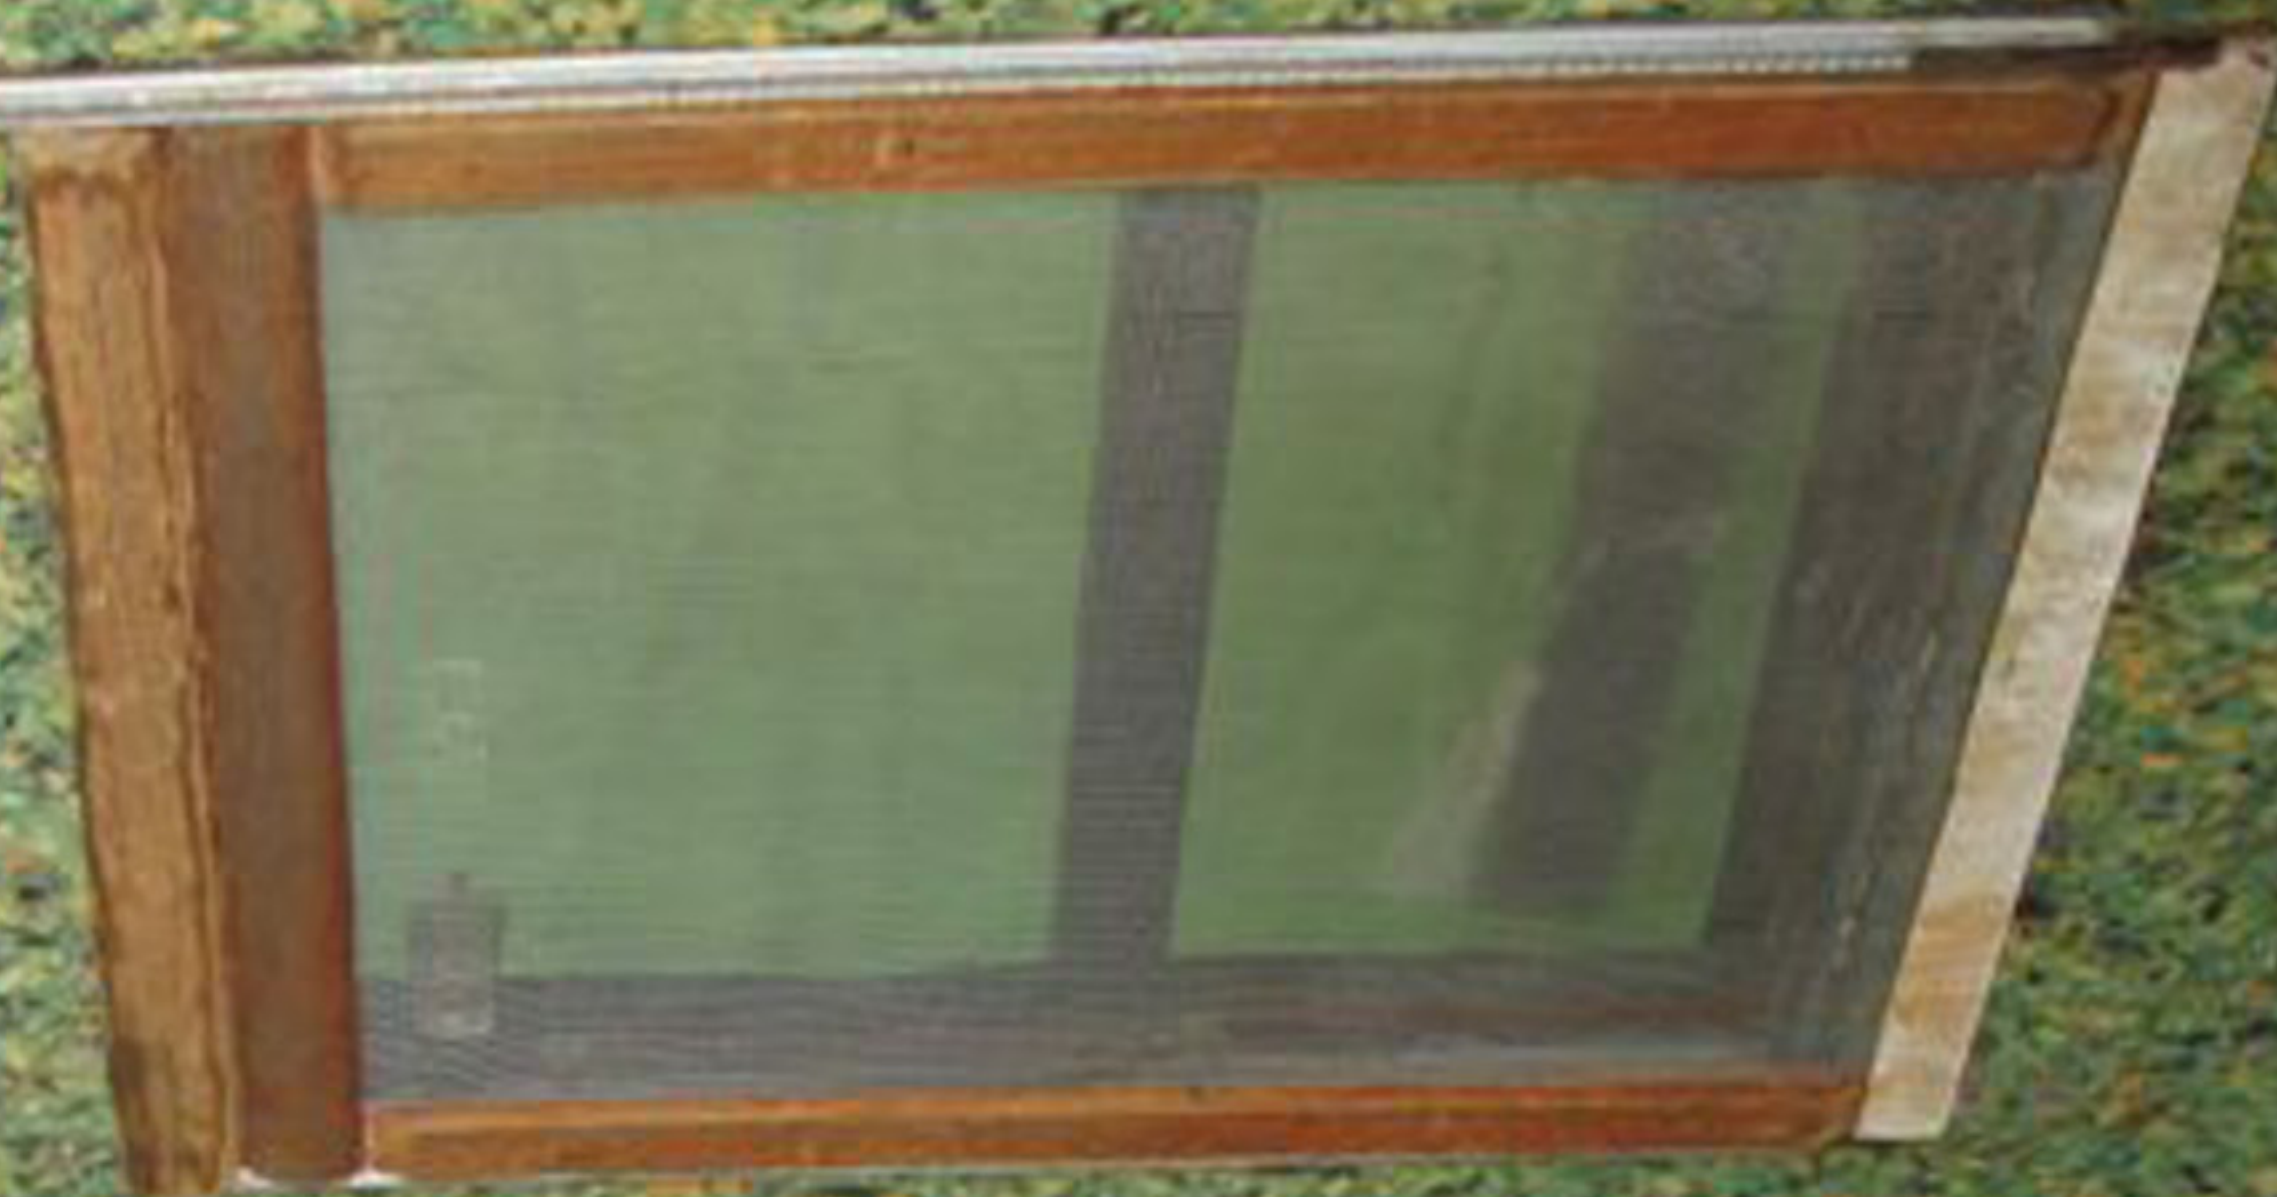
ONE HALF FOAM PANEL AND ONE HALF FLY SCREEN OR ANY COMBINATION OF THE FOUR PANELS.

FOR EASY ACCESS, COMMON USE SMALL ITEMS CAN BE KEPT BEHIND A RETAINING RAIL ALONG THE TOP OF THE THREE FOOD CUPBOARDS.

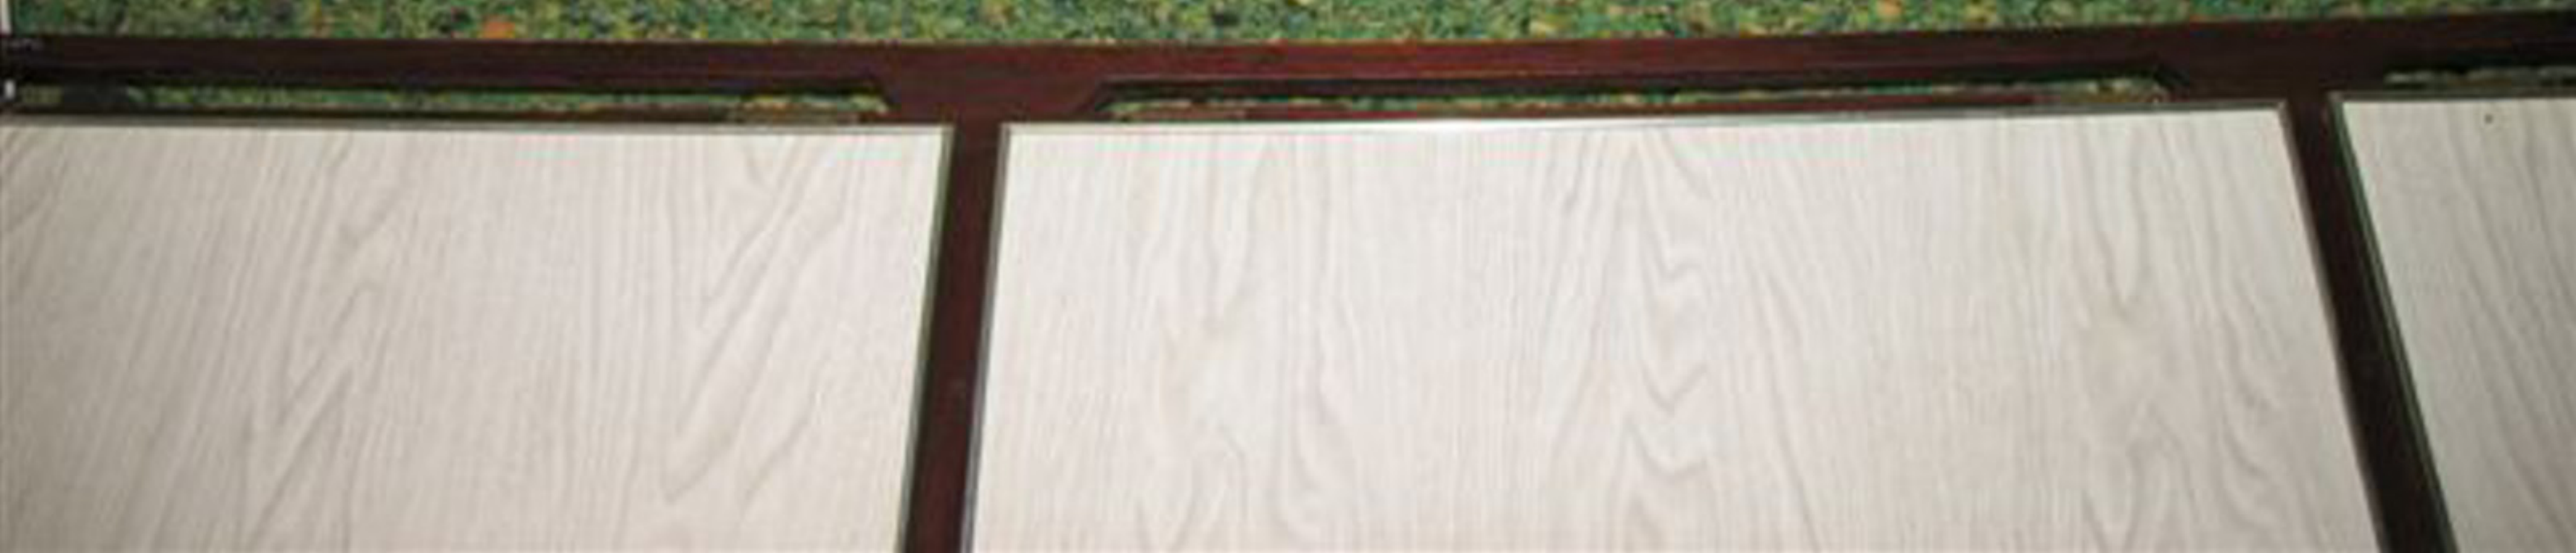
SLIDING CUPBOARD PANELS.

14 IMPERIAL GALLON, VINYL, WATER TANK ABOVE HERE. WELL PROTECTED FROM FREEZING BY ABOVE CUPBOARD AND BED BELOW.

**SKYLIGHT
SLIDING PANEL
STORAGE RACKS.**

**UNDER-
CLOTHES
CUPBOARD**

STORAGE SHELF.

**TAILGATE WINDOW CURTAIN
WITH 1 INCH FOAM BEHIND.**

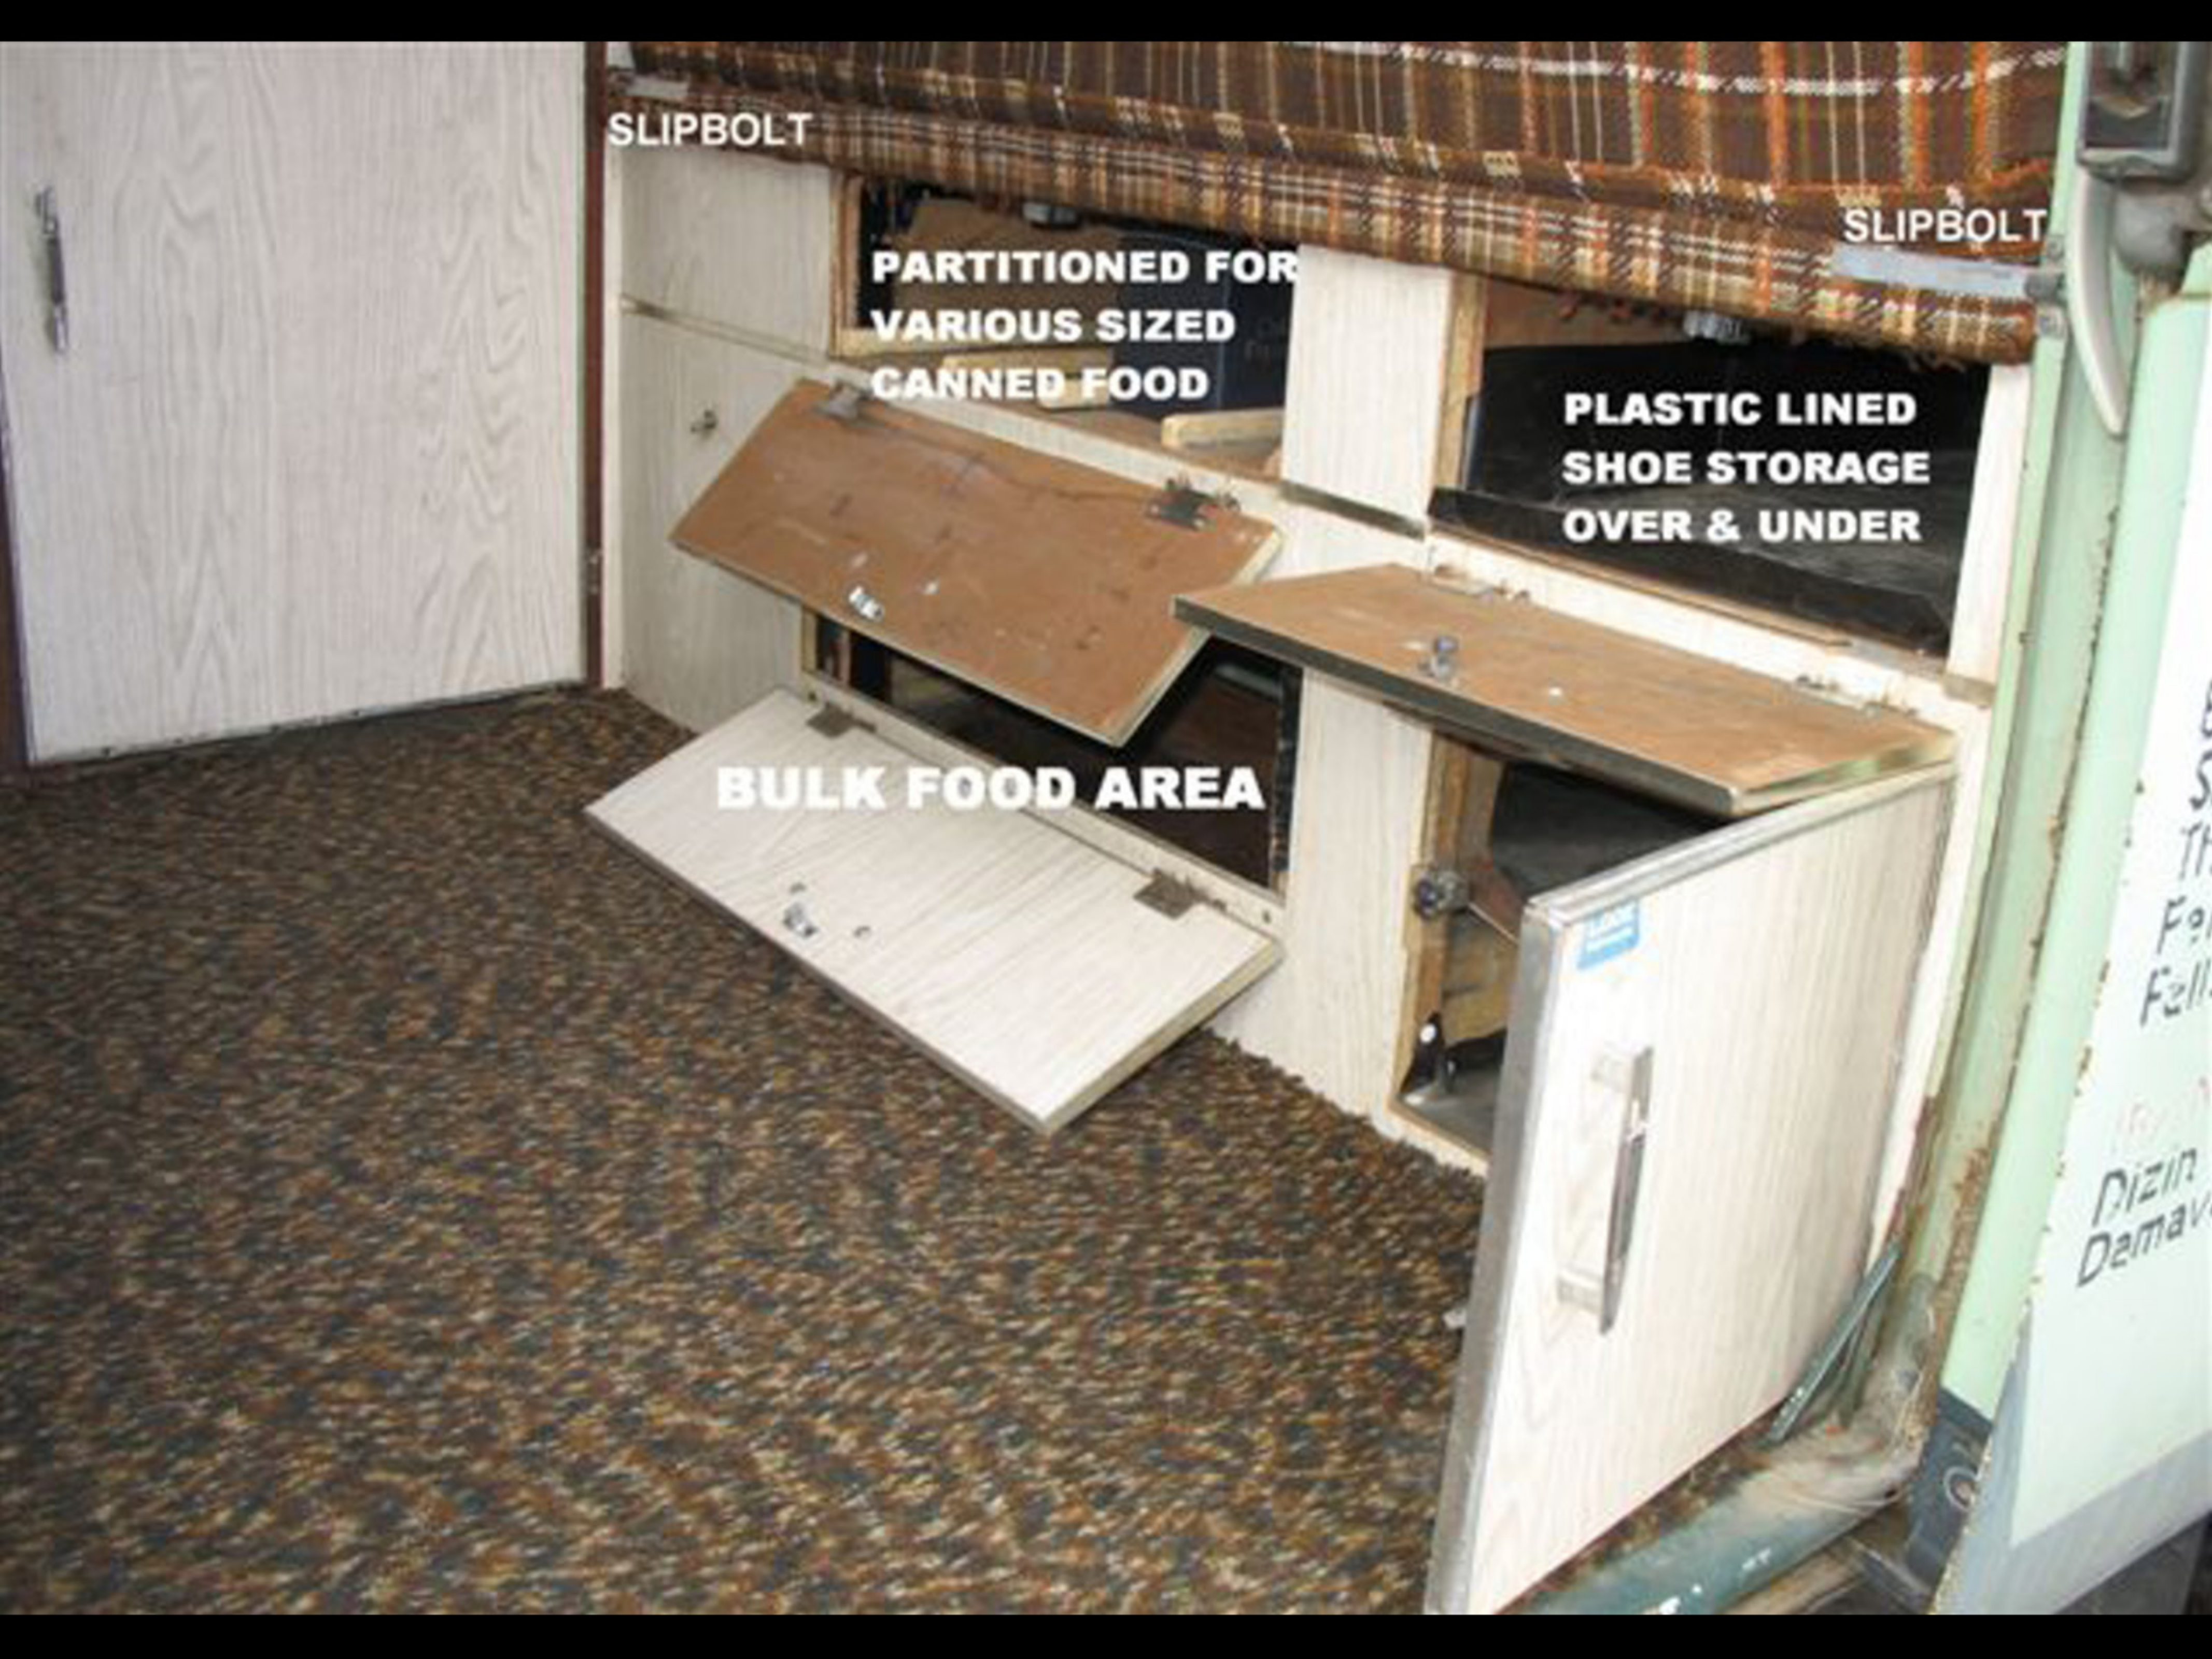
WHEN THE BEDHEAD IS IN POSITION,
BED IS OVER 7FT LONG. SHEETS WERE
CHANGED WEEKLY BY OPENING HATCH
AND MAKING UP BOTTOM OF BED
FROM THERE. BEDDING WAS FOLDED
BACK DURING THE DAY OUT OF SIGHT
WHEN REMOV-ABLE TOP END WAS
PLACED IN THE DAYTIME POSITION.

6 INCH HIGH DENSITY FOAM

**BACKREST SLIPBOLTS INTO BOTH SIDES
TO EXTEND BED. LEGS DROP DOWN.**

**LEGS CLIP BEHIND SOFA BACK-
REST BY DAY. DROP DOWN FOR
BED EXTENSION AT NIGHT.**

**BED WAS DESIGNED SO THAT IN THE EVENT OF ONE PARTY
BEING UNWELL AND WISHING TO REMAIN IN BED, THE TOP END
OF THE BED COULD BE REMOVED AND PLACED IN THE FRONT
CAB OUT OF THE WAY THUS ALLOWING THE LIVING AREA TO BE
USED AS USUAL AND THE UNWELL PARTY TO REMAIN IN BED.**

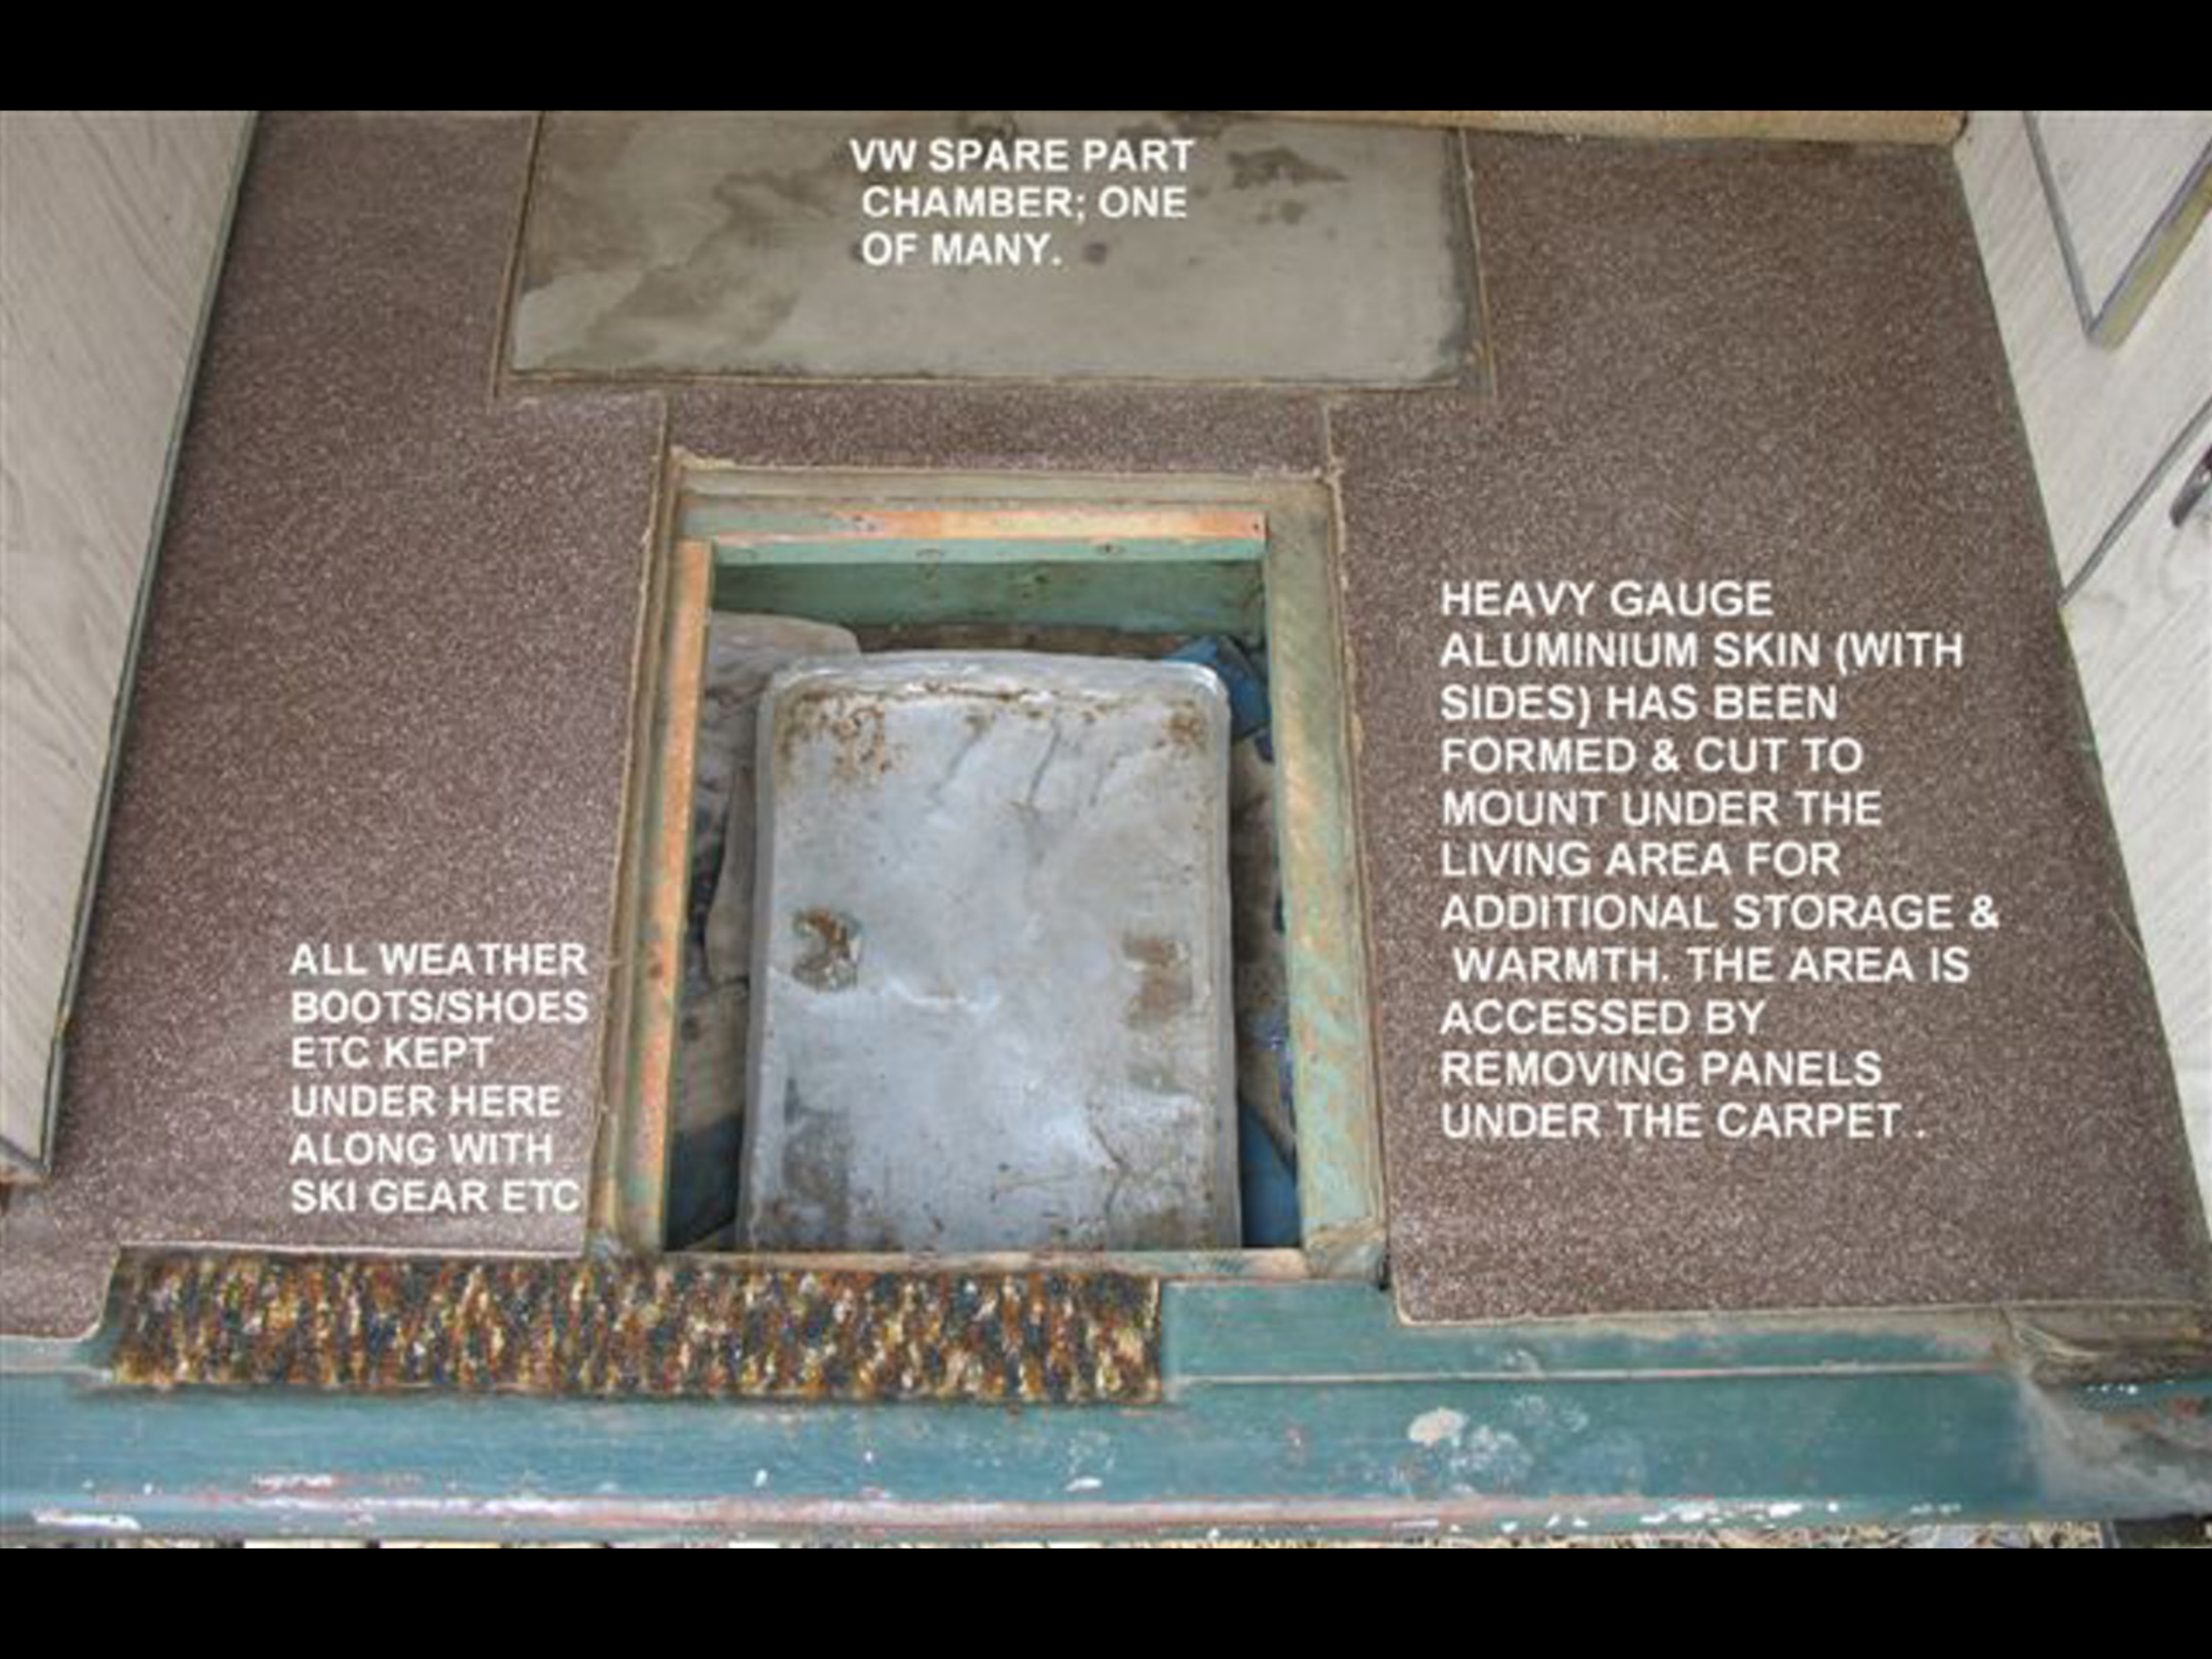
VW SPARE PART
CHAMBER; ONE
OF MANY.

ALL WEATHER
BOOTS/SHOES
ETC KEPT
UNDER HERE
ALONG WITH
SKI GEAR ETC

HEAVY GAUGE
ALUMINIUM SKIN (WITH
SIDES) HAS BEEN
FORMED & CUT TO
MOUNT UNDER THE
LIVING AREA FOR
ADDITIONAL STORAGE &
WARMTH. THE AREA IS
ACCESSED BY
REMOVING PANELS
UNDER THE CARPET.
