As experience dictated, the living quarters of RR2 was refined many times to cater for changing conditions but not forgetting the fact that it had to remain a vehicle suited for less than ideal conditions. It was no luxury motorhome but in contrast to such a vehicle, it would park, camp and go almost anywhere economically and reliably. In many countries, campgrounds were few and far between and trying to reach them, placed an undesirable burden on one's day. However, if there was one thing while travelling that we really tried to avoid, it was a campground; for the most part, they represented everything we were trying to escape from. But enough said, let's have a look inside what was our home for 17 years.

LIVING AREA VIEW
FROM SIDE DOOR

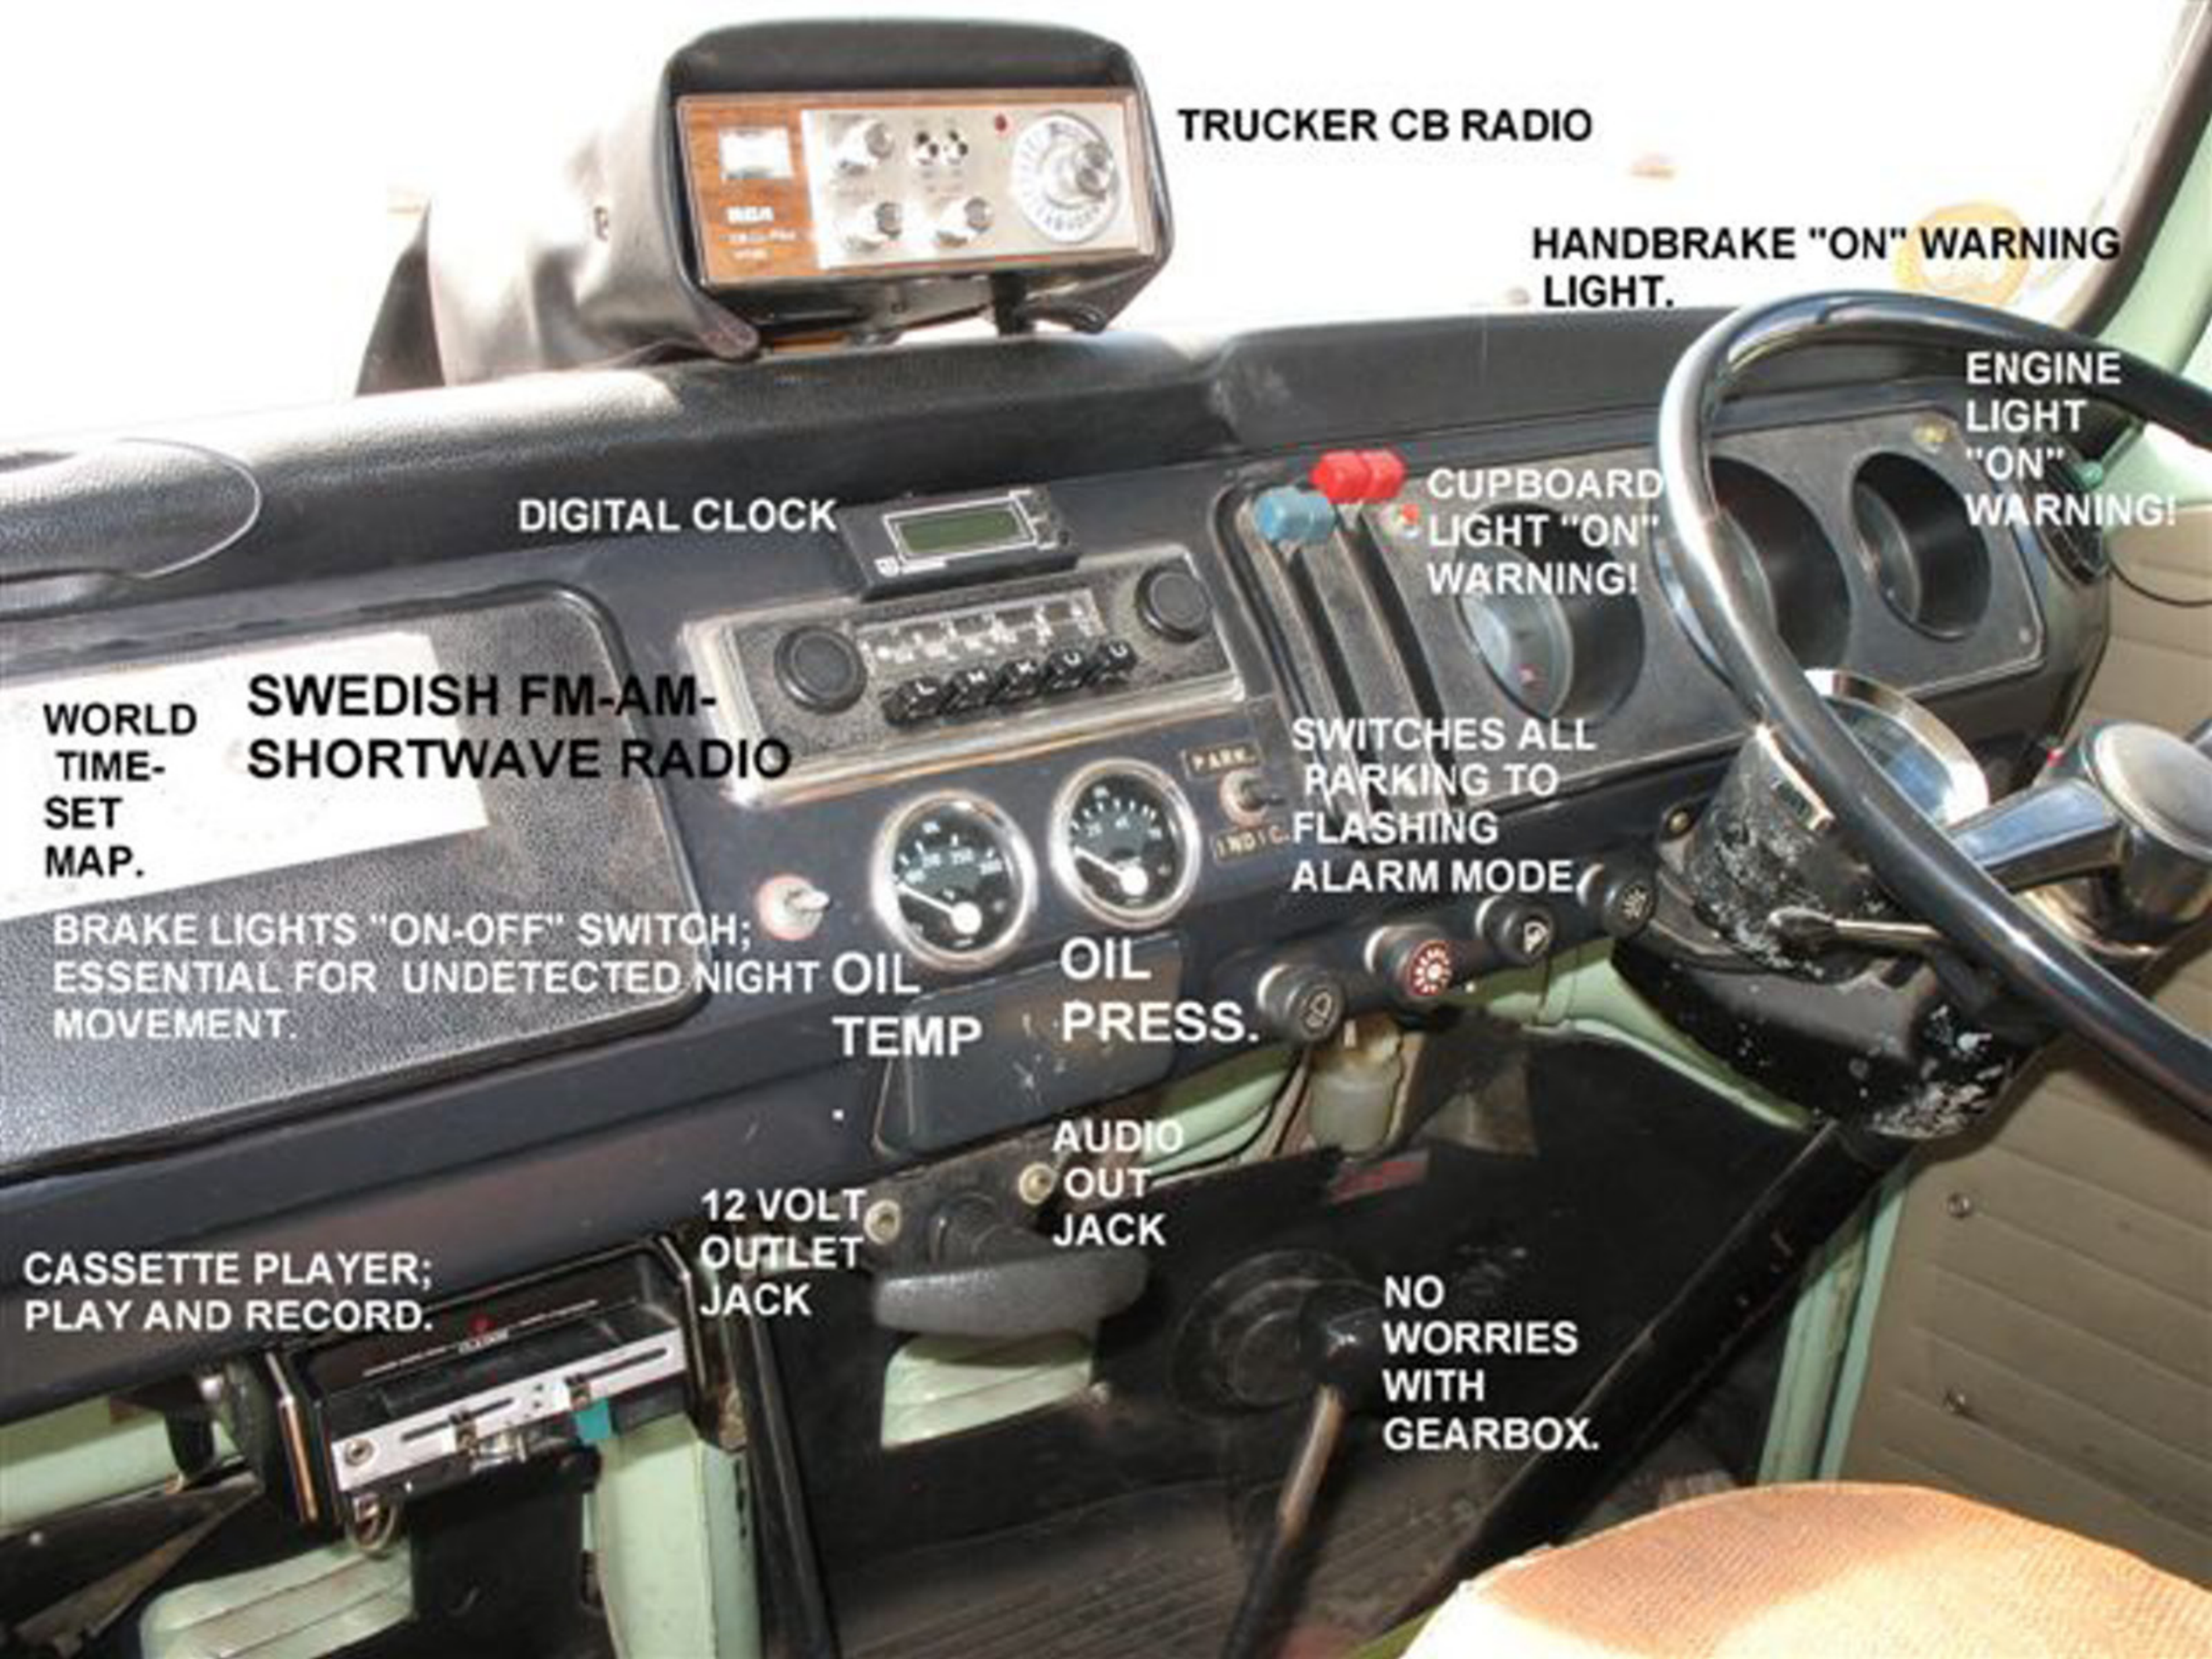
TRUCKER CB RADIO

HANDBRAKE "ON" WARNING LIGHT.

ENGINE LIGHT "ON" WARNING!

SWITCHES ALL PARKING TO FLASHING ALARM MODE

BRAKE LIGHTS "ON-OFF" SWITCH; ESSENTIAL FOR UNDETECTED NIGHT MOVEMENT.

AUDIO OUT JACK

12 VOLT OUTLET JACK

CASSETTE PLAYER; PLAY AND RECORD.

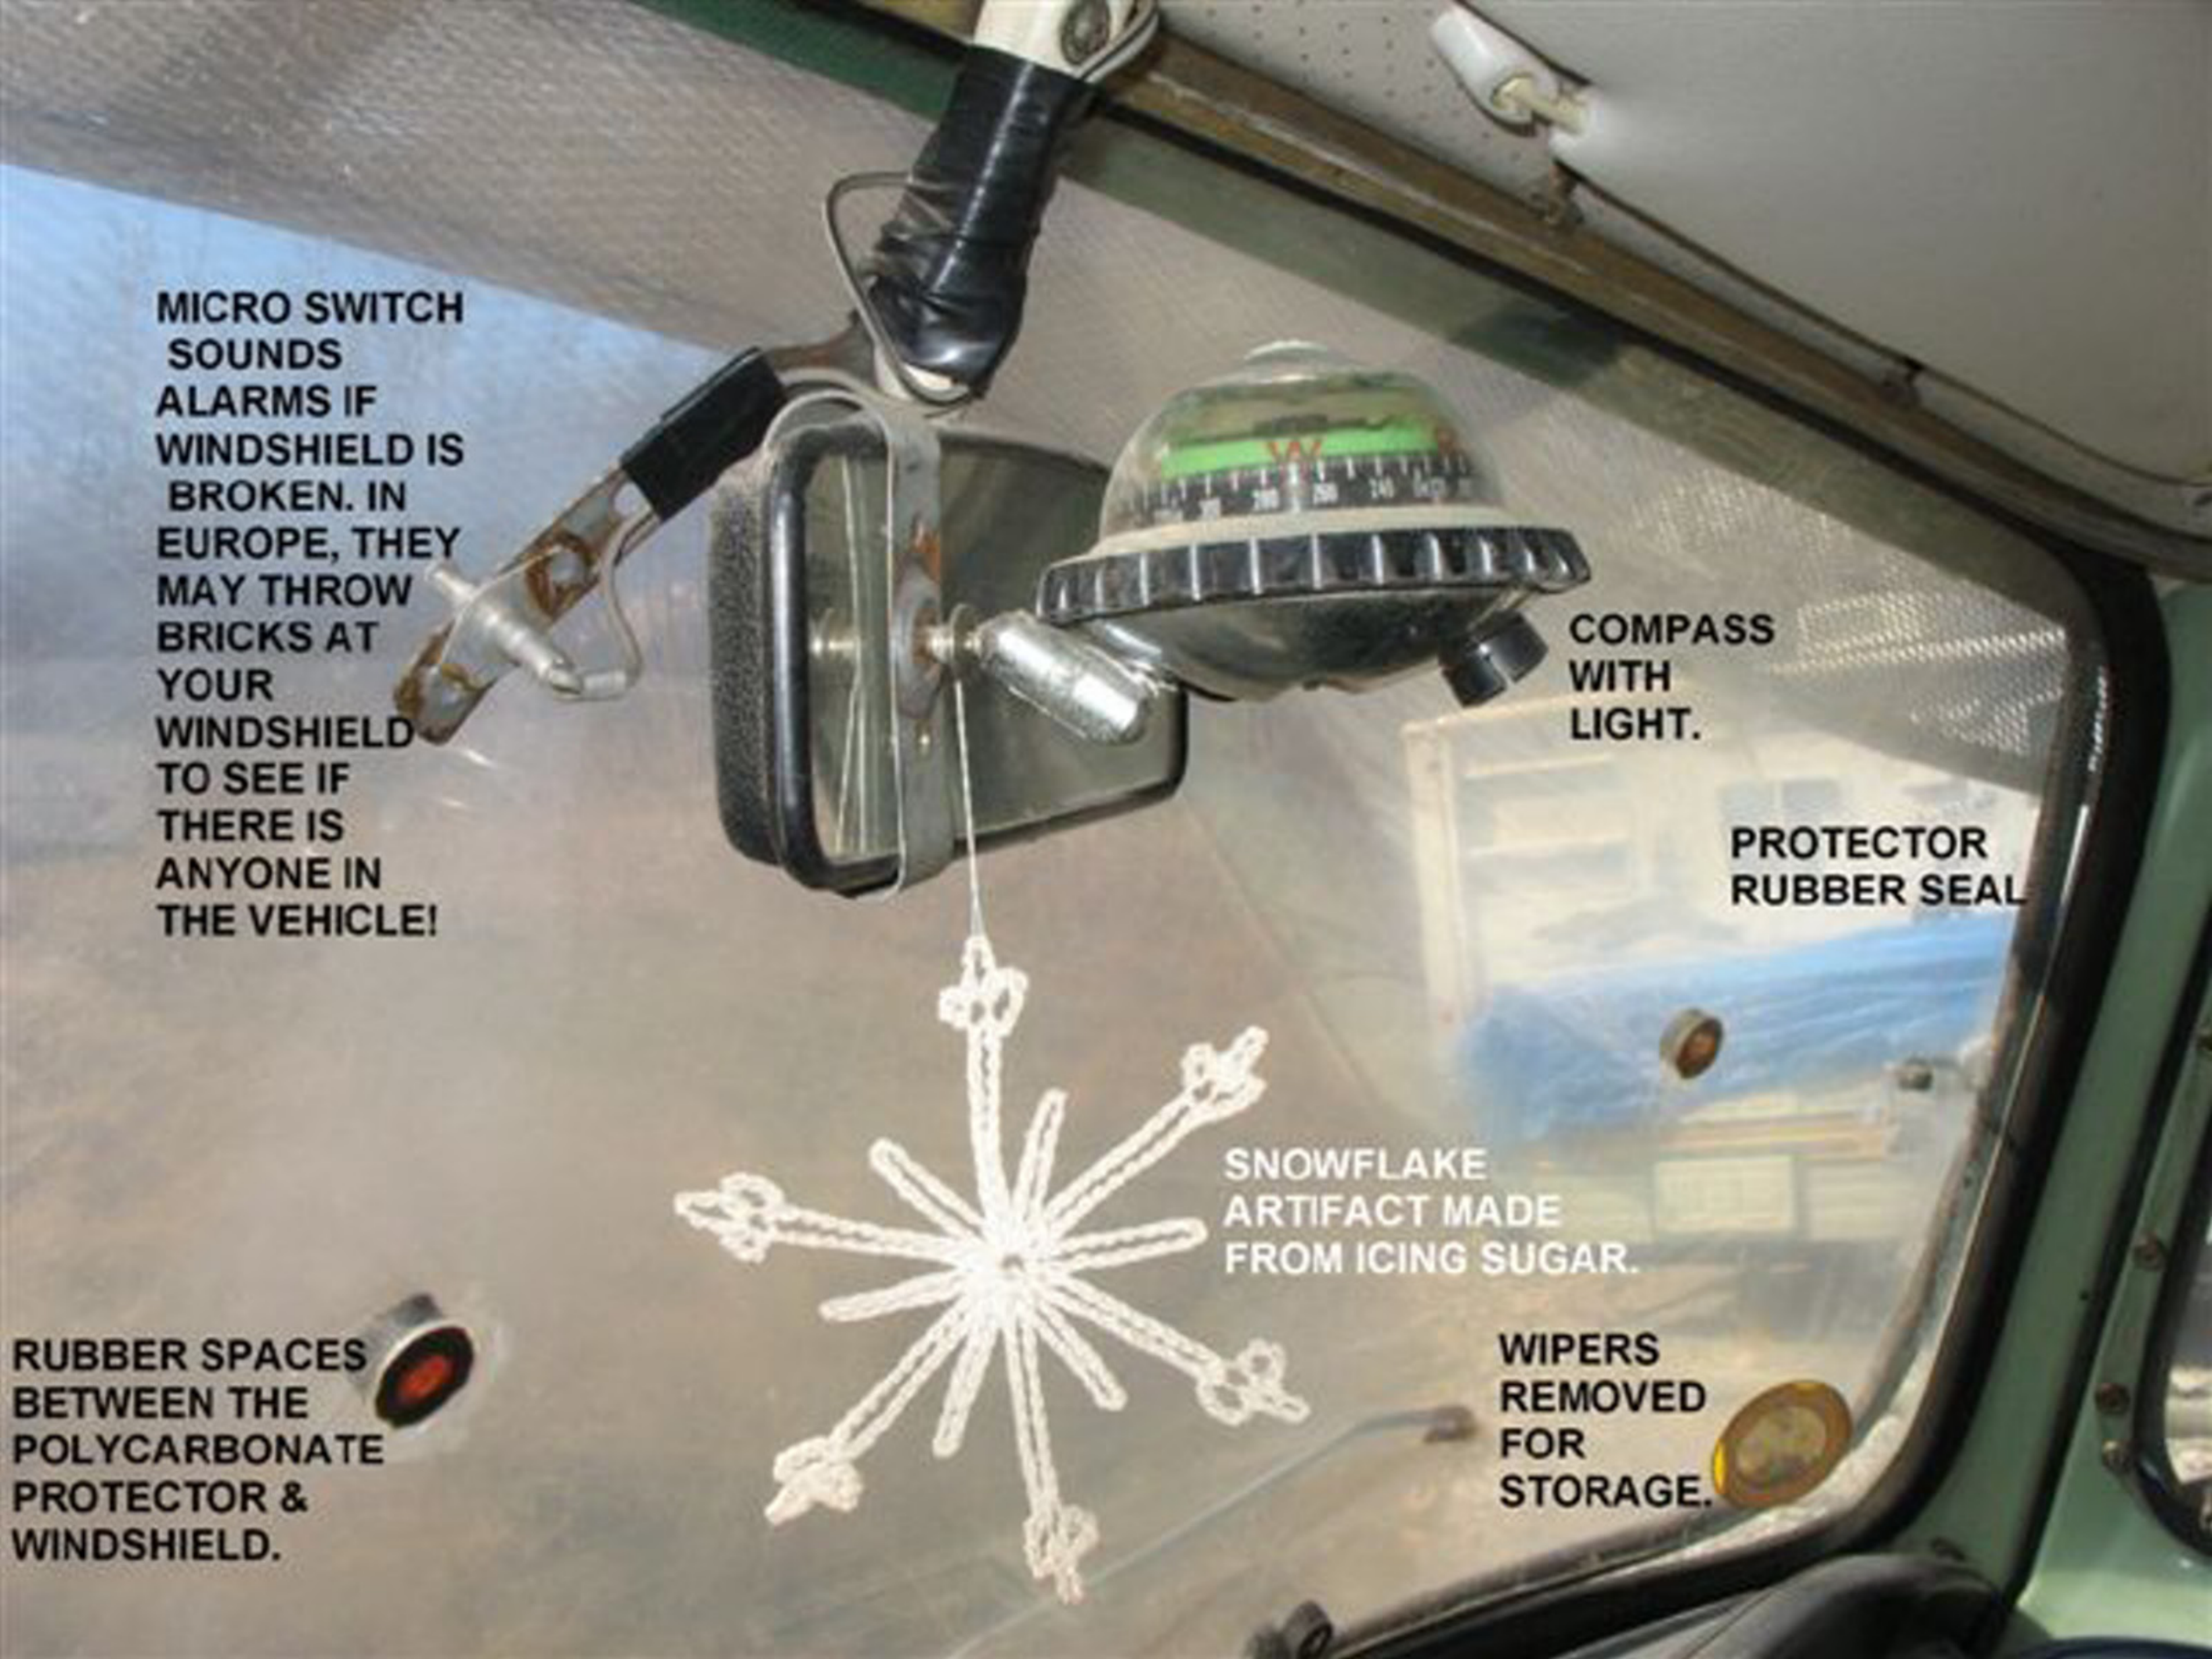
LIGHT ATTACHED
TO TACHO. SHINES
DOWN ON SPIRIT
LEVELS BELOW

QUALITY, MOVING
COIL AMP-METER
0-10-20-30

0-20, QUALITY, MOVING
COIL VOLTMETER

**MICRO SWITCH
SOUNDS
ALARMS IF
WINDSHIELD IS
BROKEN. IN
EUROPE, THEY
MAY THROW
BRICKS AT
YOUR
WINDSHIELD
TO SEE IF
THERE IS
ANYONE IN
THE VEHICLE!**

**RUBBER SPACES
BETWEEN THE
POLYCARBONATE
PROTECTOR &
WINDSHIELD.**

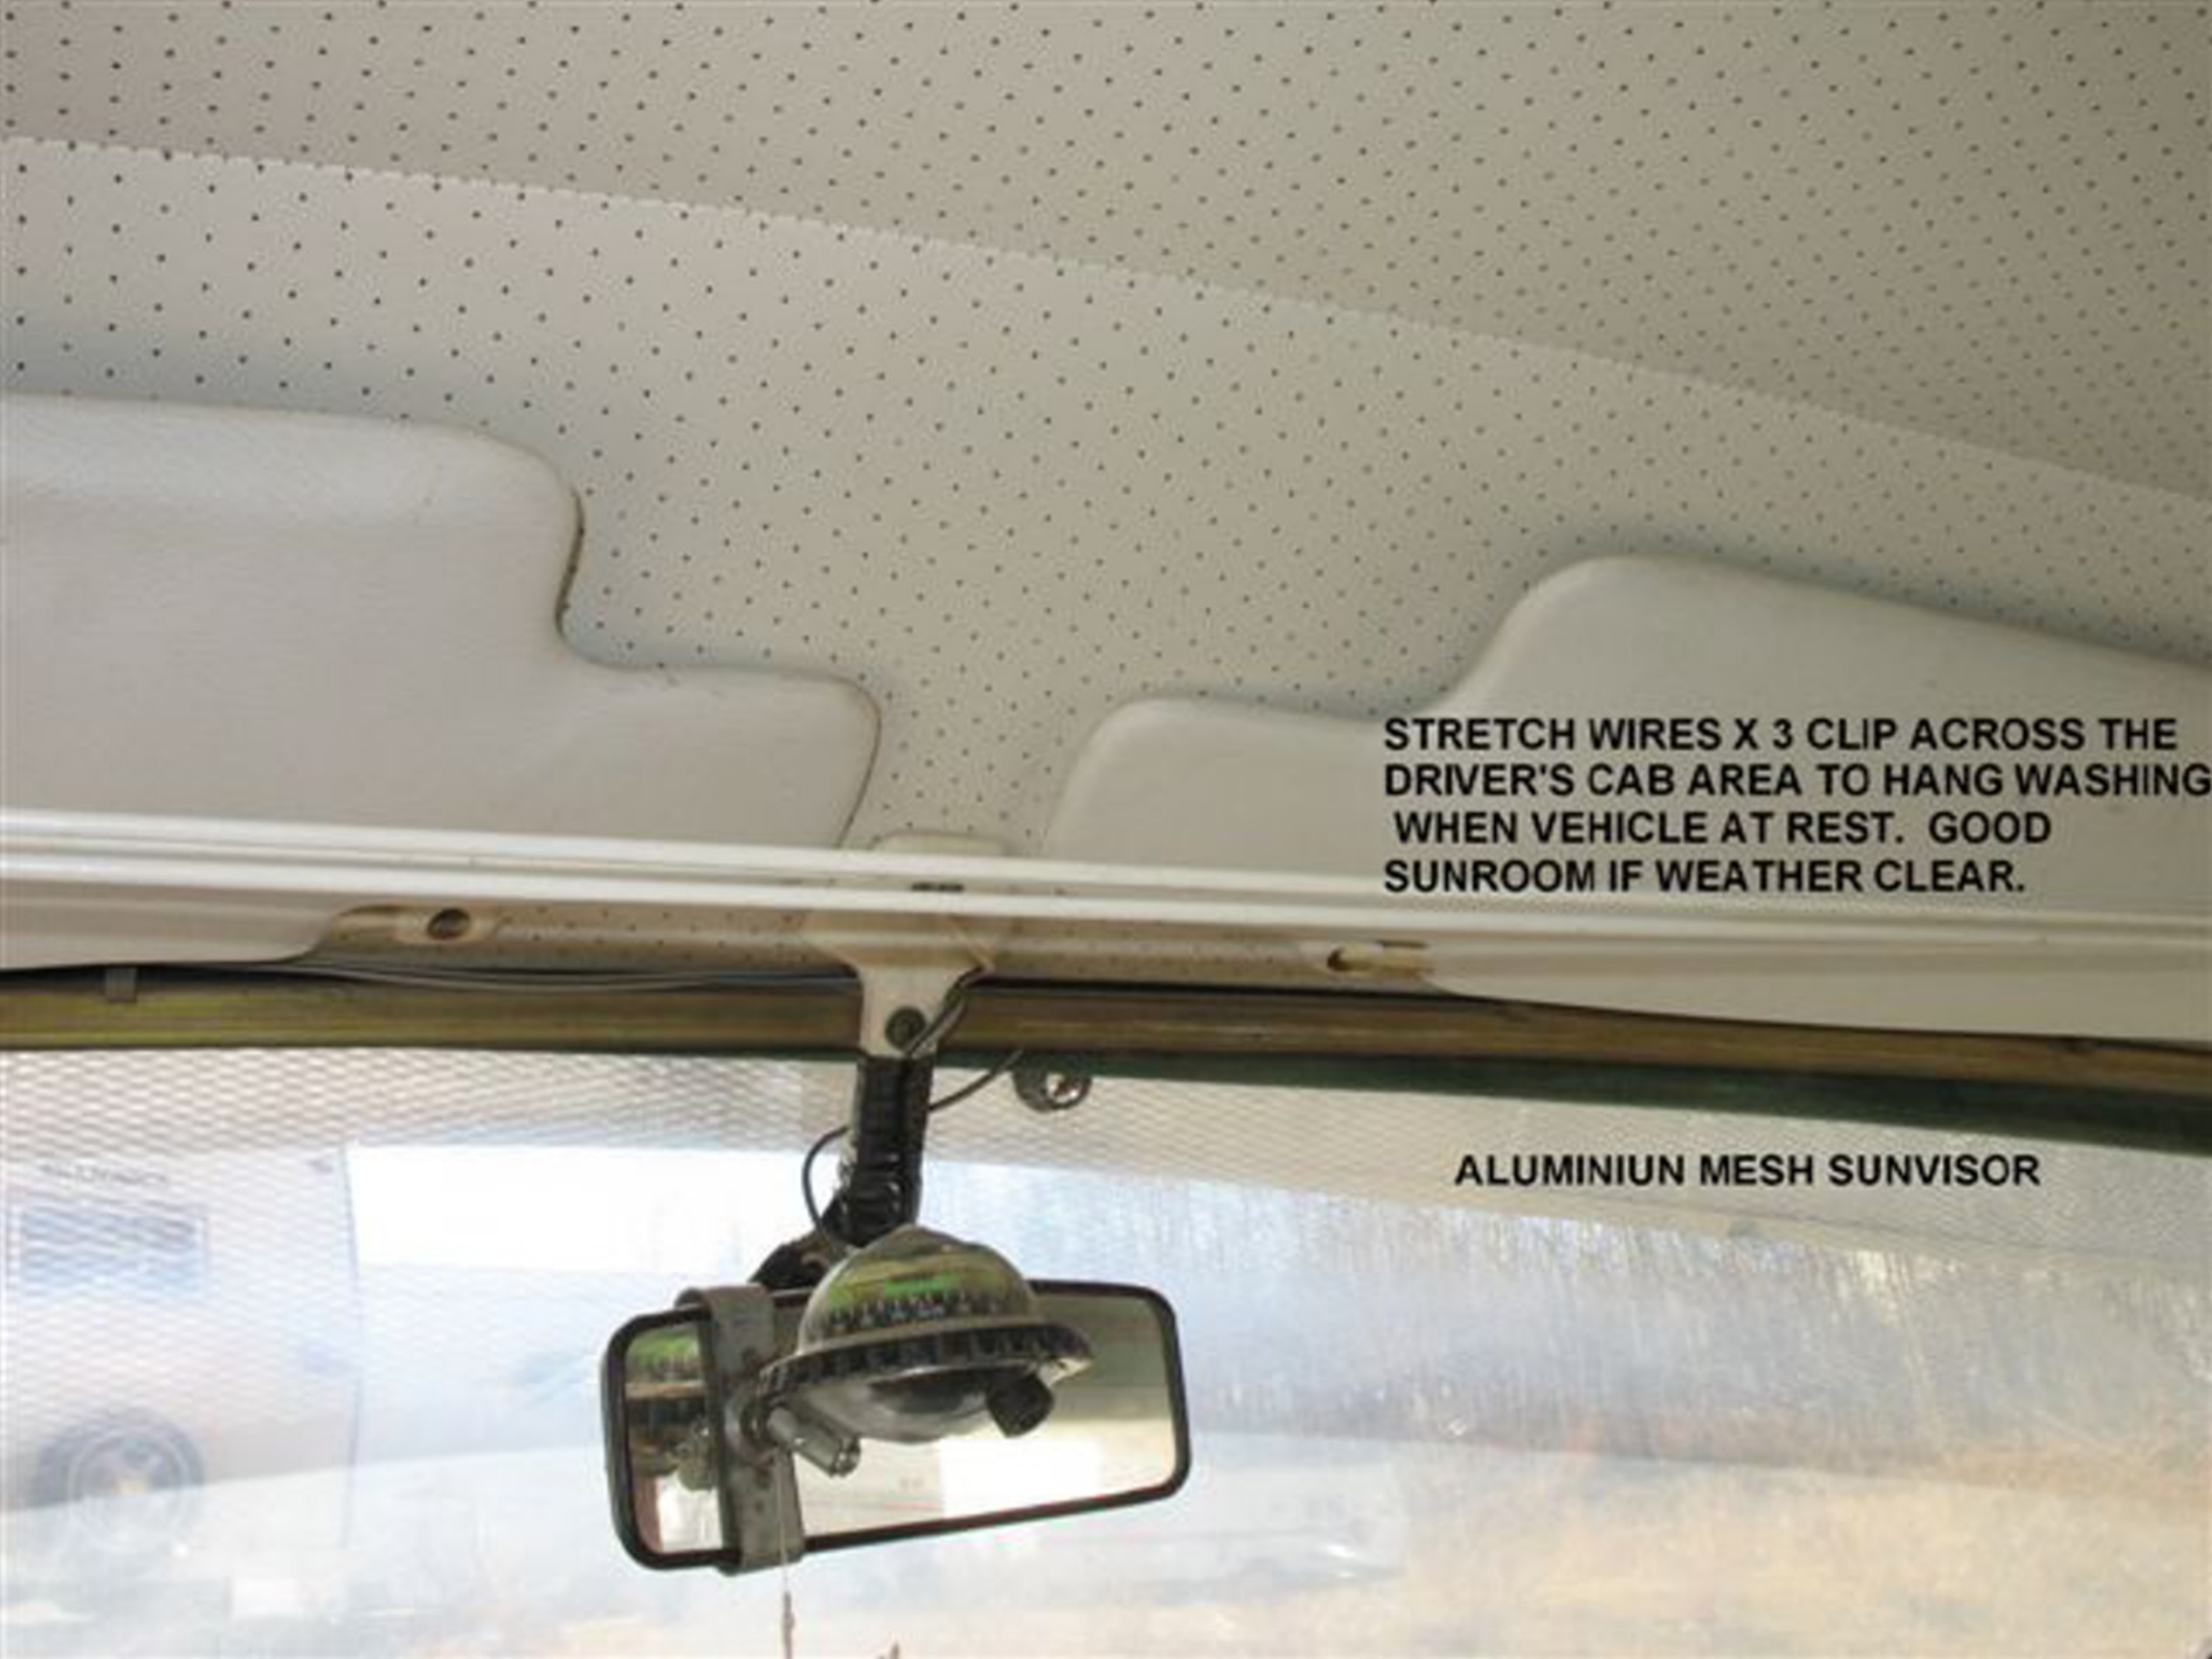
The image shows the interior of a vehicle, specifically the driver's side. The ceiling is white with a perforated pattern. A sunvisor is mounted on the ceiling, and a rearview mirror is attached to it. The sunvisor is currently down, and the rearview mirror is in its upright position. The text "STRETCH WIRES X 3 CLIP ACROSS THE DRIVER'S CAB AREA TO HANG WASHING WHEN VEHICLE AT REST. GOOD SUNROOM IF WEATHER CLEAR." is overlaid on the right side of the image. The text "ALUMINIUM MESH SUNVISOR" is overlaid on the right side of the image, below the first text block.

STRETCH WIRES X 3 CLIP ACROSS THE DRIVER'S CAB AREA TO HANG WASHING WHEN VEHICLE AT REST. GOOD SUNROOM IF WEATHER CLEAR.

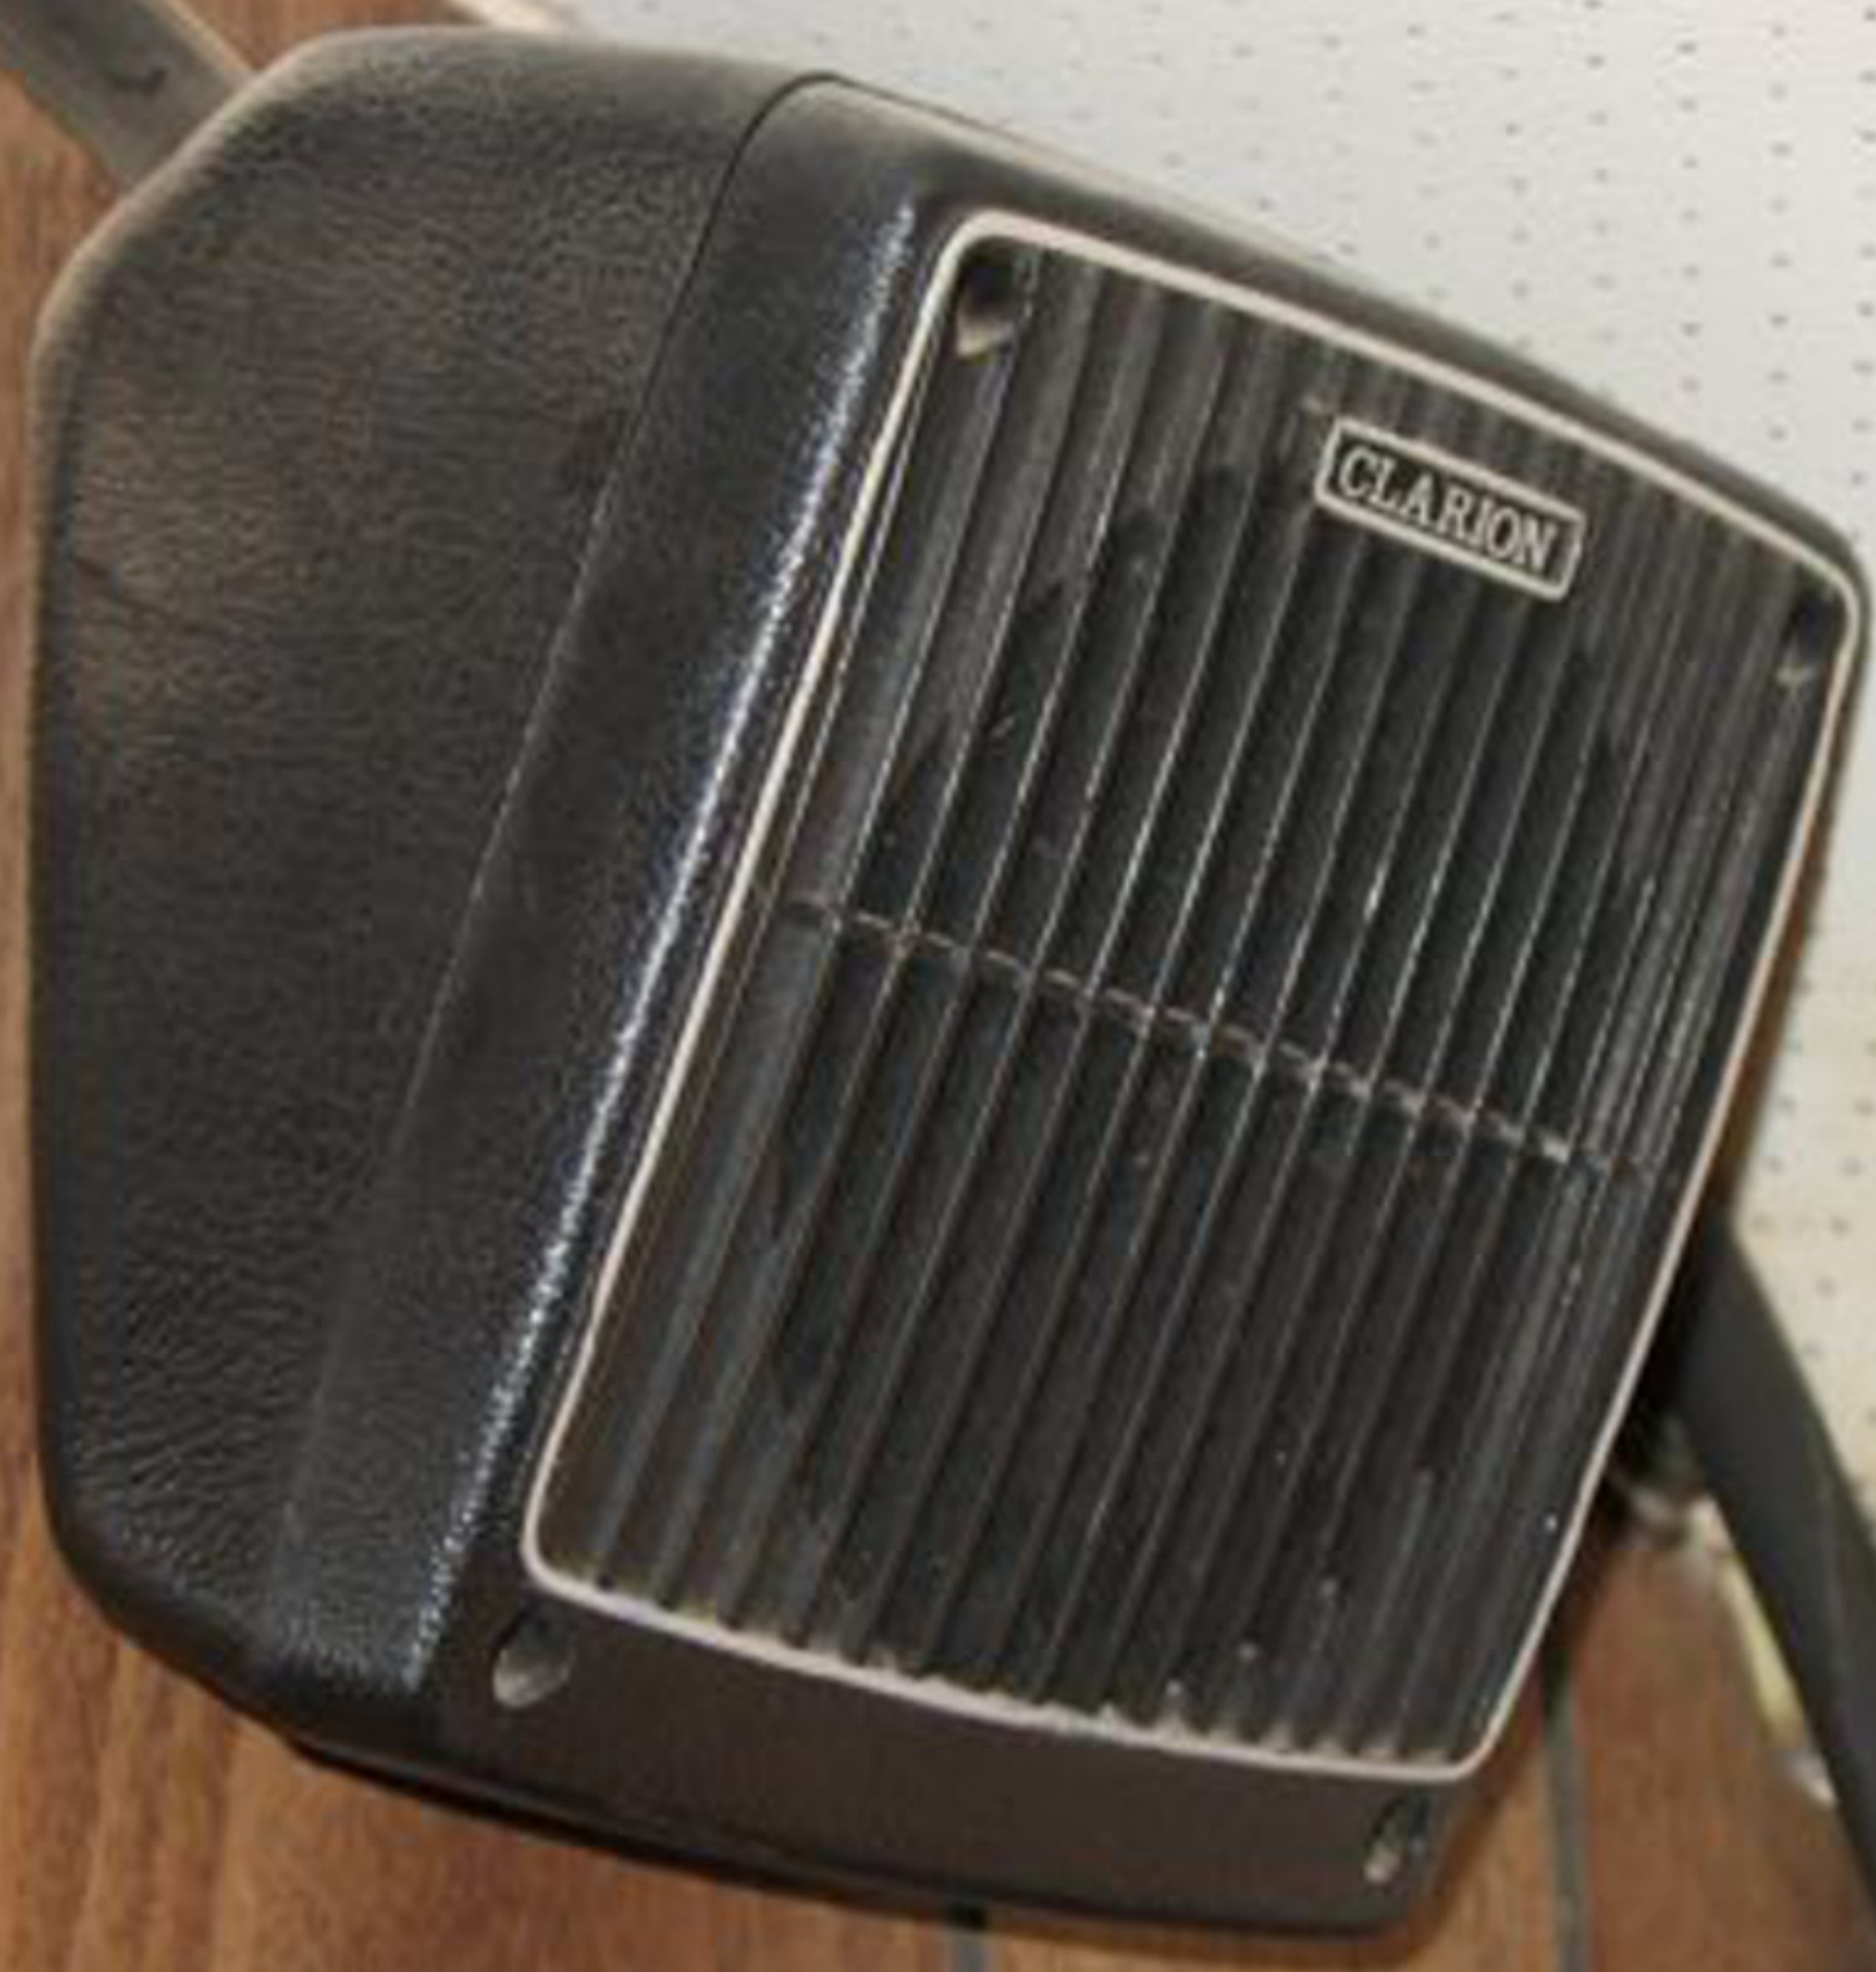
VOLUME CONTROL FOR CAB RADIO

TWO-WAY SWITCH FOR DRIVER'S CAB PA SYSTEM OR CAB RADIO TO REAR.

AC/12V DC REFRIGERATOR SWITCH

LEFT SIDE SWITCH FOR INVERTER UNIT, (12V DC TO 300 WATT 240V AC). PROVIDES POWER FOR FRONT/REAR CEILING EXHAUST FANS

RIGHT SIDE AC SWITCH TO INBUILT BATTERY CHARGER. HEAVY DUTY STEPUP TRANSFORMER IN CLOTHES CLOSET, CONVERTS 120V AC (USA) TO ALL CAMPER 240 VOLTS(AUSSIE) REQUIREMENTS IF NEEDED.

**2 LEFT, 2 RIGHT, 1
CENTRE & 1 REAR
SPEAKER IN
LIVING AREA ARE
ALL CONNECTED TO
THE TAPE PLAYER
& IN DASH RADIO.**

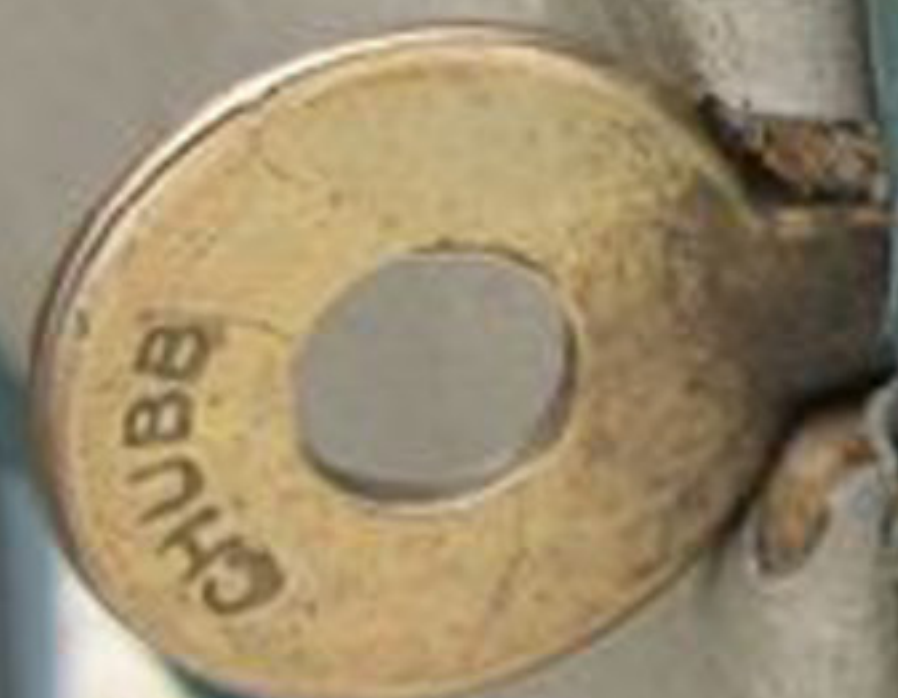
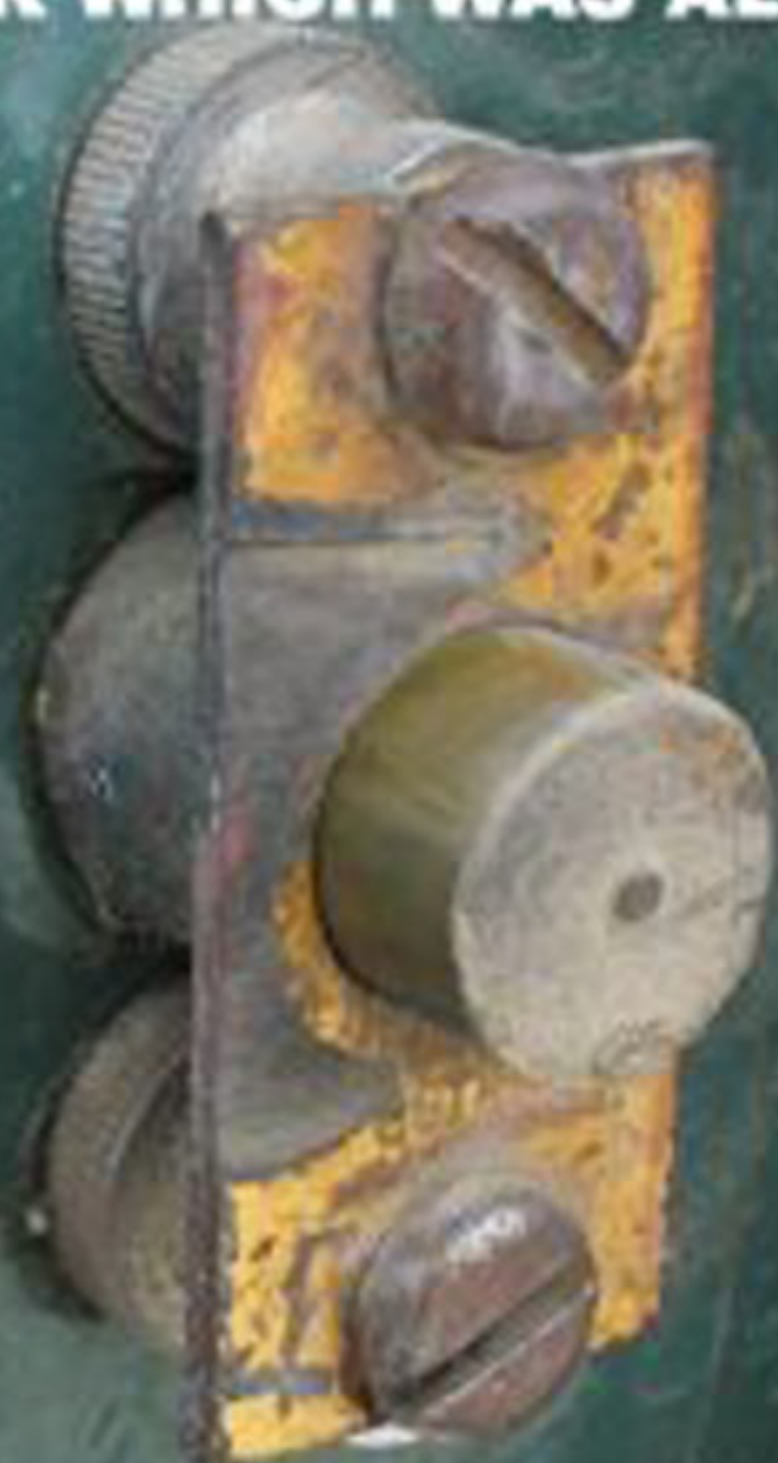
WHEN LEAVING THE VEHICLE FOR ANY LENGTH OF TIME, CHUB BOLTS SECURED THE DOOR TO THE BODY. THIS WAS DONE BY LEANING THROUGH FROM THE LIVING AREA AND THEN LEAVING THE VEHICLE FROM THE SIDE SLIDING DOOR WHICH WAS ALSO DOUBLE LOCKED WITH A SECURITY DEAD-BOLT.

**BOTH
SYSTEMS
SAVED
LOSING
EVERYTHING
MORE THAN
ONCE.**

**SLIPPING A 2 INCH BOLT
THROUGH A PRECISELY
DRILLED HOLE IN THE
DOOR, PREVENTED THE
WINDOW FROM BEING
WOUND DOWN IF THE
TRIANGULAR CORNER
WINDOW HAD BEEN
FORCED. DOOR COULD
NOT BE OPENED TO
ACCESS THIS BECAUSE OF
THE CHUB BOLT SYSTEM
DESCRIBED EARLIER.**
